October 2023
FL958A-G
NHTSA #22V-817
Transport Canada #2022-626
REVISED BULLETIN

Subject: Brake Modulator Valves

Models Affected: Specific model years 2017-2023 Freightliner 114SD, Business Class M2, and Cascadia; and Western Star 47X, 49X, and 57X vehicles, manufactured May 3, 2016, through June 18, 2022.

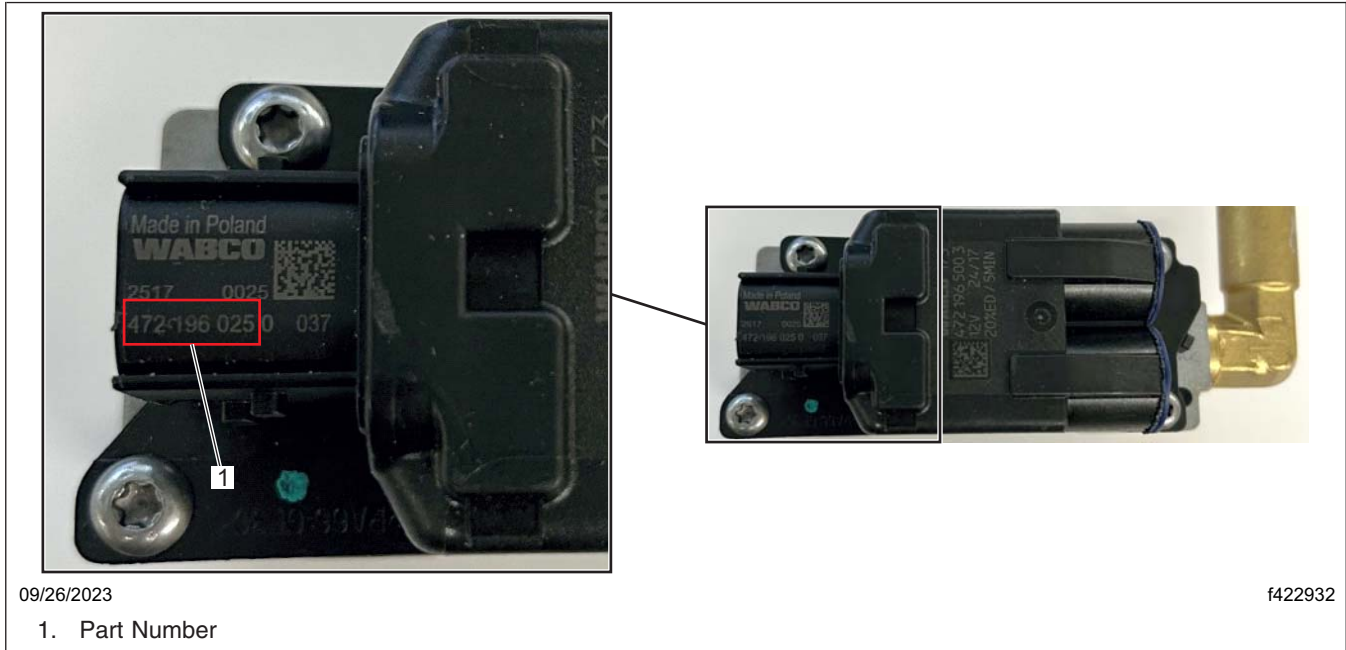
Fig. 1, Modulator Valve

4. Remove the connector from the valve, and inspect the part number underneath the connector. See [Fig. 1](#).

Good part numbers → **472 196 046 0** and **472 196 051 0**

Bad part numbers → **472 196 025 0** and **472 196 037 0**

- If the part numbers are good, install the connector. Clean a spot on the base label (Form WAR259), and attach a campaign completion sticker for FL958 (Form WAR260), indicating this work has been completed.
- If at least one of the part numbers is bad, go to the replacement procedure for the specified group, and replace both the modulator valves.
