NHTSA SAFETY RECALL NUMBER 22E-055

AWNING INSPECTION AND WELD/SEAM REPAIR

Recall Number:	22E-055		
Product:	Awnings		
Date:	Original: July 15, 2022 Current: Sept. 1, 2022	Labor Rate:	.30 hours inspection only .30 hours repair only 1.5 hours fabric replacement only

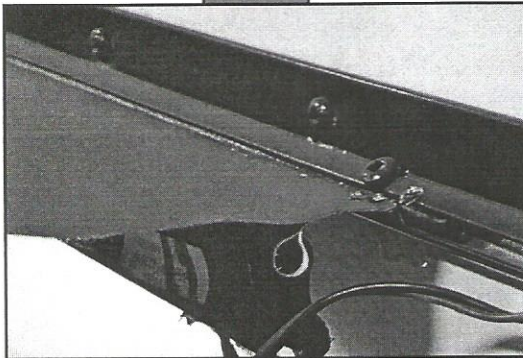
Fig. 1

The purpose of this document is to provide guidance, as well as visual aides, to dealers performing inspection on units that may have insufficient awning weld(s). The inspection point is at the awning fabric seam at the awning rail at the wall of the unit (Fig. 1). This only affects awnings manufactured January 17, 2022 – June 14, 2022. The date of manufacture can be located on the variant code label (Fig. 2) located on the awning.
