**PRODUCT CAMPAIGN BULLETIN**

**APPLICABILITY:** 2019-2022MY Ascent

**NUMBER:** WRL-22R

**SUBJECT:** PTC Heater Ground Bolt

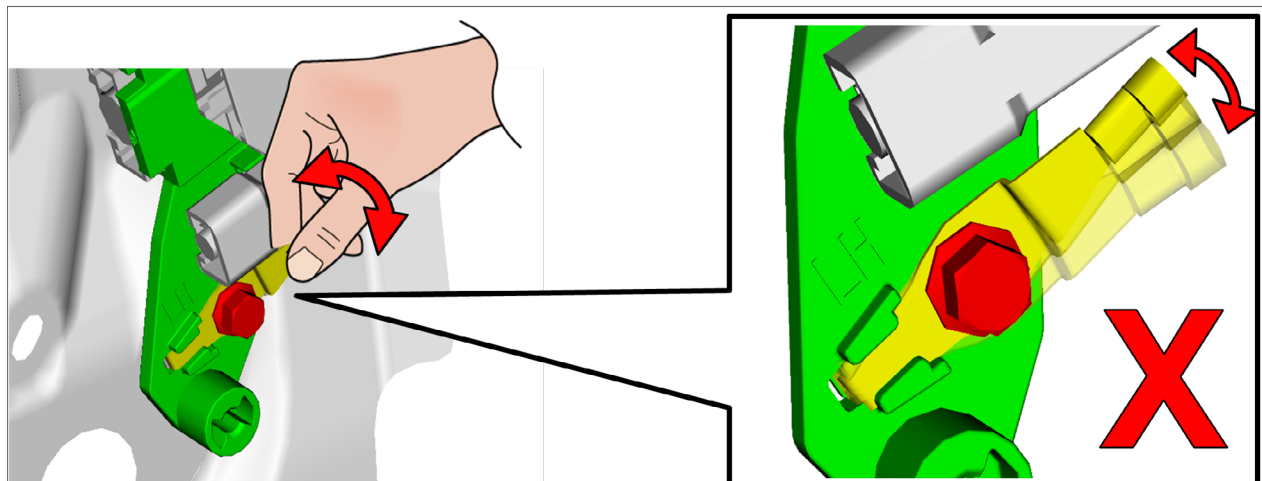
**CAUTION:** Any loose connection could cause a possible thermal event.

**STEP 26:** Confirm there is no movement with the ground terminal. Check for any loose contact by attempting to move the terminal with your fingers in an up/down direction. There is no need to pull the ground cable when checking for loose contact.
