## IMPORTANT SAFETY RECALL

**Re: Safety Recall – Smart-Steer 2.0 Self-Steer Axle with 702887 Steer Arm**

# SERVICE BULLETIN #SB015

## Subject: SMART-STEER 2.0 Axle with 702887 Steer Arm

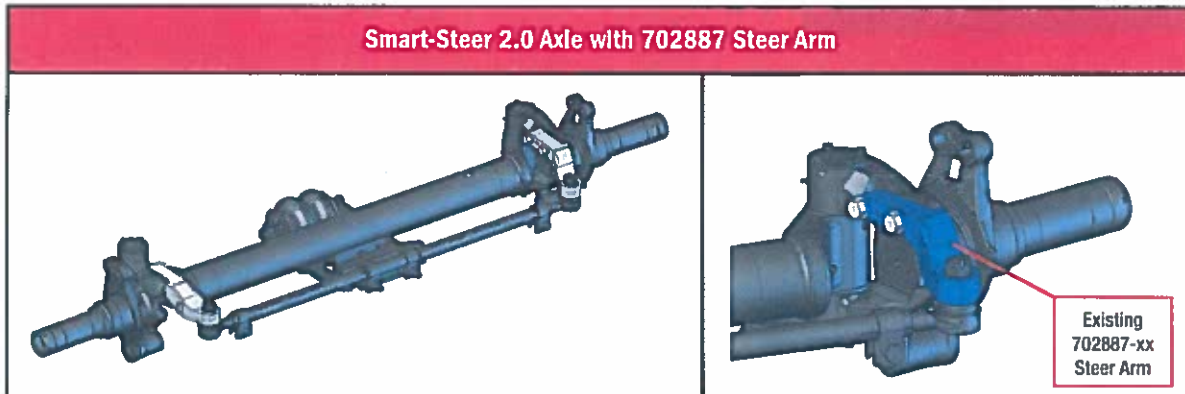
Based on feedback from our customers and recent analysis, Dexter Heavy Duty has identified an ongoing issue with the 702887 steer arm configuration on the Smart-Steer 2.0 self-steer axles. Under certain repeated heavy loading conditions, the steer arm has the potential to fail.

Upon receiving this service bulletin Dexter recommends making immediate arrangements with a Dexter authorized service facility to replace the steer arms on your self-steer axle(s).

1. Remove the existing steer arms and mounting hardware.
2. Clean mounting surface and surrounding surfaces to prepare for mounting of the new bolt-on steer arm and additional welds.
3. Grind a 3/16" chamfer along the mounting face edge (see page three for location & detail).
4. Mount new design steer arms (Part # 703293-LH/RH) with supplied hardware and torque to 400 ft-lbs.
5. Add welds as shown on page three of this bulletin.
