TO: Mercedes-Benz Dealer Principals, General Managers, Sales Managers, Service Managers, Parts Managers	FROM: Gregory Gunther, Department Manager, Vehicle Compliance and Analysis, Engineering Services
RE: <b>Recall Campaign Launch Notification</b> <b>Replace the Steering Coupling Locking Screws</b> <b>MY21-22 GLE-Class and GLS-Class</b> <b>(167 platform)</b>	DATE: January 13, 2023

# Recall Campaign Bulletin

Campaign No. 2022120016, January 2023

## **Replace the Steering Coupling Locking Screws**

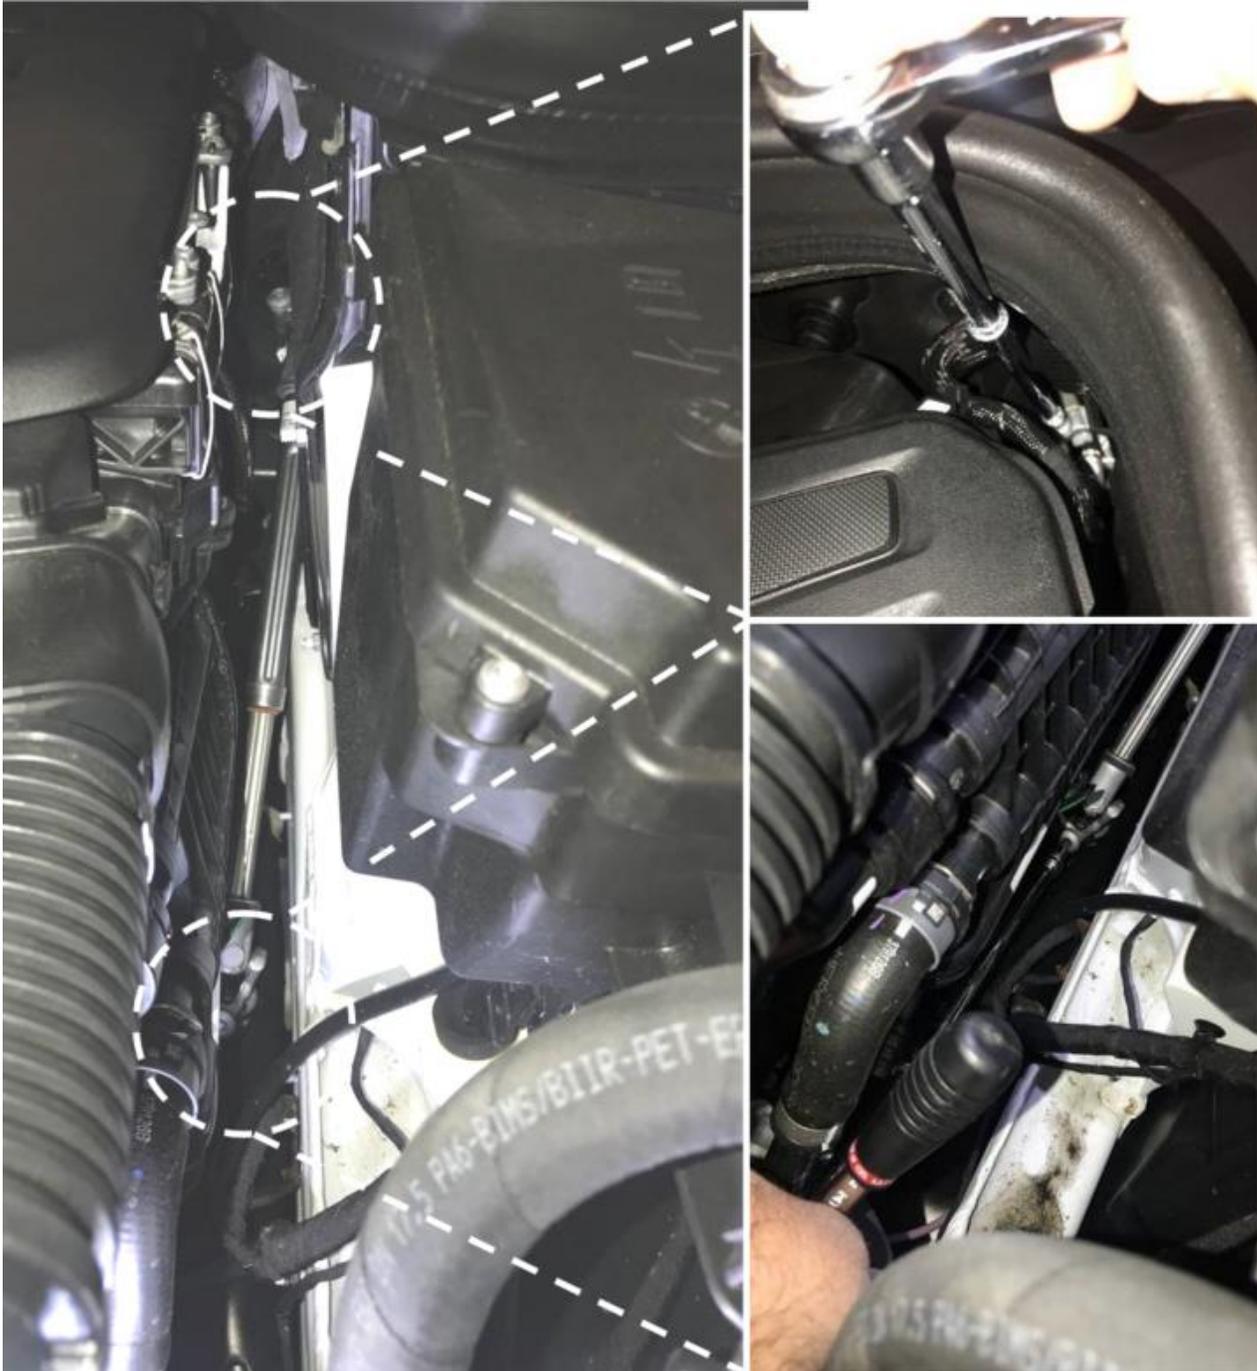
Figure 1

Mercedes-Benz AG (“MBAG”), the manufacturer of Mercedes-Benz vehicles, has determined that on certain Model Year (“MY”) 2021-2022 GLE and GLS (167 platform) vehicles, the steering coupling locking screws might not be tightened to the specified torque value. Insufficient tightening torque of the steering coupling locking screws might lead to free play in the connection, which would cause noises when driving on uneven roads. Should these noises not be noticed and therefore the vehicle not be brought to a workshop, the steering coupling locking screws may subsequently loosen further due to vibrations during driving and ultimately might back out of the steering coupling. In this condition, it cannot be fully ruled out that the steering coupling may detach from the steering shaft. This could impair the ability to steer the vehicle, which could increase the risk of a crash. Before the issue occurs, the driver may be made aware of the issue by resulting noises when driving on uneven roads. An authorized Mercedes-Benz dealer will replace the steering coupling locking screws on the affected vehicles.

1. Replace bolt at upper and lower universal joint of the steering coupling (Figure 1,2).

**i** Bolts shall be accessible from engine compartment at the top.

**i** Turn steering column until both bolts are accessible.

**Hm** Steering coupling bolt to steering shaft or rack-and-pinion steering **42 Nm**.
