Vehicle Compliance & Analysis

IMPORTANT RECALL CAMPAIGN UPDATE

Campaign No. 2023010004, January 2023

Check Sliding Roof Bonding

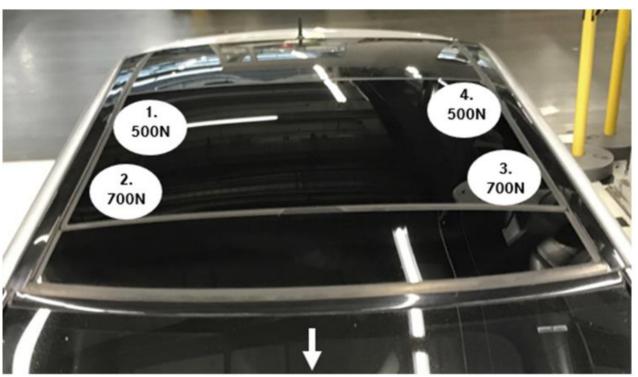
Figure 2 (Test sequence 1, 2, 3, 4 - arrow indicates direction of travel)

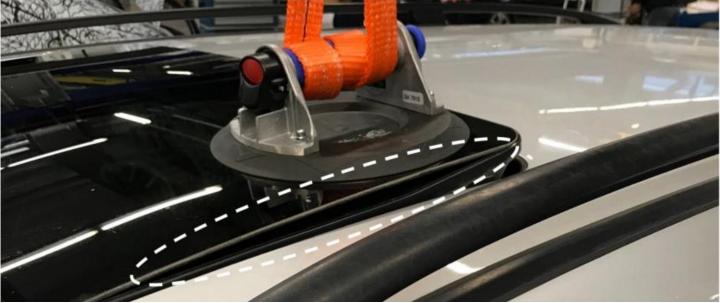
i If the panoramic sliding sunroof panel is detached from the padding of the sliding sunroof/ tilting roof frame at one of the test points (see Figure 3), replace the sliding sunroof panel.

Figure 3, not OK (shown here on a sliding sunroof)

- a. If the panoramic sliding sunroof panel is detached from the padding: Perform work procedure.
- b. If the panoramic sliding sunroof panel is not detached from the padding: Perform operation step 4 and end the measure.
- 4. Perform function test of panoramic sliding sunroof.
 - To do so, open and close panoramic sliding sunroof (tilt and slide positions).

1. Replace panoramic sliding sunroof panel (AR77.21-P-0500PB)
