TO: Mercedes-Benz Dealer Principals, General Managers, Sales Managers, Service Managers, Parts Managers	FROM: Gregory Gunther, Senior Manager, Vehicle Compliance and Analysis, Engineering Services
RE: Recall Campaign Updated Notification Check for Water Entry in the Spare Wheel Well MY12-20 GLE/ML and GLE Coupe (166 and 292 platform)	UPDATE: March 14, 2024

Check for Water Entry in the Spare Wheel Well

Campaign No. 2023010002, February 2023

SUBJECT: **Model GLE/ML and GLE Coupe (166 and 292 platform)
Model Year 2012-2019**

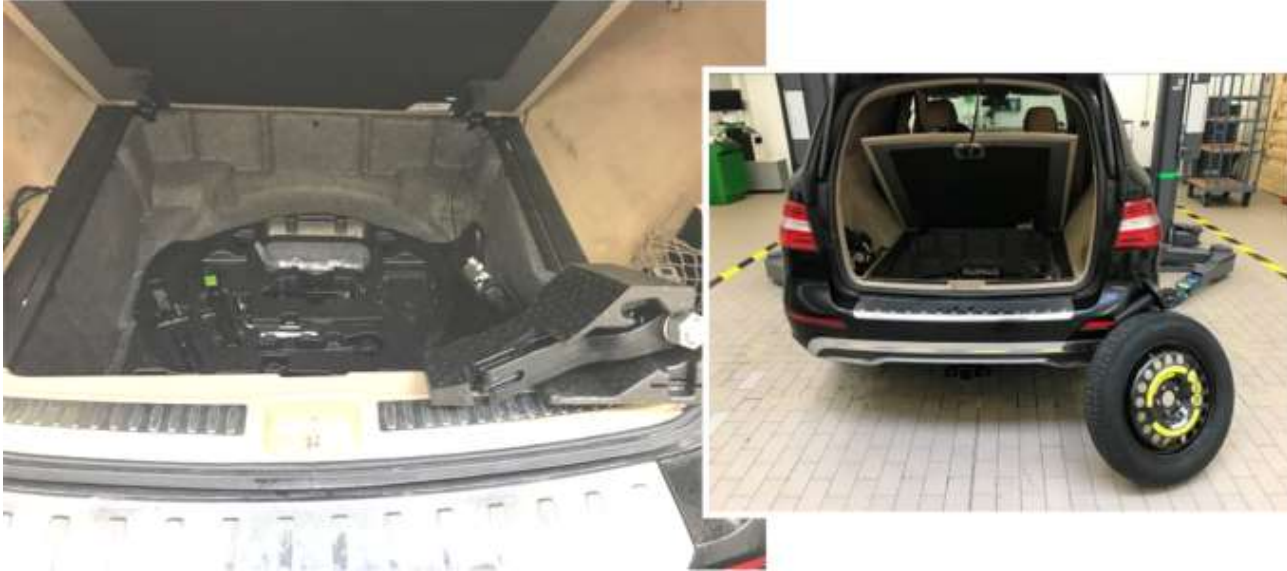
Figure 1

1. Open trunk.
2. Lift spare wheel well cover and secure it from falling down.
3. In vehicles with spare tire option code 690, remove spare tire and cover (**Figure 1**).

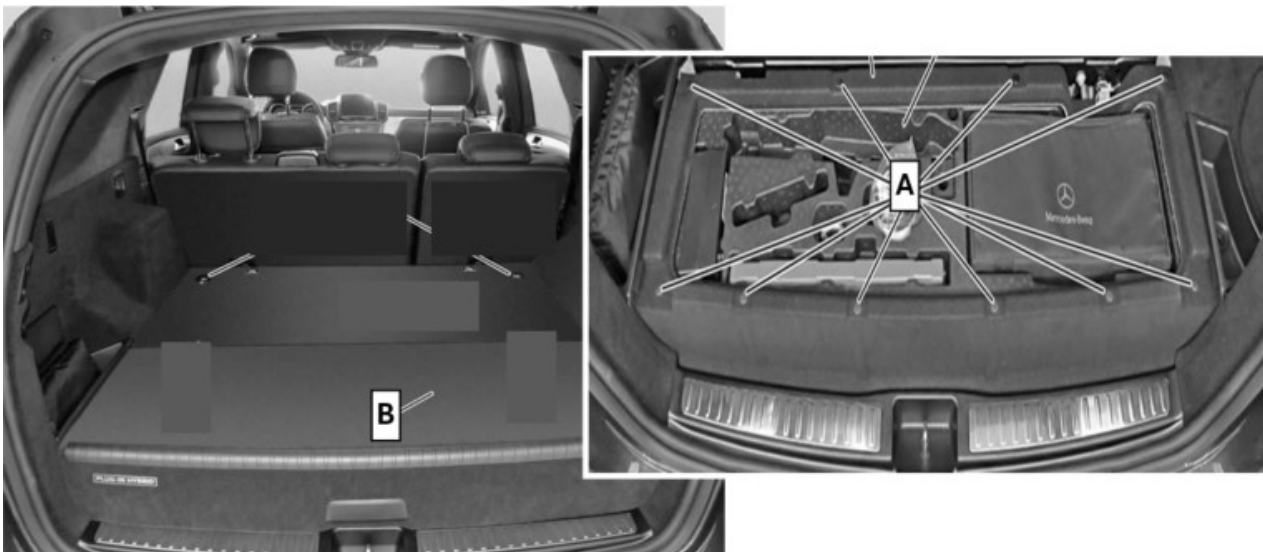
Figure 2

4. In hybrid model 166.063, remove load compartment shelf (**A, Figure 2**) with vehicle tool kit.

i Load compartment floor (**B, Figure 2**) does **not** need to be removed (just folded up).

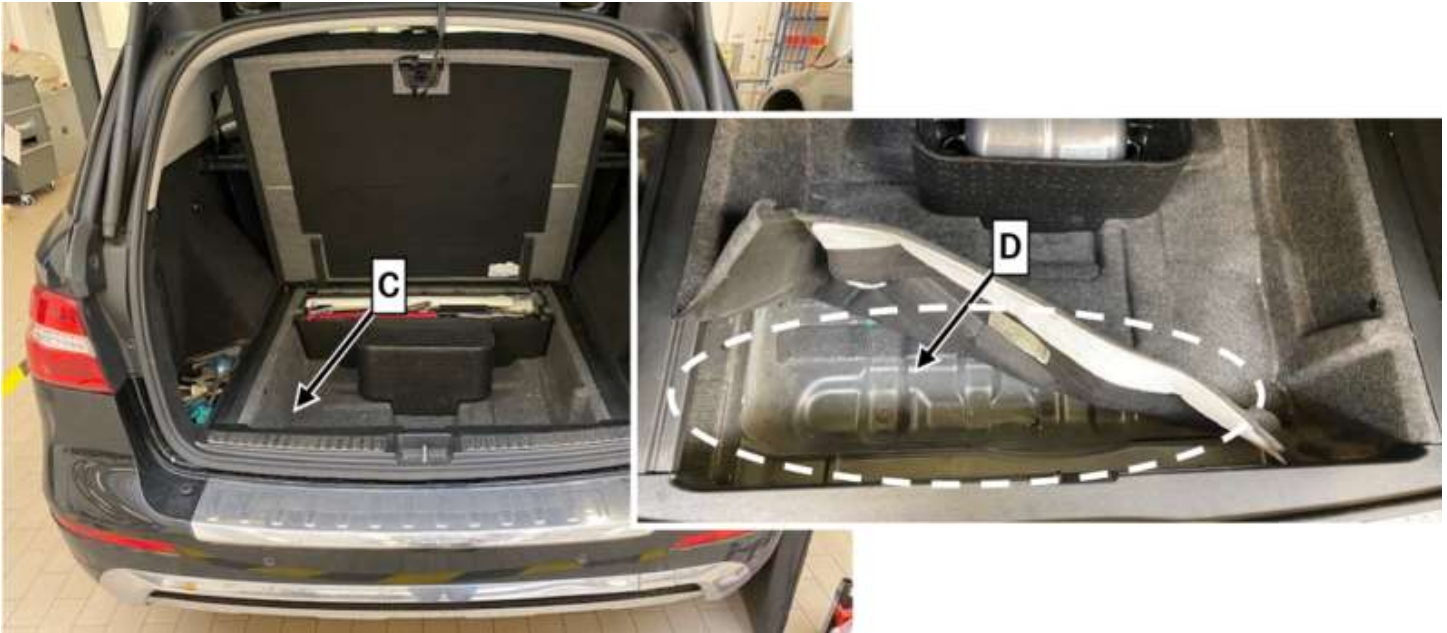
Figure 3

5. Lift left rear felt insert (C, Figure 3) and check for humidity or water deposits in marked area (D, Figure 3).
i There is no felt trim in hybrid model 166.063.

- a. If humidity or water deposits are **not** present in area (D, Figure 3): Carry out **work procedure A**.
- b. If humidity or water deposits are present in area (D, Figure 3): Carry out **check/test procedure 2**.

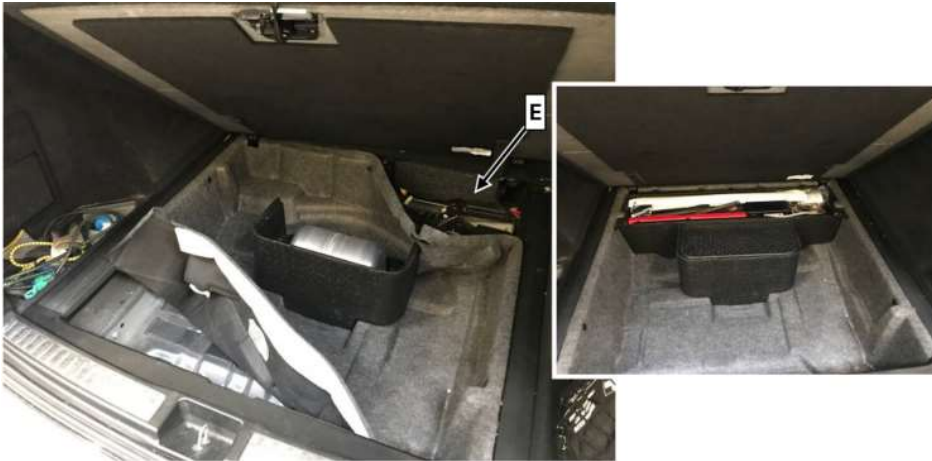
Figure 4

2. Lift right front felt insert (**E, Figure 4**).

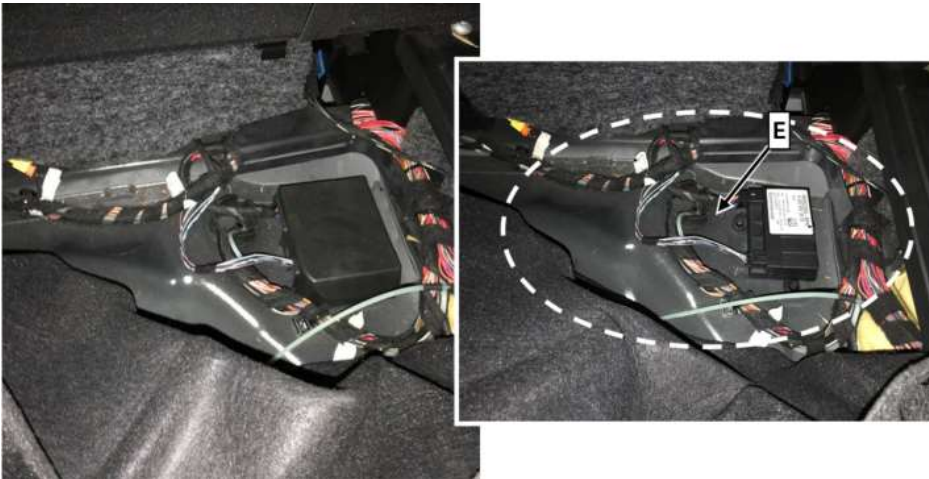
Figure 5

3. Check the area around the fuel system control unit for humidity or water deposits (**E, Figure 5**).

- a. If humidity or residual water are **not** present in area (**E, Figures 4 and 5**): Carry out **work procedure A** and install remaining parts.
- b. If humidity or residual water are present in area (**E, Figures 4 and 5**): Carry out **work procedures A and B**.
