TO: Mercedes-Benz Dealer Principals, General Managers, Sales Managers, Service Managers, Parts Managers	FROM: Gregory Gunther, Senior Manager, Vehicle Compliance and Analysis, Engineering Services
RE: Recall Campaign Updated Notification Check for Water Entry in the Spare Wheel Well MY12-20 GLE/ML and GLE Coupe (166 and 292 platform)	UPDATE: February 16, 2024

Campaign No. 2023010002, February 2023

SUBJECT: **Model GLE/ML and GLE Coupe (166 and 292 platform)**
Model Year 2012-2019

Check for Water entry in the Spare Wheel Well

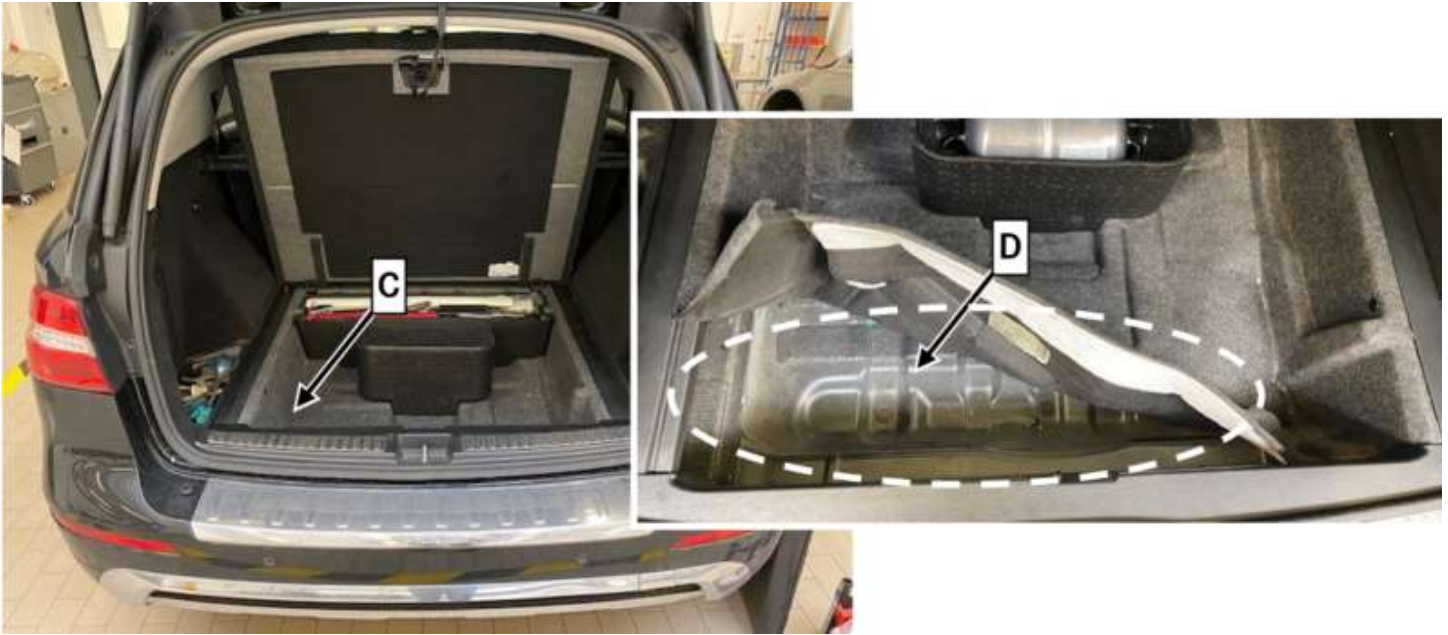
Figure 3

5. Lift left rear felt insert (C, Figure 3) and check for humidity or water deposits in marked area (D, Figure 3).
i There is no felt trim in hybrid model 166.063.

- a. If humidity or water deposits are **not** present in area (D, Figure 3): Carry out **work procedure A**.
- b. If humidity or water deposits are present in area (D, Figure 3): Carry out **check/test procedure 2**.
