TO: Mercedes-Benz Dealer Principals, General Managers, Sales Managers, Service Managers, Parts Managers	FROM: Gregory Gunther, Senior Manager, Vehicle Compliance and Analysis, Engineering Services
RE: Recall Campaign Updated Notification Check for Water Entry in the Spare Wheel Well MY12-20 GLE/ML and GLE Coupe (166 and 292 platform)	UPDATE: February 16, 2024

IMPORTANT RECALL CAMPAIGN UPDATE

Campaign No. 2023010003, February 2023

Check for Water entry in the Spare Wheel Well

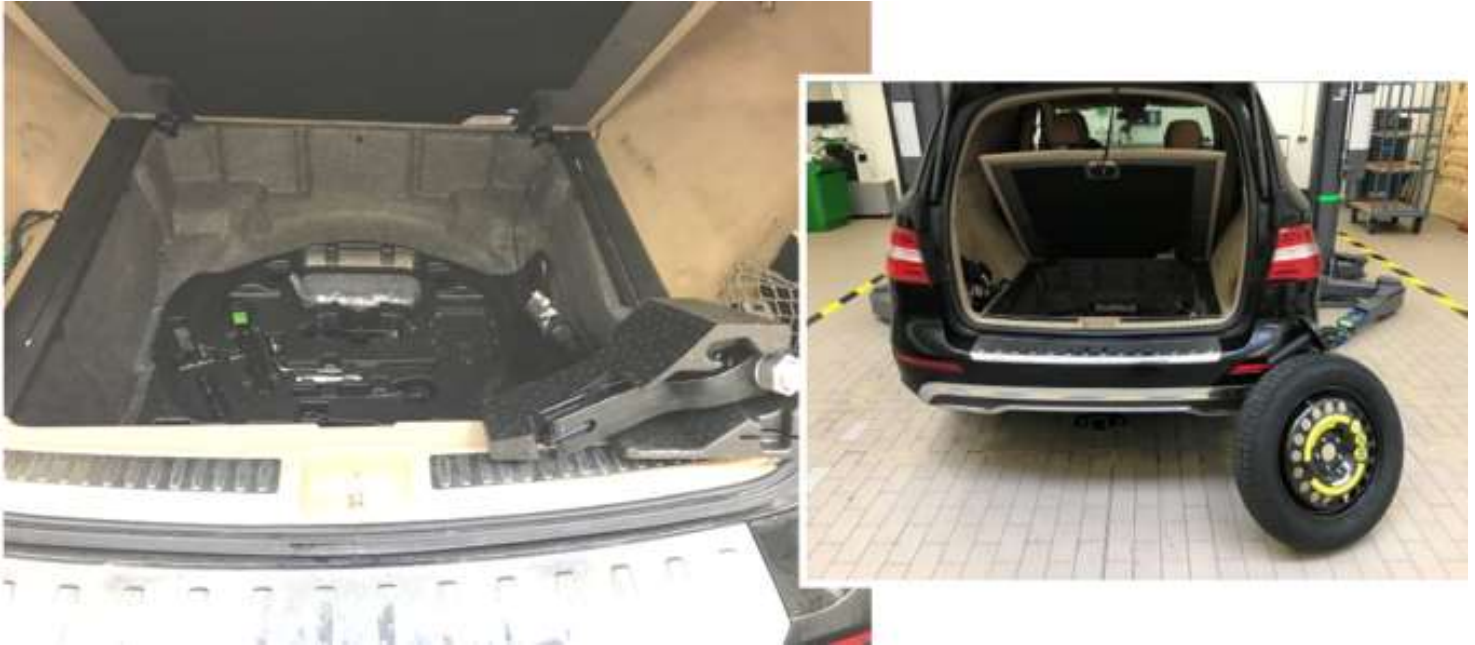
Figure 1

1. Open trunk.
2. Lift spare wheel well cover and secure it from falling down.
3. In vehicles with spare tire option code 690, remove spare tire and cover (Figure 1).

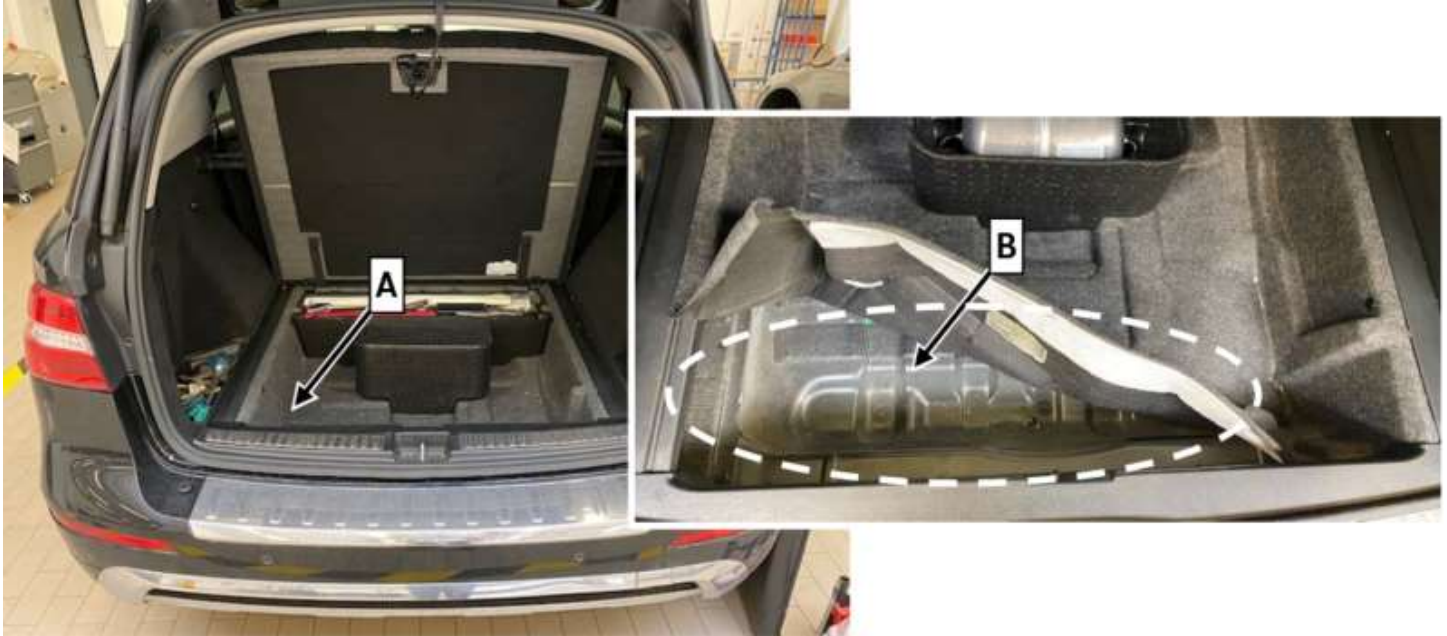
Figure 2

4. Lift left rear felt insert (A, Figure 2) and check for humidity or water deposits in marked area (B, Figure 2).

- a. If humidity or water deposits are **not** present in the area (B, Figure 2): Carry out **work procedure A**.
- b. If humidity or water deposits are present in the area (B, Figure 2): Carry out **check/test procedure 2**.

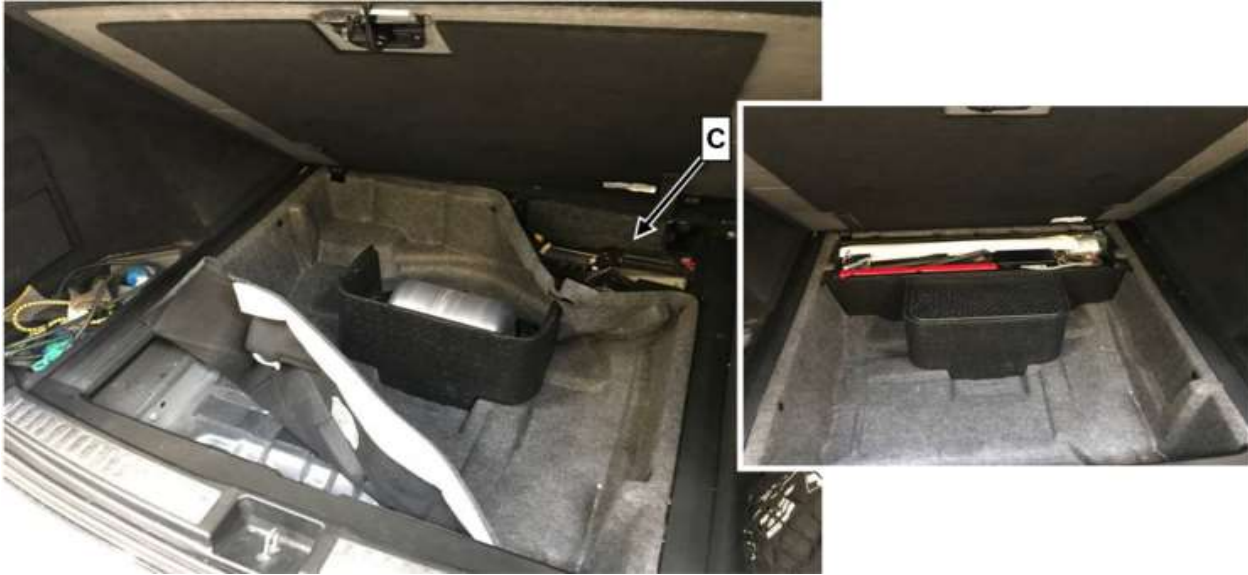
Figure 3

1. Lift right front felt insert (C, Figure 3).

i First remove tool insert.

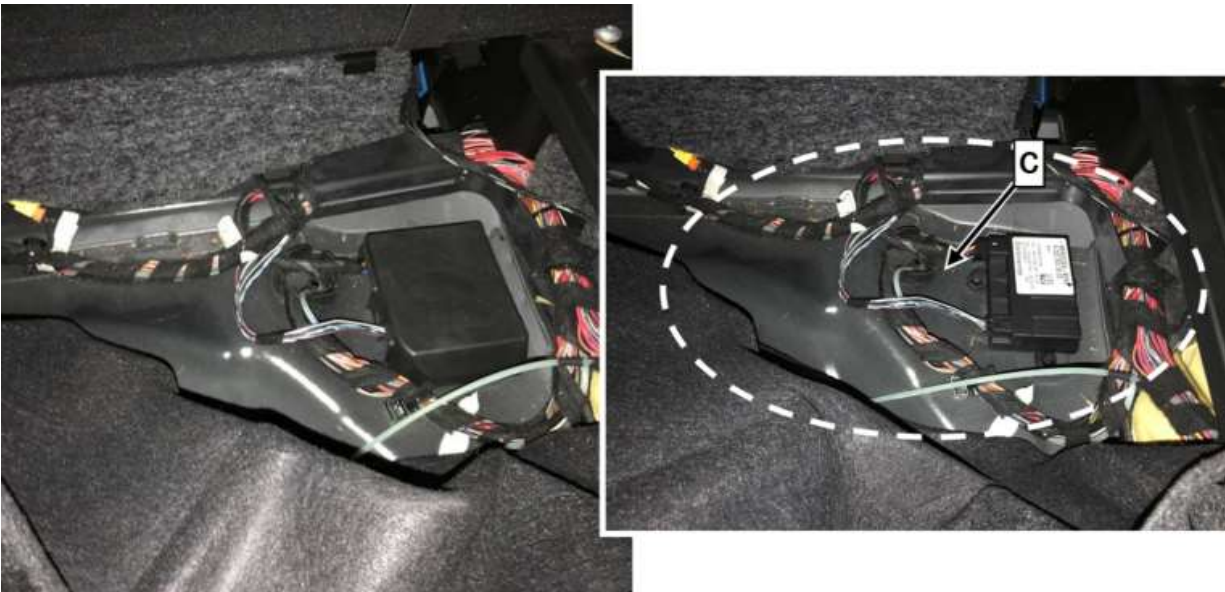
Figure 4

2. Check area around fuel system control unit for humidity or water deposits (C, Figure 4).

- a. If humidity or water deposits are **not** present in area (C, Figures 3 and 4): Carry out **work procedure A** and install remaining parts.
- b. If humidity or water deposits are present in area (C, Figures 3 and 4): Carry out **work procedures A and B**.
