TO: Mercedes-Benz Dealer Principals, General Managers, Sales Managers, Service Managers, Parts Managers	FROM: Gregory Gunther, Senior Manager, Vehicle Compliance and Analysis, Engineering Services
RE: <b>Recall Campaign Updated Notification</b> <b>Check for Water Entry in the Spare Wheel Well</b> <b>MY12-20 GLE/ML and GLE Coupe</b> <b>(166 and 292 platform)</b>	UPDATE: March 14, 2024

### Check for Water Entry in the Spare Wheel Well

Campaign No. 2023010003, February 2023

SUBJECT: **Model GLE/ML and GLE Coupe (166 and 292 platform)**  
**Model Year 2016-2020**

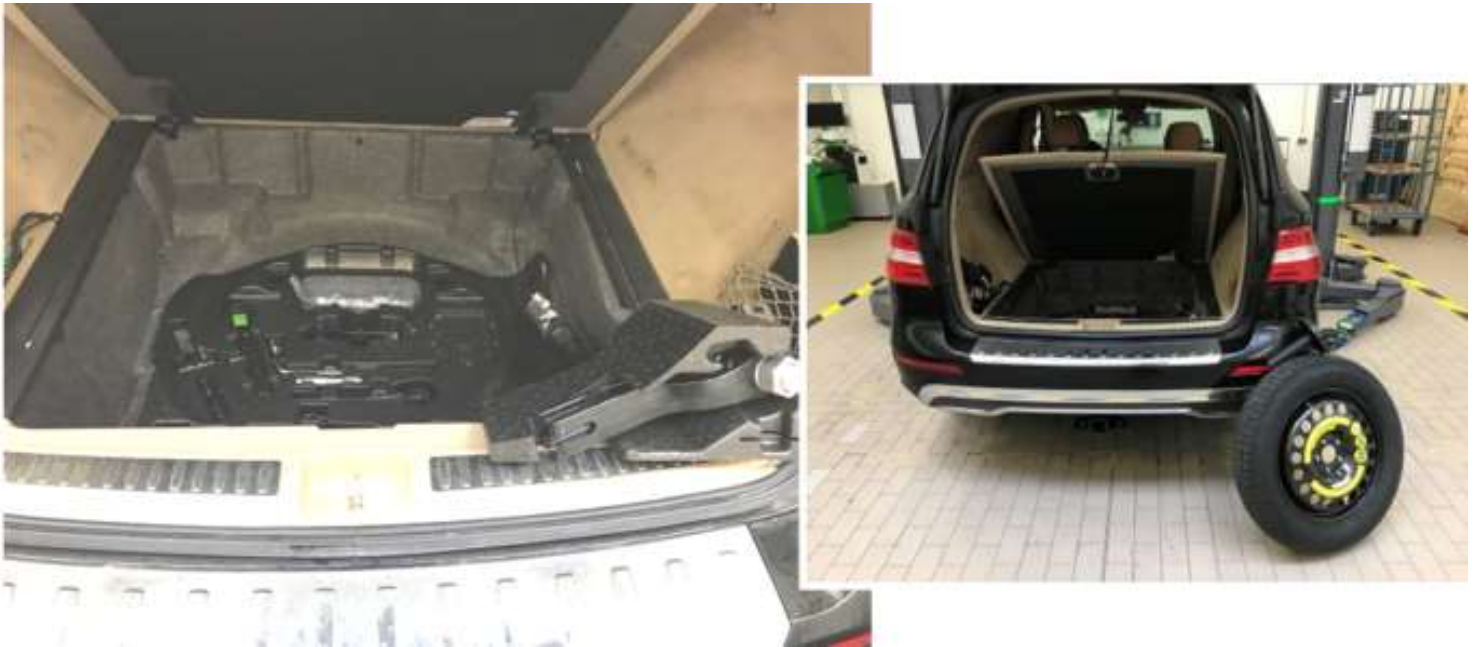
**Figure 1**

1. Open trunk.
2. Lift spare wheel well cover and secure it from falling down.
3. In vehicles with spare tire option code 690, remove spare tire and cover (Figure 1).
