IMPORTANT SAFETY RECALL

NHTSA Recall Number: 22V-071

Altec Industries, Inc. has decided that a defect which relates to motor vehicle safety exists in certain DC45/47 and DM45/47B digger derricks and AM55E aerial devices built from May 2018 to January 2021. This is to inform you that your vehicle may contain a defect that could affect the safety of a person. The front bulkhead plate on the subbase on the affected units was manufactured from a material having a lower than specified yield strength. This could cause cracking of the bulkhead plate. Cracking of the bulkhead plate could lead to failure of the outrigger attachment, causing uncontrolled boom movement. **Death or serious injury could result from uncontrolled boom movement.**

Subbase Bulkhead Plate Reinforcement

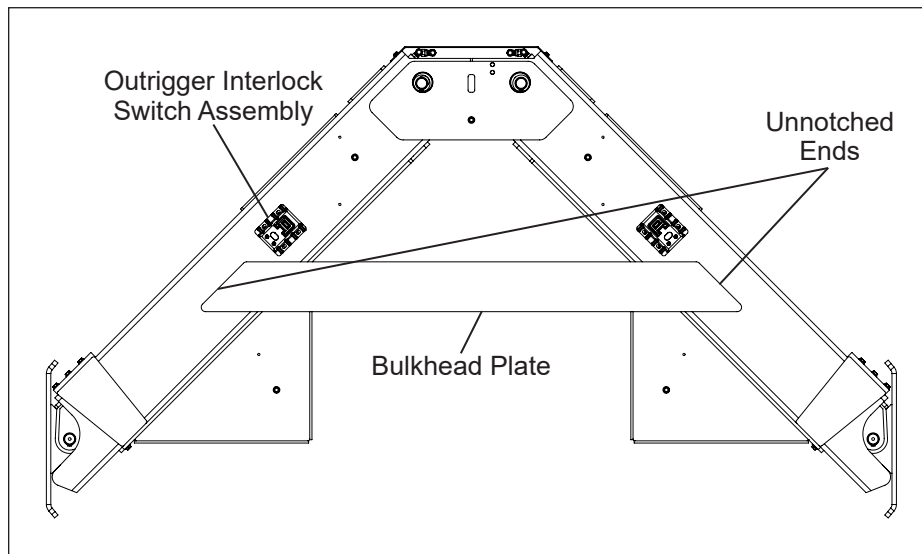
Figure 1 — Outrigger with Unnotched Bulkhead Plate

1. Position the unit on a level surface, apply the parking brake, and chock the wheels. Engage the power take-off (PTO), and extend the front outriggers far enough to remove the bulge from the front tires. Do not extend the rear outriggers. Disengage the PTO, and turn off the engine. Remove the key from the ignition, and secure it following your employer's vehicle lockout/tagout procedure.
2. Find the bulkhead plate welded to the front end of the subbase and the front surface of the A-frame outriggers located directly behind the chassis cab (refer to Figures 1 and 2). Confirm whether the ends of the bulkhead are unnotched, as shown in Figure 1, or notched, as shown in Figure 2.

4. Based on the inspection result from step 2, determine the part number of the kit required to repair the unit as described below.
- If the bulkhead plate has unnotched ends, the unit requires the Subbase Bulkhead Doubler Kit, Standard Height, part number 991465427.

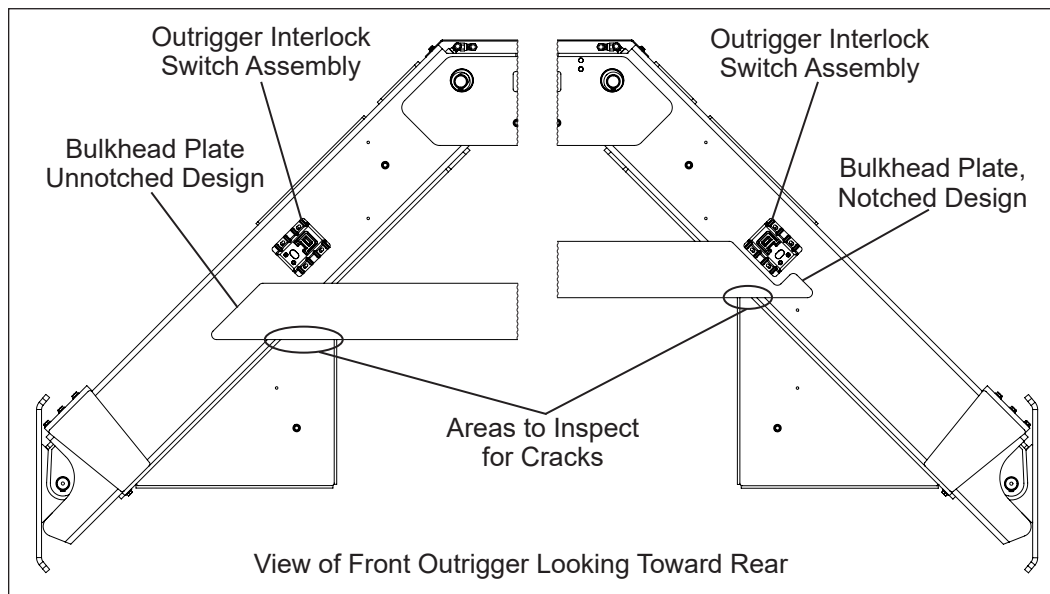
Figure 3 — Crack Inspection

Background: Altec has learned that the front bulkhead plate on the subbase on the affected units was manufactured from a material having a lower than specified yield strength. This could cause cracking of the bulkhead plate.

Death or serious injury could result from uncontrolled boom movement. Cracking of the bulkhead plate could lead to failure of the outrigger attachment, causing uncontrolled boom movement.

3. Inspect for cracks in the bottom portion of the bulkhead plate at both ends (refer to Figure 3). If cracks are found, mark them with a paint stick or felt-tip marker.

- If no cracks were found, install the kit no later than the unit's next preventive maintenance interval or 90 days from the receipt of this CSN, whichever comes first.

- If crack(s) were found, install the kit no later than 30 days from the date of the inspection.

If the customer or the customer's warranty provider installs the kit, all welds must be applied by a welder having the AWS D1.1 3G qualification for uphill progression welding on steel.
