IMPORTANT SAFETY RECALL
See enclosed VIN list

**August 2022
FL937A
NHTSA #22V-394**

Subject: Freightliner Steering Assembly U-Joint Pinch Bolts

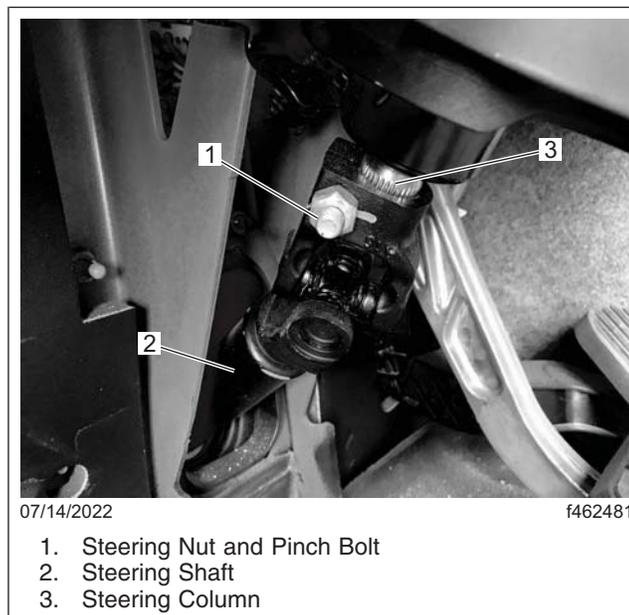
Fig. 1, Steering Pinch Bolt Location

1. Park the vehicle on a level surface, shut down the engine, and set the parking brake. Chock the rear tires.
2. Locate the steering shaft inside the cab, as shown in [Fig. 1](#).
3. Check the connections between the steering column and steering shaft, and the nut to pinch bolt connection, as shown in [Fig. 1](#). Remove the steering column cover to see the bolt.
4. Inspect the nut to pinch bolt connection. There must be bolt threads exposed beyond the nut as shown in [Fig. 1](#).

Are the bolt threads visible?

NO → **DO NOT** drive the vehicle. Have it immediately towed to the nearest DTNA dealership for repair.

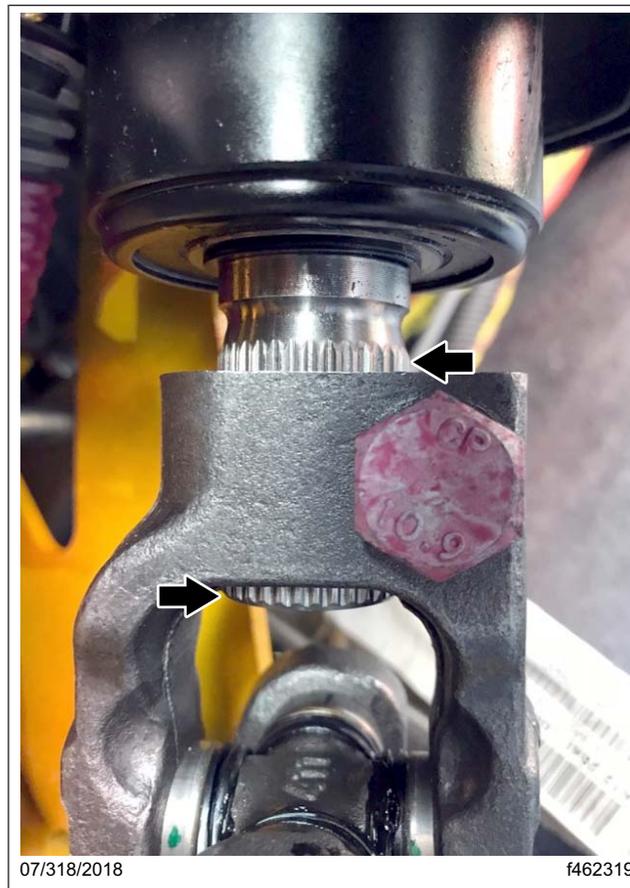
Fig. 2, Steering Shaft Splines

5. Inspect the exposed splines of the steering shaft connection as shown in **Fig. 2**. It may be necessary to turn the steering wheel to gain adequate visibility of the splines.

If the steering shaft splines are not visible on both sides of the bolted connection, **DO NOT** drive the vehicle. Have it immediately towed to the nearest DTNA dealership for repair.

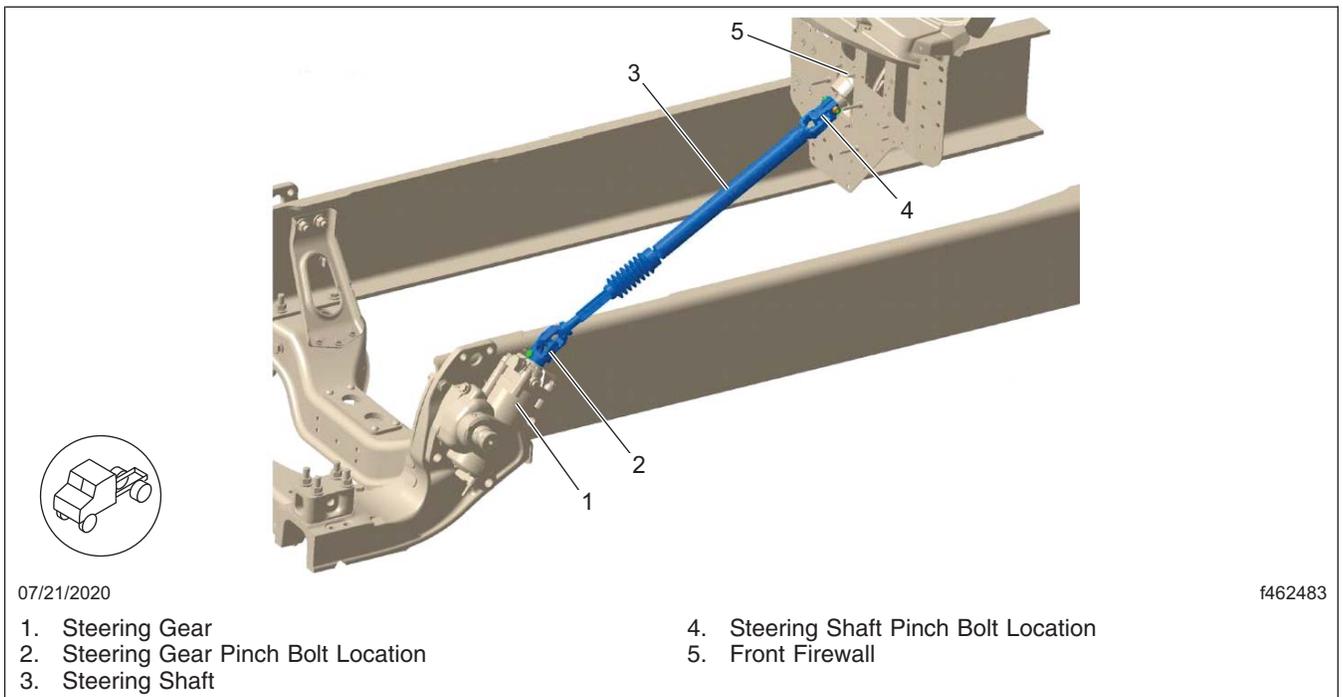
Fig. 3, Steering Assembly

1. Open the hood.
2. Locate the universal joint of the steering shaft at the front of the firewall. See [Fig. 3](#) and [Fig. 4](#).
3. Check the connections between the steering column and the steering shaft at the front of the firewall, and the nut to pinch bolt connection. See [Fig. 4](#).

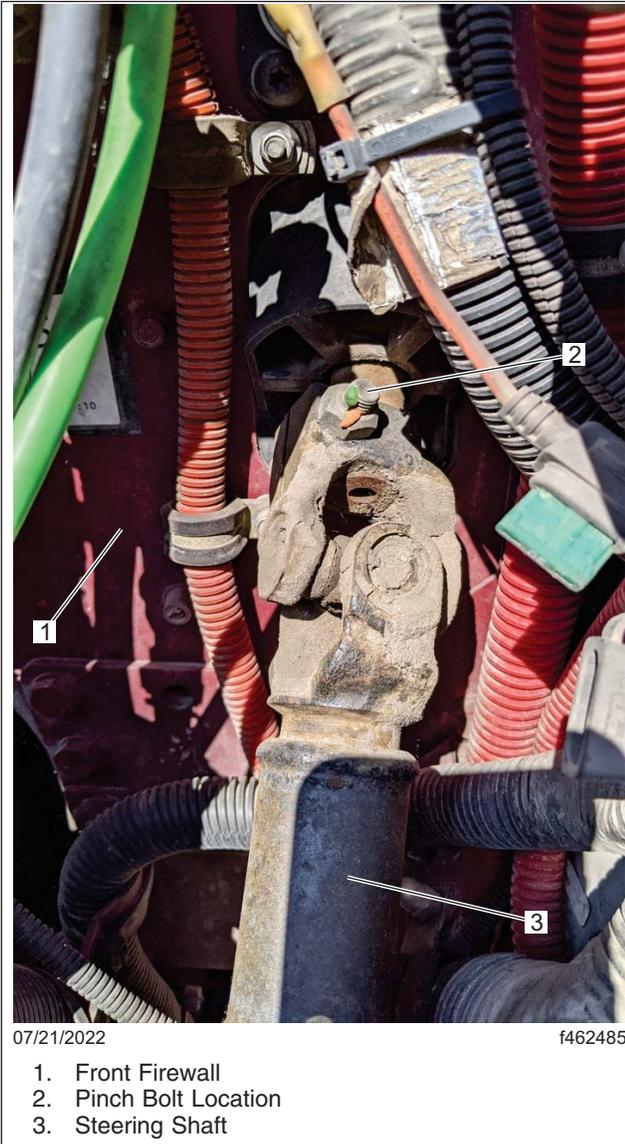
Fig. 4, Pinch Bolt and Front Firewall Location

4. Inspect the nut to pinch bolt connection. There must be bolt threads exposed beyond the nut as shown in [Fig. 1](#).
Are the bolt threads visible?
YES → Go to the next step.
NO → **DO NOT** drive the vehicle. Have it immediately towed to the nearest DTNA dealership for repair.
5. Inspect the exposed splines of the steering shaft connection as shown in [Fig. 2](#). It may be necessary to turn the steering wheel to gain adequate visibility of the splines.
If the steering shaft splines are not visible on both sides of the bolted connection, **DO NOT** drive the vehicle. Have it immediately towed to the nearest DTNA dealership for repair.
If the steering shaft splines are exposed on both sides of the bolted connection, go to the next inspection.

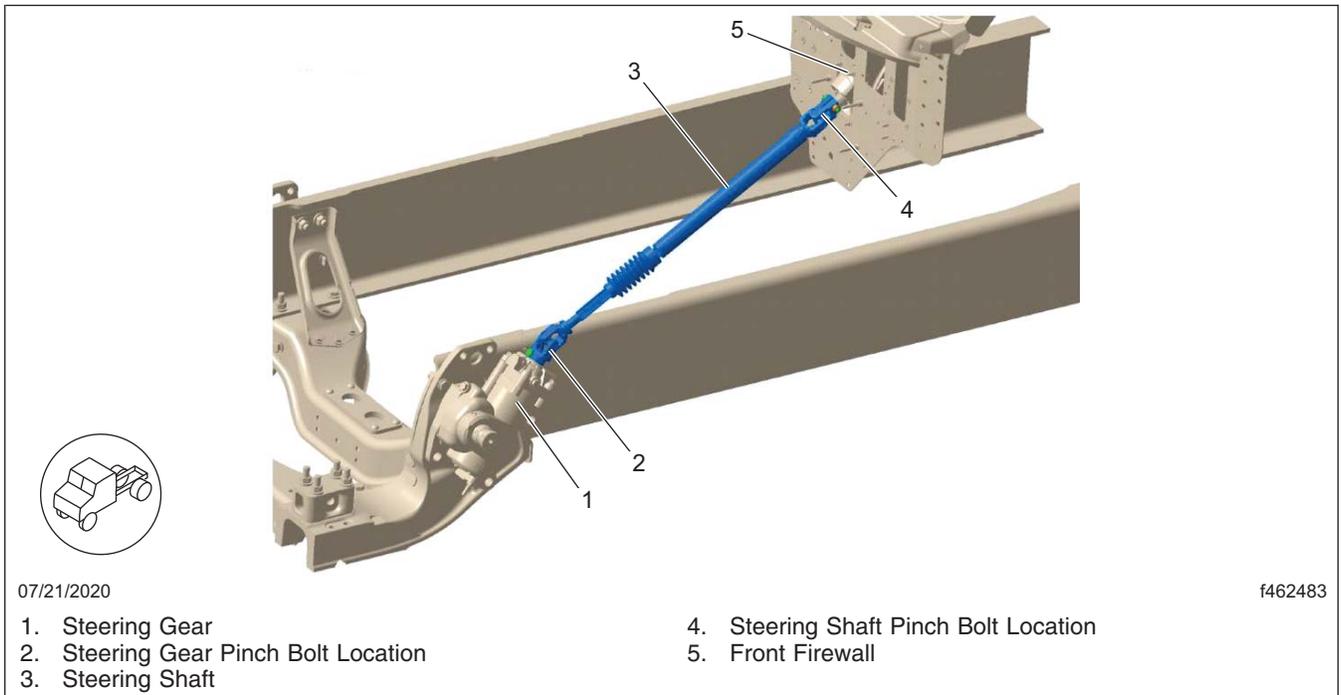
Fig. 3, Steering Assembly

1. Locate the universal joint at the steering gear. See [Fig. 3](#) and [Fig. 5](#).
2. Check the connections between the steering shaft and the steering gear, and the nut to pinch bolt connection. See [Fig. 5](#).

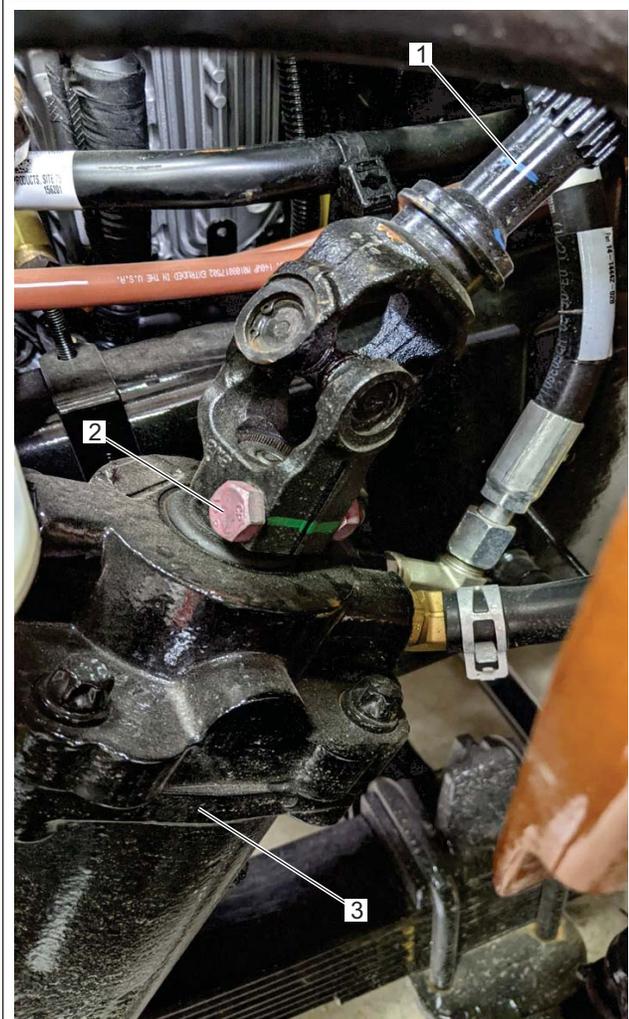
Fig. 5, Pinch Bolt and Steering Gear Location

3. Inspect the nut to pinch bolt connection. There must be bolt threads exposed beyond the nut as shown in [Fig. 1](#).
Are the bolt threads visible?
YES → Go to the next step.
NO → **DO NOT** drive the vehicle. Have it immediately towed to the nearest DTNA dealership for repair.
4. Inspect the exposed splines of the steering shaft connection as shown in [Fig. 2](#). It may be necessary to turn the steering wheel to gain adequate visibility of the splines.
If the steering shaft splines are not visible on both sides of the bolted connection, **DO NOT** drive the vehicle. Have it immediately towed to the nearest DTNA dealership for repair.
If the steering shaft splines are exposed on both sides of the bolted connection, the vehicle may be driven to the nearest DTNA dealer for the formal inspection and to complete the recall.
