IMPORTANT SAFETY RECALL NOTICE

GILLIG Campaign ID 22V-548 referencing Cummins Campaign ID 22E-060

GILLIG is recalling a population of battery electric transit buses manufactured between 01/16/2019 and 06/02/2022, equipped with Cummins energy storage systems. Cummins has decided that its energy storage systems contain a defect which relates to motor vehicle safety.

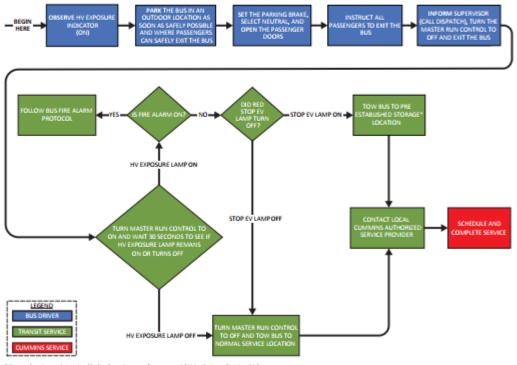
Figure 1-1, Stop EV and

An isolation detection system monitors the separation of the highvoltage system and the low-voltage system and chassis. The "HV Exposure" indicator (Figure 1-1) will always be accompanied by the "Stop EV" indicator (Figure 1-1), which means a critical EV system fault has been detected. An electronic buzzer will sound continuously and propulsion may be disabled immediately. This is similar to a typical stop engine indicator. You may be able to override HV Exposure Indicator Lamps the shutdown in order to park the bus in a safe location. See "Stop System Override" for more information and procedures.

Once you are safely stopped, apply the parking brake, select neutral on the push-button shift selector, evacuate all passengers per your company's standard procedures, and turn the Master Run Control to OFF. After the bus is stopped and the parking brake is set, both contactors in all HV battery packs will be opened to shut down HV. This eliminates possible exposure to HV from a damaged HV wire or component. See the diagnostic flow chart (Figure 1-2) for the troubleshooting process to follow.
