# AWNING INSPECTION AND WELD/SEAM REPAIR

<b>Recall Number:</b>	22E-055		
<b>Product:</b>	Awnings		
<b>Date:</b>	July 13, 2022	<b>Labor Rate:</b>	.20 hours inspection only    .30 hours repair only 1.5 hours fabric replacement only

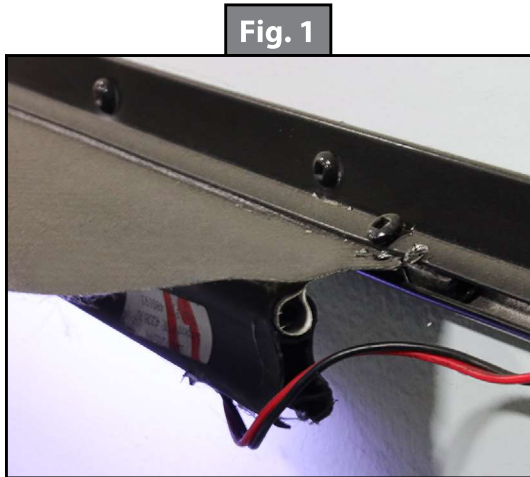
**Fig. 1**

The purpose of this document is to provide guidance, as well as visual aides, to dealers performing inspection on units that may have insufficient awning weld(s). The inspection point is at the awning fabric seam at the awning rail at the wall of the unit (Fig. 1). This only affects awnings manufactured January 17, 2022 – June 14, 2022. The date of manufacture can be located on the variant code label (Fig. 2) located on the awning.

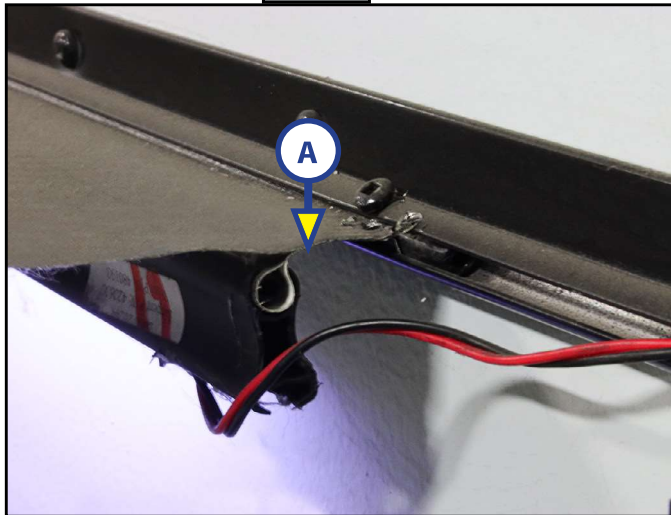
**Fig. 3**

1. Position stepladder next to the unit to view the topside of the awning at the unit wall from either end (drive/idler side).
2. Inspect the weld near the awning rail (Fig. 3A).
  - A. Fig. 3 shows no separation at the seam. It does not require repair or replacement.
  - B. Fig. 3 shows separation at the seam (Fig. 4A).
    - I. If the separation is less than 6 inches, repair can be accomplished using the procedure described in [TI-434](#).
    - II. If the separation is over 6 inches it will require awning fabric replacement using the procedure described in [TI-166](#).
