Dealer Service Instructions for:

Equipment Safety Recall Z51 NHTSA 22E-062 Taillamps

Z51/NHTSA 22E-062

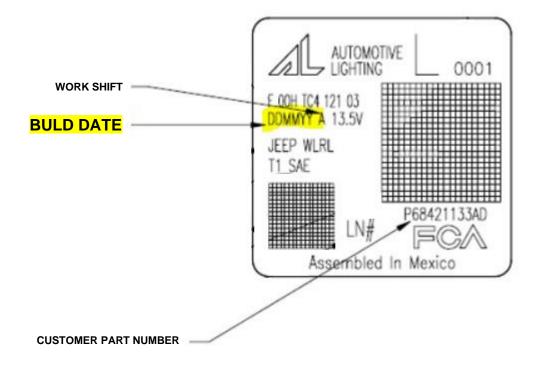
Figure 1 – Inspect Lamp Build Date

- 1. Inspect the taillamp build date which is found on the part label as shown below. Suspect taillamps have a build date prior to Nov. 10, 2021 (Figure 1).
 - Build date is prior to Nov. 10, 2021. Suspect lamp, exchange for a NEW taillamp.
 - ▶ Build date is Nov. 10, 2021, or later. Good lamp, return to customer.
