VOLUNTARY RECALL CAMPAIGN

Classification: EL22-014	Reference: NTB22-086	Date: September 28, 2022
-----------------------------	-------------------------	-----------------------------

VOLUNTARY SAFETY RECALL CAMPAIGN 2017 ROGUE; WIRE HARNESS INSPECTION

CAMPAIGN ID #: PC918
APPLIED VEHICLES: 2017 Rogue (T32)

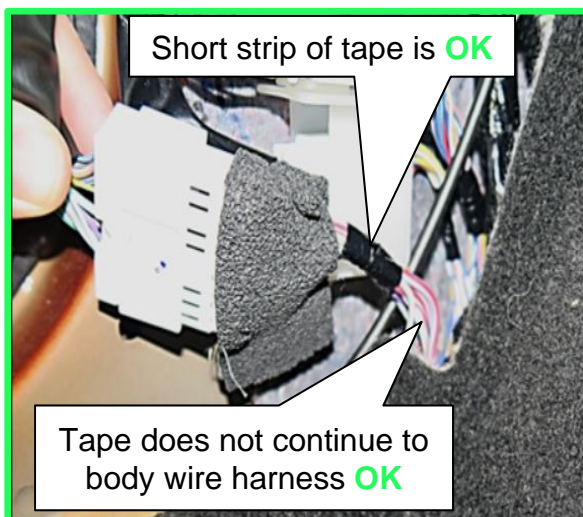
Figure 2

4. Carefully pull the wire harness away from the body and inspect the B42 wire harness connector branch for tape that runs the full length of the wire harness branch.
 - If the tape does NOT run the full length of the wire harness branch, as shown in Figure 2, no further action is needed. Skip to step 6 on page 5 for reassembly.
 - If tape is present and runs the full length from the connector to the body wire harness, as shown in Figure 3, continue to step 5.
 - One strip of tape on the wire harness branch is OK.
 - Foam on the M74/B42 wire harness connectors is OK.

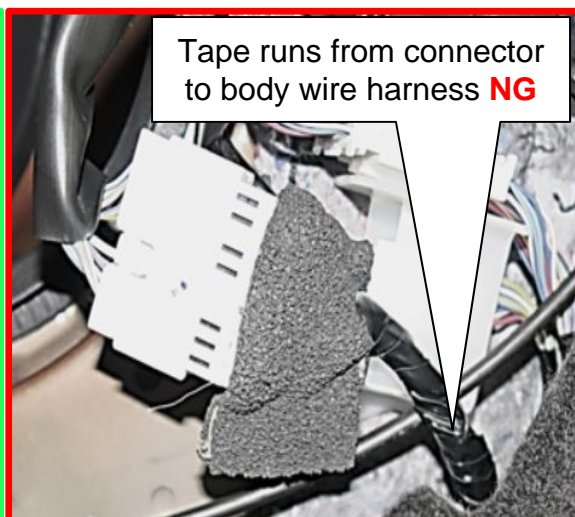
Figure 3

5. If tape is present on the length of the wire harness branch, as shown in Figure 3, take a clear photo and send it in an email to FQA_Inspection_support@nissan-usa.com with the following information:
 - Email Subject PC918 2017 Rogue Wire Harness
 - Dealer Code
 - VIN
 - Contact Name
 - Contact Email Address
 - Contact Phone Number

NOTE: The email and photo will serve as notification to Nissan in the event an NG condition is found. No further action is required in this case and the vehicle can be returned to the customer.
