VOLUNTARY RECALL CAMPAIGN

Classification: EL22-001	Reference: NTB22-076	Date: August 25, 2022
-----------------------------	-------------------------	--------------------------

VOLUNTARY SAFETY RECALL CAMPAIGN 2014-2016 ROGUE; WIRE HARNESS CONNECTOR CORROSION

CAMPAIGN ID #: R21B9
APPLIED VEHICLES: 2014-2016 Rogue (T32)

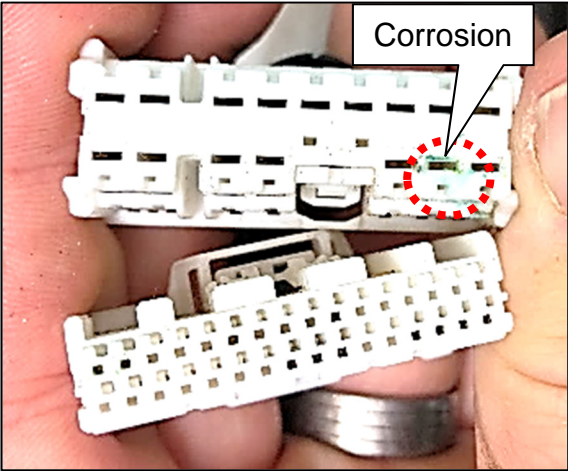
Figure 9

10. Inspect the M74 and B42 wire harness connectors for any signs of corrosion (Figure 9 - Figure 13).
- If signs of corrosion are found, proceed to step 11 on page 8 to replace both M74 and B42 wire harness connectors.
 - If there are no signs of corrosion, skip to step 20 on page 12 to apply white lithium grease to both wire harness connectors.

Examples of Corrosion

11. Replace the M74 and B42 wire harness connectors as follows:
