February 2022

Dealer Service Instructions for:

Safety Recall Z08 / NHTSA 22V-035 Windshield Wipers

2019-2020 (D2) Ram 3500 Pickup

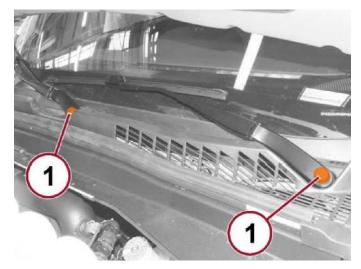
Figure 1 - Windshield Wiper Arm Nuts

The windshield wipers on about 171,700 of the above vehicles may have been built with an improperly formed wiper arm head joint that did not fully form the splines of the head joint on the wiper arm. This can allow the joint to strip and result in the wiper arm failing to operate properly when the system is activated. Prior to complete wiper system failure, the driver may notice that one or both wipers do not clear the windshield properly or that the wipers are not in their proper rest positions. An improperly functioning wiper system may, in certain circumstances, lead to diminished road visibility which can cause a vehicle crash without prior warning.

- 1. Open the hood.
- 2. Carefully pry the plastic nut caps (1) off of the nuts on the pivot end of the wiper arms (Figure 1).

- A paint pen to mark the 12 o'clock position on the nut, or
- A torque angle gauge, or
- A torque wrench with the ability to measure torque angle.
- 3. Using one of these methods, tighten both nuts 90 degrees (one quarter turn).

NOTE: Do not loosen or remove the nut or arm, or torque the nut to a specified value. Tighten the nut by adding 90 degrees (one quarter turn) only.

- 4. Verify wipers are functioning properly by running them on low and high speed. If wiper system issues are present after performing the steps above, refer to wiper diagnosis and repair in DealerCONNECT/Service Library.
- 5. Install the plastic nut caps (1) onto the wiper arm pivot nuts (Figure 1).
- 6. Close the hood and return the vehicle to the customer.
