ANA1 - Check Chassis Settings on the Rear Axle and Correct Them if Necessary (Recall Campaign)

Model Line: **Cayenne (9YA)/Cayenne Coupé (9YB)**

Model Year: **As of 2021 up to 2022**

Concerns: **Suspension alignment**

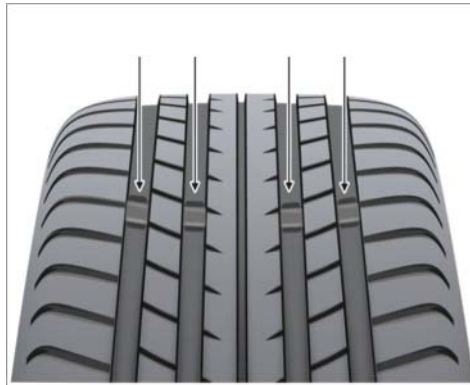
Check tires

<p>Differential wear: Measure tread depth as in Fig. ⇒ <i>Check tires -Arrows-</i> across all main tread grooves per tire rear axle (inside to outside), and between the driver and passenger side of the rear axle ⇒ then create max. difference $\leq 2 \text{ mm} / 0.078 \text{ in}$</p>	<p>Tread depth: Measuring tread depth over all main profile grooves ⇒ take minimum value $\geq 4 \text{ mm} / 0.157 \text{ in}$ (summer) $\geq 5 \text{ mm} / 0.197 \text{ in}$ (M&S)</p>	<p>Shoulder wear: Visual inspection of the inner and outer shoulders of the rear-axle tires Visual inspection as per sample photos</p>
--	--	--

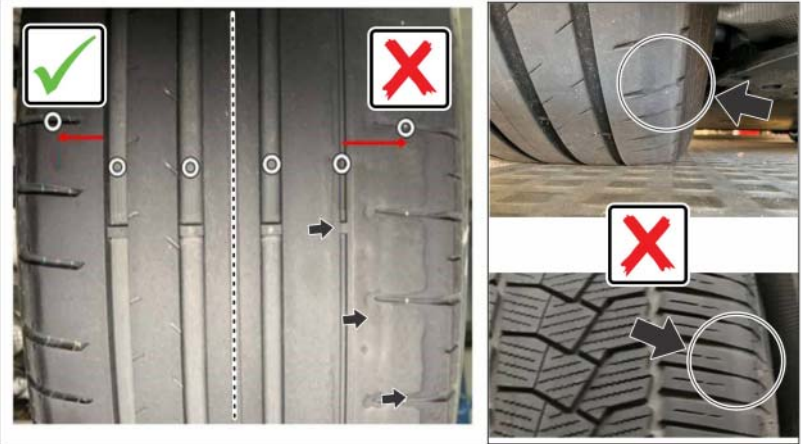
Tire wear overview

OK ↓	Not OK ↓			
Differential wear Front axle/rear axle ≤ 3 mm/ 0.118 in				
OK ↓	<table border="1" style="width: 100%; border-collapse: collapse;"> <tr> <td style="text-align: center;">Not OK ↓</td> <td rowspan="2" style="text-align: center; vertical-align: middle;">Replace tires on the rear axle</td> </tr> <tr> <td style="text-align: center;">Replace tires on the front axle</td> </tr> </table>	Not OK ↓	Replace tires on the rear axle	Replace tires on the front axle
Not OK ↓	Replace tires on the rear axle			
Replace tires on the front axle				
Set alignment to OK according to adjustment values (final alignment)
