FL888 (D21R7)

**Subject: Tie Rod Clamp (Lock Nut) Over-Crimped
Tie Rod End Clamp Bolts**

Models Affected: 2, 3 & 5 DETROIT™ Front Steer Axles

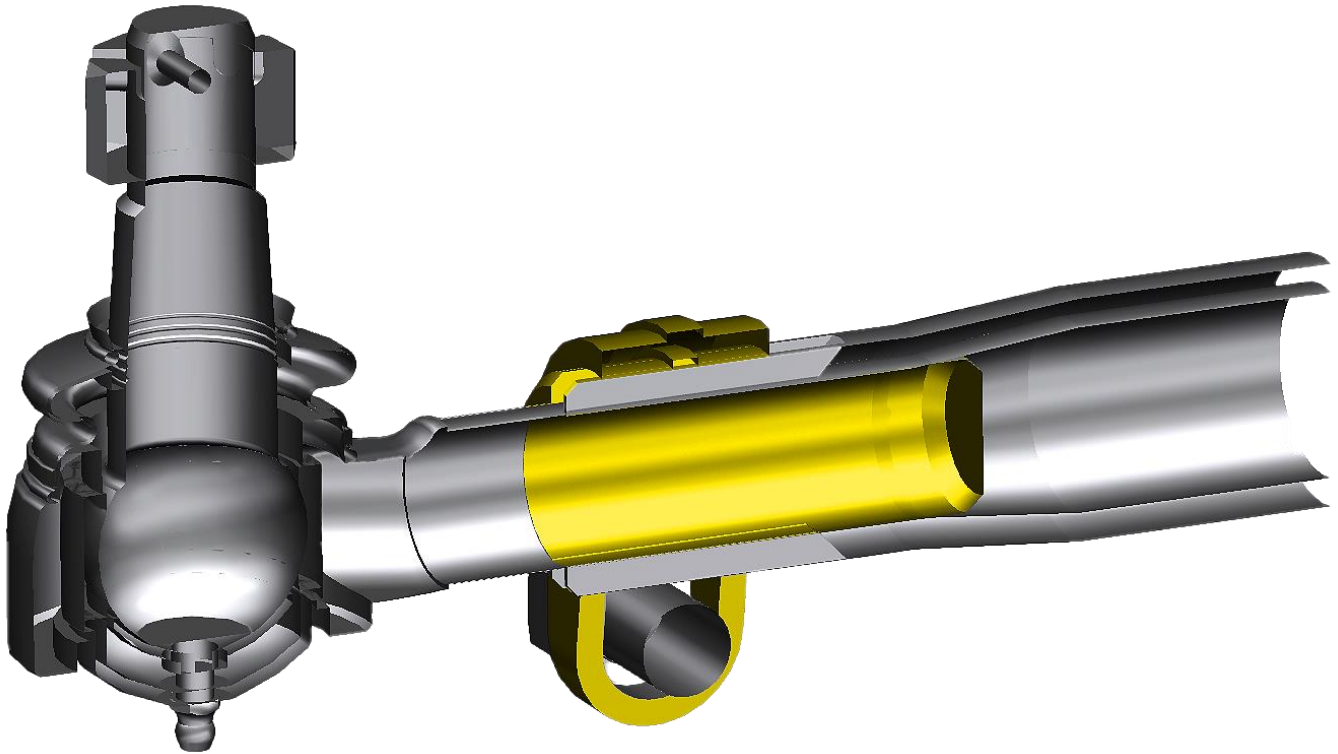
Fig. 5, Clamp rib should engage onto detents to align clamp position

- b. Ensure clamp locating rib remains centered over the tie rod cross-tube detents. See Fig 5. Failure to engage the clamp centering rib with tie rod cross-tube may result in a loose tie rod end despite reaching appropriate torque on the locknut/bolt assembly.

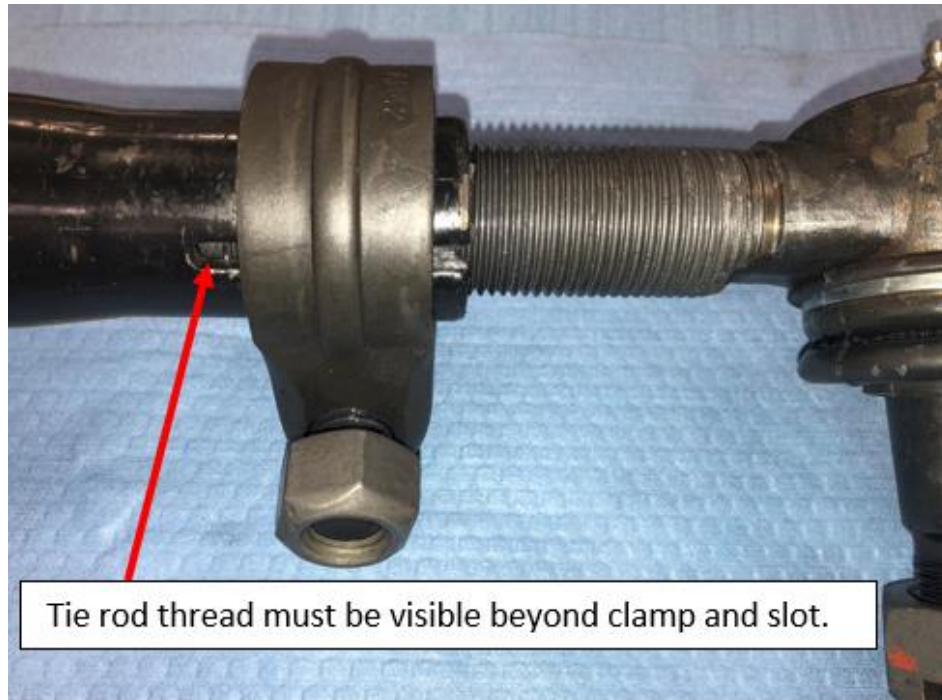
Fig. 6, Clamp Position and Tie Rod Thread Engagement

- c. Threaded tie rod end should also extend into the tube beyond the cut/slot and clamp positioned like below. See Fig 6.
