**HYUNDAI**  
**Technical Service Bulletin**

GROUP <b>RECALL</b>	NUMBER <b>22-01-029H-2</b>
DATE <b>JULY 2022</b>	MODEL(S) <b>SANTA FE SPORT (AN) SANTA FE (NC) SANTA FE XL (NC)</b>

**SUBJECT:** ABS MODULE MULTI-FUSE INSTALLATION  
 (RECALL 218)

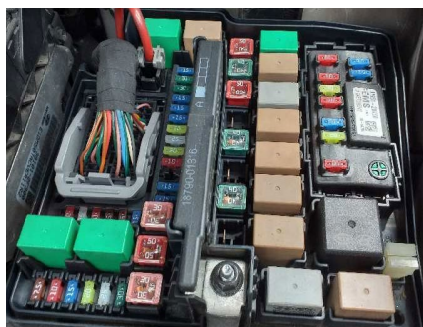
**Description:** Certain 2017-2018MY Santa Fe Sport (AN), 2017-2018MY Santa Fe (NC), and 2019MY Santa Fe XL (NC) vehicles may develop an electrical short in the hydraulic unit assembly (HECU) which may increase the risk of an engine compartment fire. This bulletin describes the procedure to install a replacement multi-fuse.
