RECALL INSPECTION AND REPAIR INSTRUCTIONS

NHTSA Recall #: 22V-068

Tiffin #: TIF-120

Models Involved: 2018-2022 Allegro & Breeze units with the 2000W inverter option

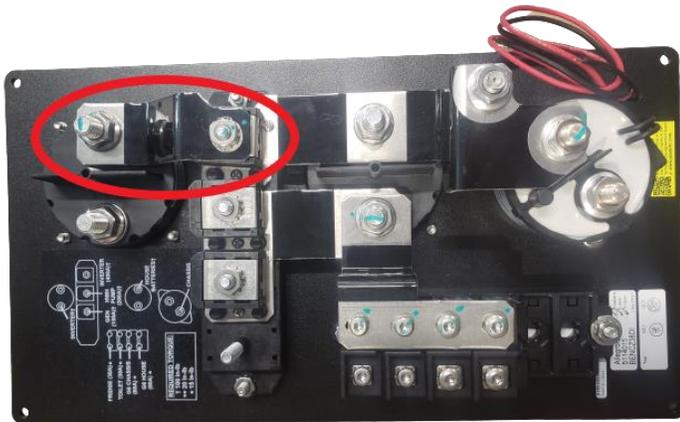
- Remove the DCD panel, and locate the buss bar between the inverter stud and the 400A Zcase fuse.

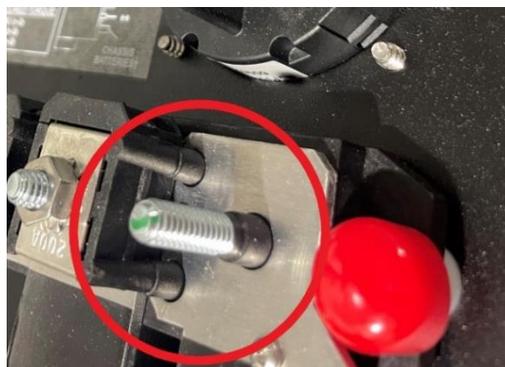
- Using the wrench, remove the nuts from the studs, and remove the buss bar.
- Remove the 400A fuse from the stud and examine the base plate and stud for any signs of overheating or damage.

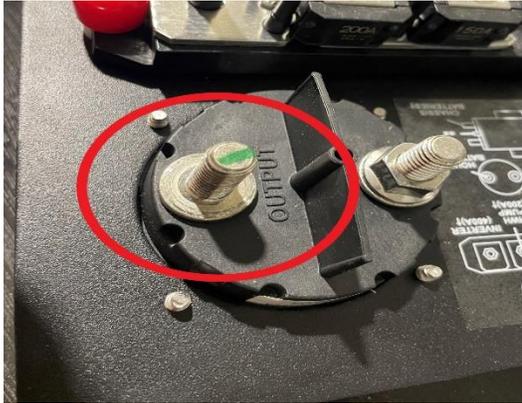
7. Examine the rear side of the inverter rotary knob for any signs of overheating or damage.
