RECALL INSPECTION AND REPAIR INSTRUCTIONS

NHTSA Recall #: 22V-068

Models Involved: 2018-2022 Allegro & Breeze units with the 1200W inverter option

Purpose: To correct the torque on the DCD panel and update torque label.

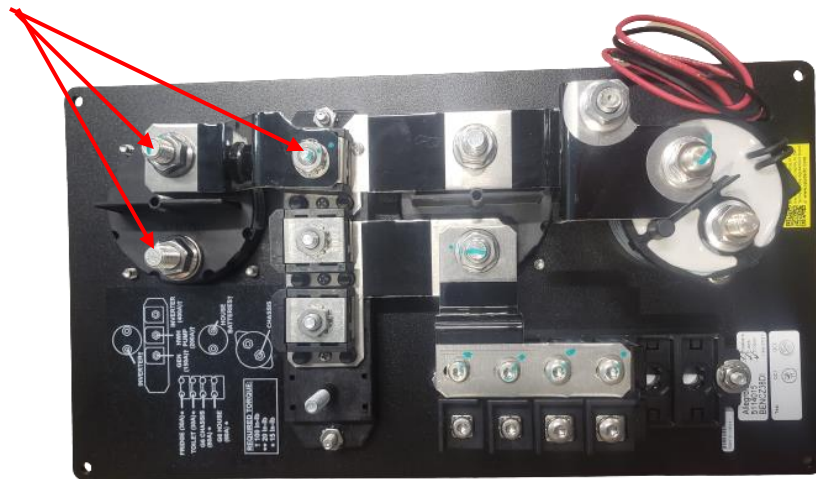
- Remove the DCD panel, and check and adjust the torque as necessary.

100-inch lbs.
