# Audi

# **Compliance Recall** Code: 72M6

Subject	Center Rea	r Seat Belt W	/iring Harne	255	
Release Date	March 04, 2022				
Affected Vehicles	Country	Beginning Model Year	Ending Model Year	Vehicle	Vehicle Count
	USA	2022	2022	E-TRON GT	693
	CAN	2022	2022	E-TRON GT	159
	action. Elsa is ✓ Can ✓ If El				
Problem Description	The wiring harness for the center rear seat belt buckle may be routed incorrectly and interfere with the inner lower LATCH anchor of the right rear seat. This may obstruct the accessibility of the lower child seat anchors and inhibit the child seat from being properly secured. Due to one of the lower child seat anchors not being accessible, a child seat on the right rear seat may not be properly secured increasing the risk of injury in case of a crash.				
Corrective Action	Inspect the wiring harness for the center rear seat belt buckle for damage and correctly route and secure it on the affected vehicles if necessary.

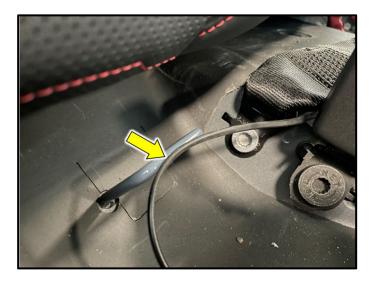
• Inspect the rear center seat belt buckle wiring harness in the area shown <arrow>.

- If the wiring harness <arrow> has not been damaged:
  - The wiring harness must be rerouted and secured.
    - See Section D
- If the wiring harness <arrow> has been damaged:
  - The center seat belt buckle must be replaced.
    - See Section C
  - The wiring harness must be rerouted and secured after replacing center seat belt buckle.
    - See Section D

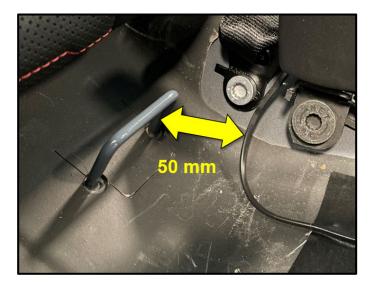
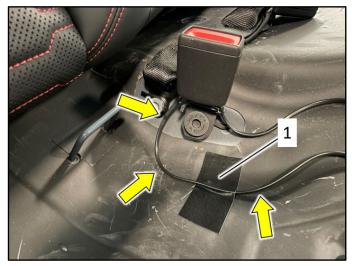
• The distance from the wiring harness to the Isofix anchorage should be 50 mm.

- Route the wiring harness <arrows> as shown.
- Clean the surface of the floor with isopropyl alcohol or equivalent cleaning spray.
- Secure wiring harness with an 80 mm long piece of fabric tape <1>.
