Recall Campaign Bulletin

Campaign No. 2022030015, March 2022

SUBJECT: **Model GLE-Class (167 platform)**
Model Year 2020

Replace Prefuse Box

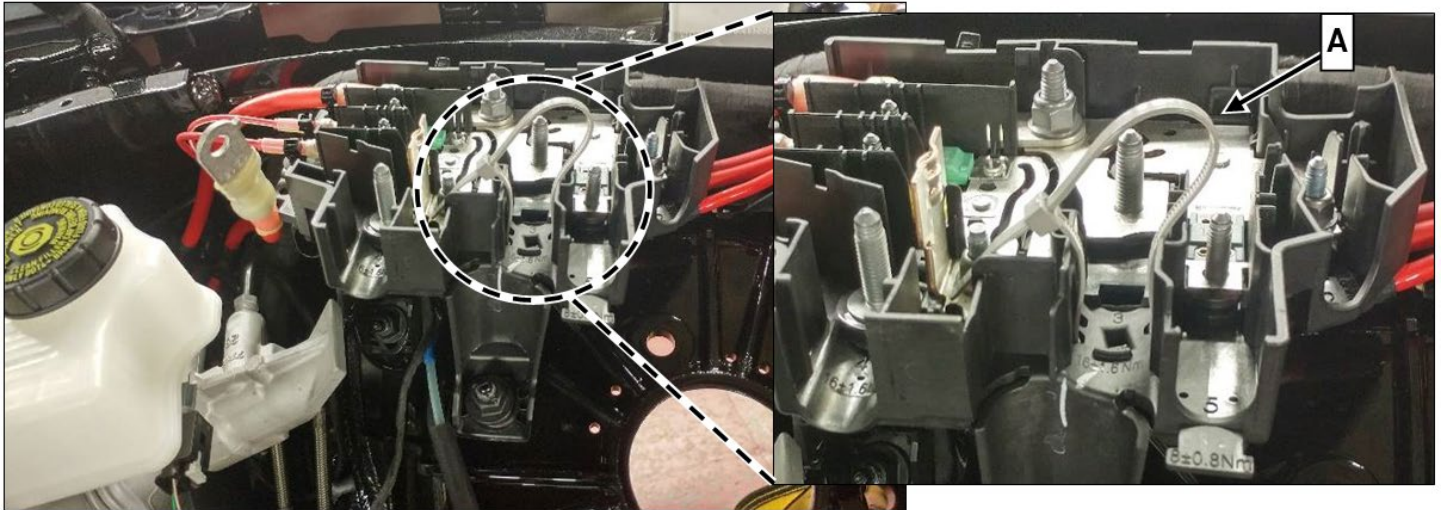
Figure 1

1. Switch off ignition and keep transmitter keys outside of transmitter range (at least 2 meters / 6.6 feet).
2. Remove cover for left air/water duct above prefuse box in engine compartment.
i For basic data, see **AR54.15-P-1330ME**, operation step 2.
3. Remove cover of prefuse box in engine compartment.
i For basic data, see **AR54.15-P-1330ME**, operation step 3.
4. Check whether there is a cable tie (**A**) for the supply line from the alternator to the prefuse box in the engine compartment at connection 3 (**Figure 1**).

- a. **Cable tie** at connection 3 of prefuse box **not** present:
Carry out **work procedure**.
- b. **Cable tie** at connection 3 of prefuse box **present**:
Assemble in reverse order and **end measure**.

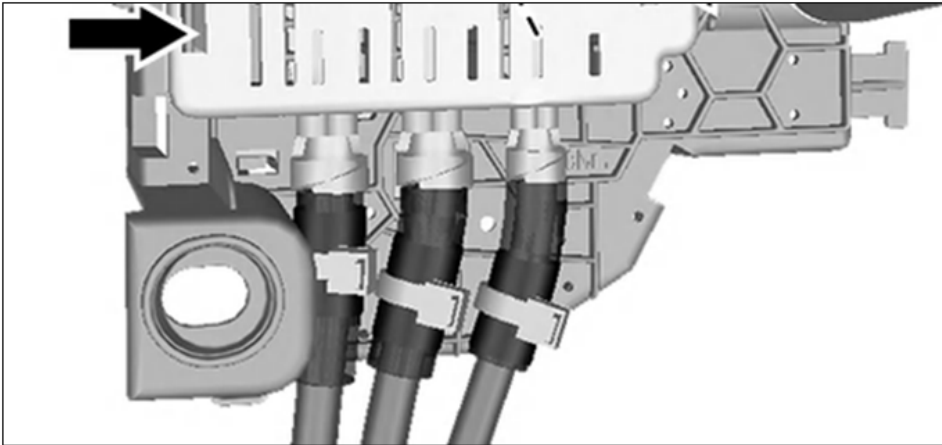
Figure 2

The cable ties for the remaining electrical cables must be replaced (**Figure 2**).

The number of electrical cables varies depending on the vehicle equipment.

1. Replace prefuse box in engine compartment.

The cable tie for the supply line at connection 3 of the prefuse box is included in the delivery package.
