SIB 11 01 22

2024-05-13

RECALL 22V-119: POSITIVE CRANKCASE VENTILATION (PCV) BLOW-BY HEATER

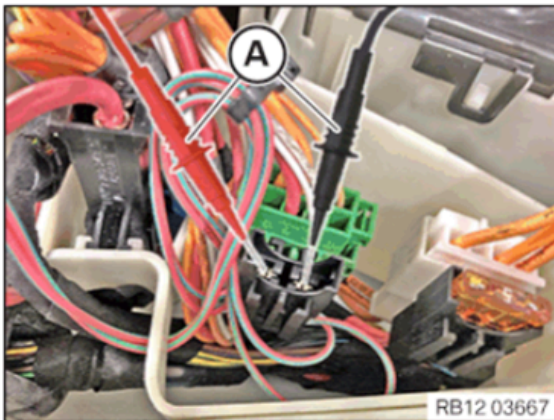
Removing the electronics ... < Repair procedure 4/7 > Installing lid of electronics ...

- Connect the current measurement device (ammeter) as shown with the fuse not plugged in.

The measured current value must even out after 4 min to a value between 1.0 A and 0.3 A.

- » Current value not in the specified range

Replace additional components if damaged because of the short-circuited crankcase ventilation blow by heater. This may include the intake manifold, crankcase ventilation hoses and or the electrical harness as consequential damage.

- Perform troubleshooting according to the wiring diagram.

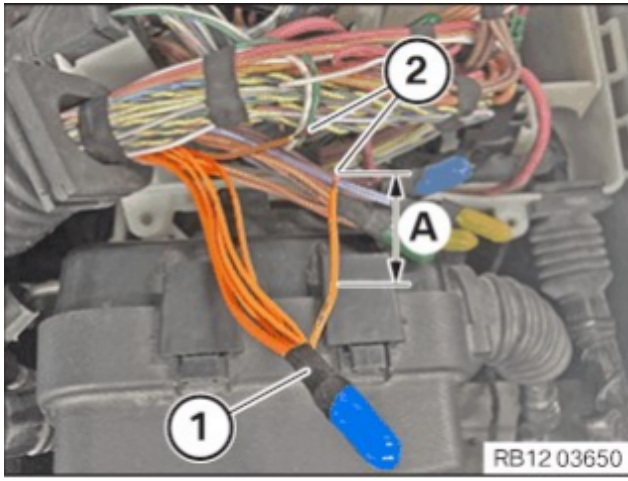
Repair Instruction 00 72 067 “Retrofitting component protection and checking function of angle fitting” indicates the splice cap is blue, this is not the actual color of the splice cap.

The picture has been edited to highlight the splice cap with blue coloring (1).

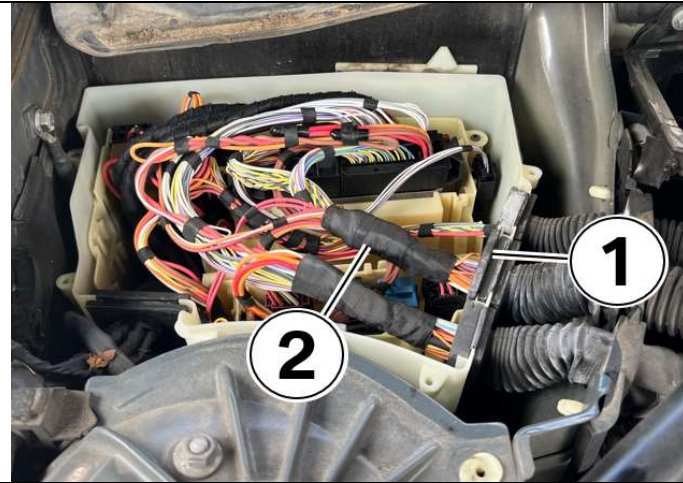
Locate the middle harness (1) in the e-box.
Unwrap the tape from the harness (2).

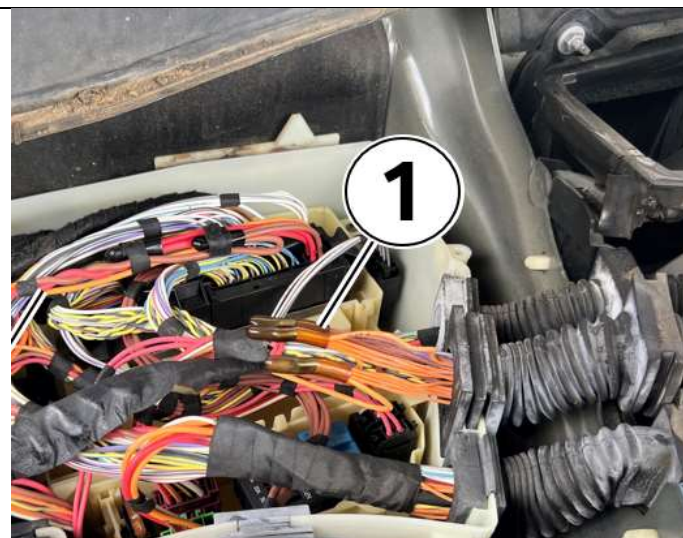
Under the tape there will be several splices with orange colored wire (1).
Select the splice that has exactly 6 orange wires in it.
Any splices with more or less wire will be the incorrect splice.

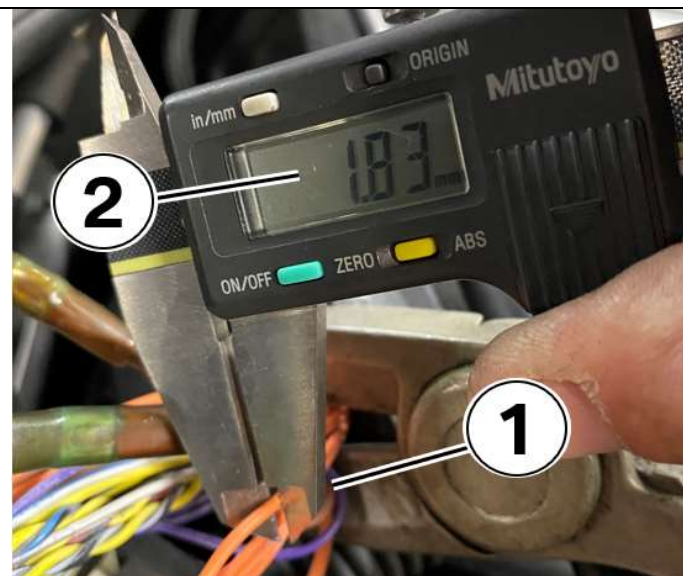
To identify the correct wire a digital caliper must be used to ensure accuracy. Use the digital caliper to measure the outside diameter (1) of each wire in this splice. Do not separate the splice.

In this example the correct wire is measured at 1.83 mm.

Select the wire that measures between 1.70 – 1.90 mm (1) and continue with Repair Instruction 00 72 067 “Retrofitting component protection and checking function of angle fitting”.

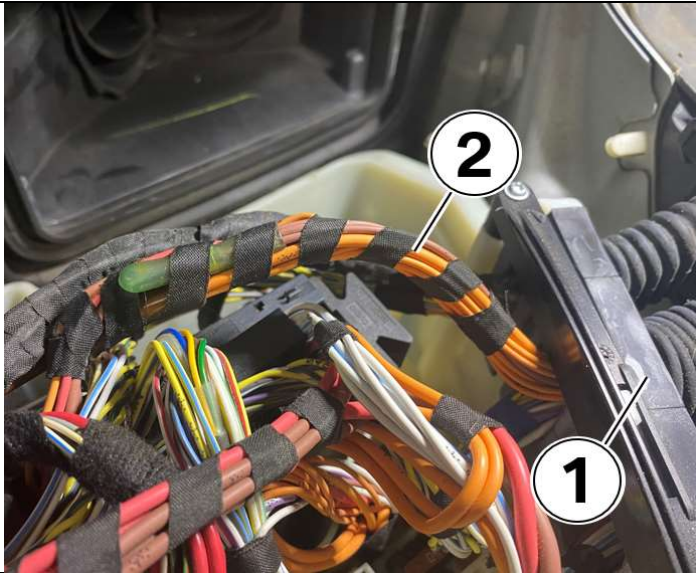
Locate the middle harness (1) in the e-box.

Unwrap the tape from the harness (2).

Select the splice that has exactly 8 orange wires in it.

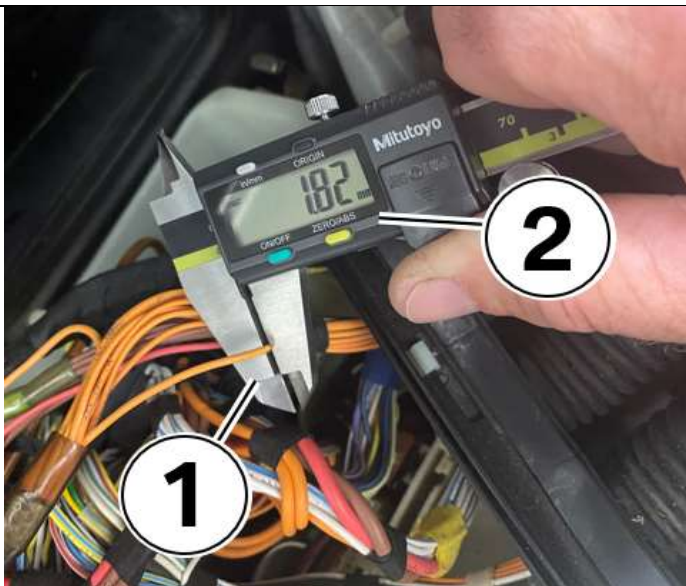
To identify the correct wire a digital caliper must be used to ensure accuracy. Use the digital caliper to measure the outside diameter (1) of each wire in this splice. Do not separate the splice.

In this example the correct wire is measured at 1.82 mm.

Select the wire that measures between 1.70 – 1.90 mm (1) and continue with Repair Instruction 00 72 067 “Retrofitting component protection and checking function of angle fitting”.

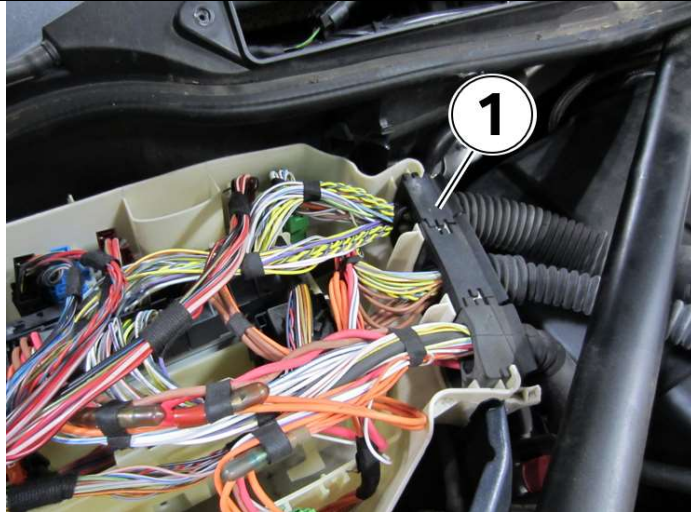
Locate the harness (1) at the rear corner of the e-box.

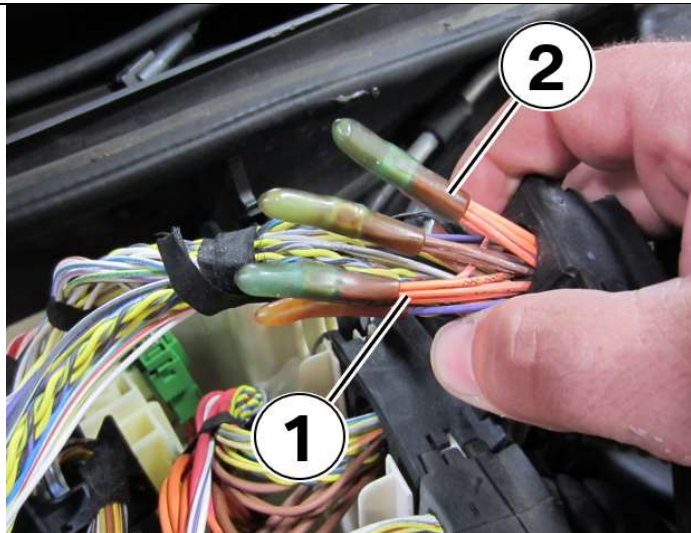
The splice will be located under the soft rubber boot, you will need to remove the harness from the e-box and pull back the rubber boot to expose them.

Under the tape will be several splices with orange wire, select the splice that has exactly 6 orange wires in it.

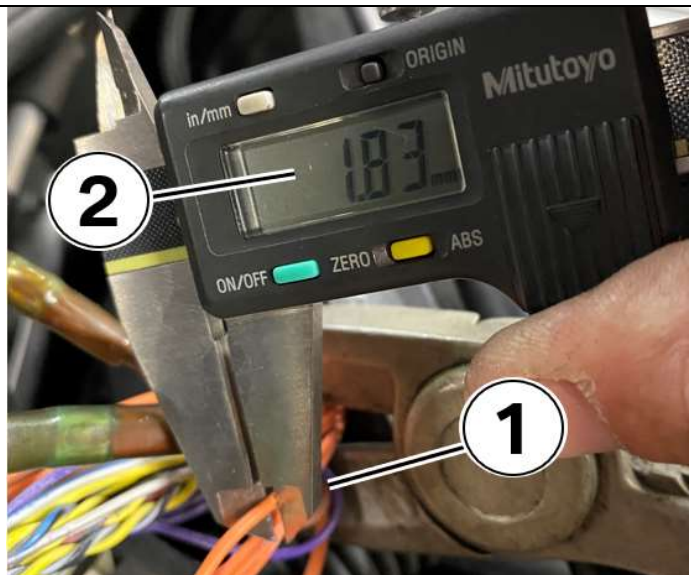
To identify the correct wire a digital caliper must be used to ensure accuracy. Use the digital caliper to measure the outside diameter (1) of each wire in this splice. Do not separate the splice.

In this example the correct wire is measured at 1.83 mm.

Select the wire that measures between 1.70 – 1.90 mm (1) and continue with Repair Instruction 00 72 067 "Retrofitting component protection and checking function of angle fitting".

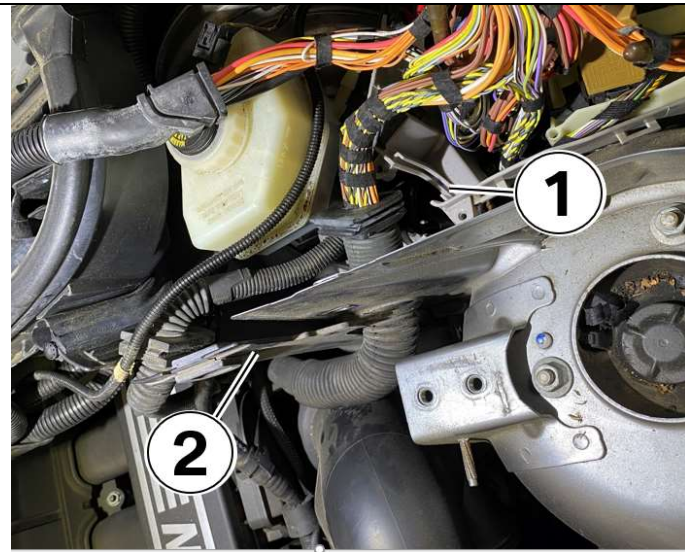
Locate the harness (1) at the front corner of the e-box.

You will need to loosen the surrounding plastic trim (2) to access the soft rubber boot.

The splice will be located under the soft rubber boot, you will need to remove the harness from the e-box and pull back the rubber boot to expose them.

For photo clarity the strut brace was removed. Do not remove the strut brace to perform this procedure.

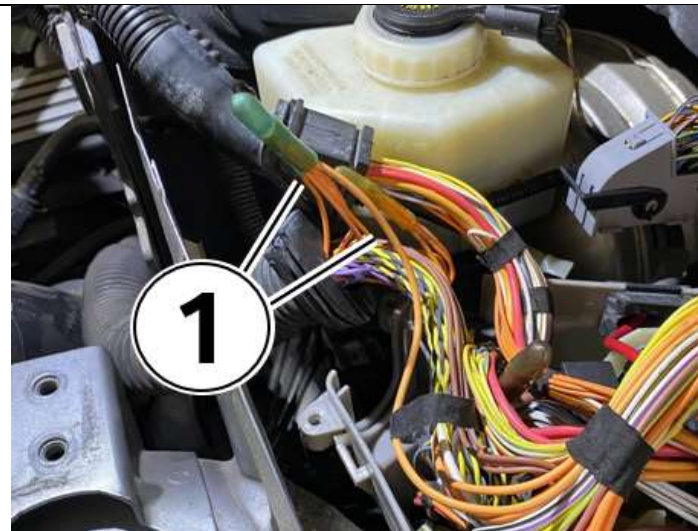
Unwrap the tape from the harness.

Under the tape there will be several splices with orange wire, select the splice that has exactly 6 orange wires in it.

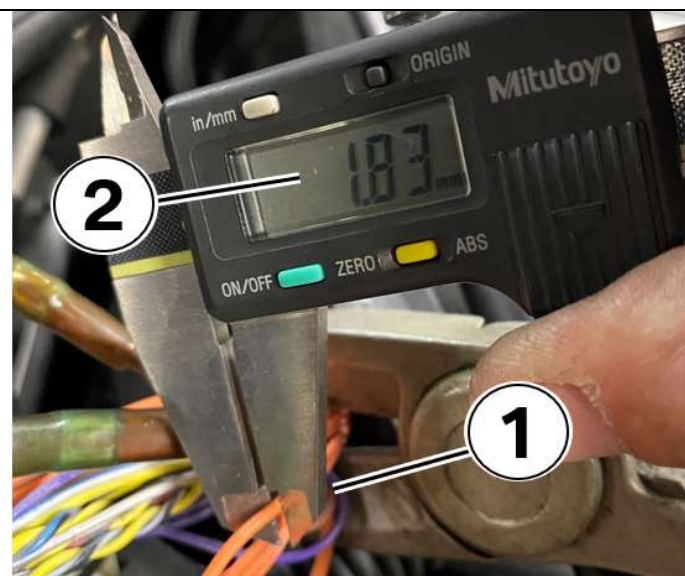
To identify the correct wire a digital caliper must be used to ensure accuracy. Use the digital caliper to measure the outside diameter (1) of each wire in this splice. Do not separate the splice. In this example the correct wire is measured at 1.83 mm.

Select the wire that measures between 1.70 – 1.90 mm (1) and continue with Repair Instruction 00 72 067 "Retrofitting component protection and checking function of angle fitting".

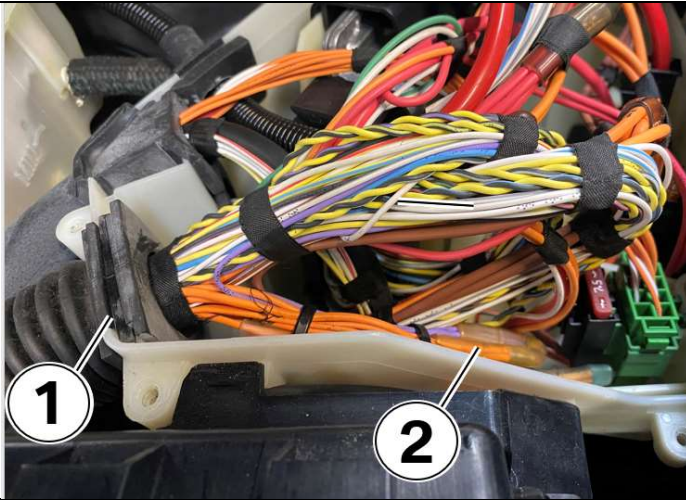
Locate the harness (1) at the front corner of the e-box.

In this particular application the splices are already exposed (2).

There will be several splices with orange wire, select the splice that has exactly 6 orange wires in it.

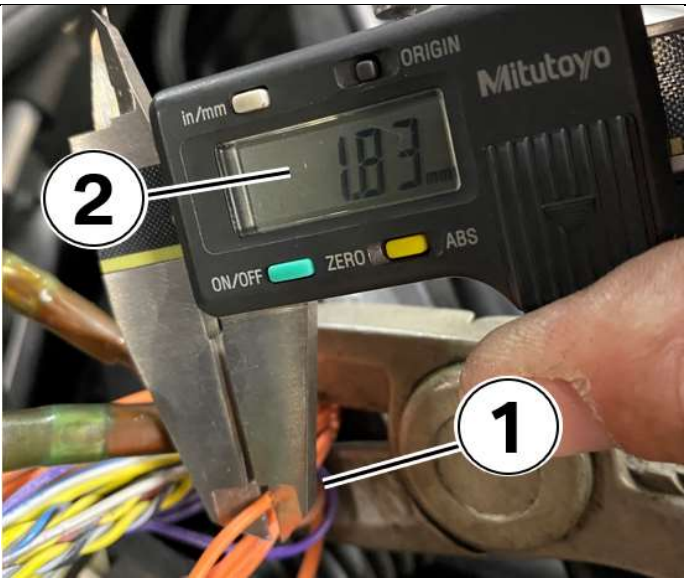
To identify the correct wire a digital caliper must be used to ensure accuracy. Use the digital caliper to measure the outside diameter (1) of each wire in this splice. Do not separate the splice.

In this example the correct wire is measured at 1.83 mm.

Select the wire that measures between 1.70 – 1.90 mm (1) and continue with Repair Instruction 00 72 067 "Retrofitting component protection and checking function of angle fitting".

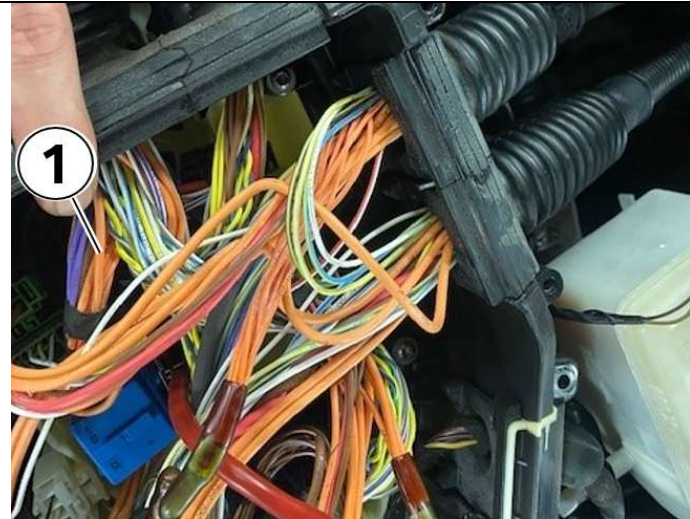
Locate the harness (1) in the e-box.

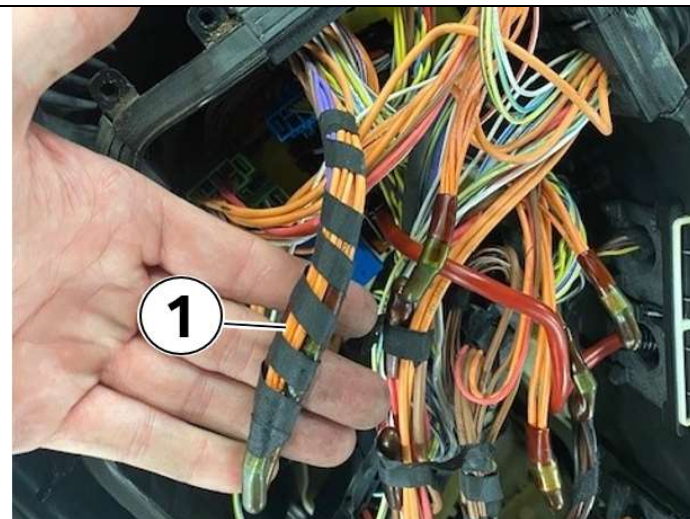
Gently pull the harness upward to expose the portion of the harness that contains the splices.

Remove the tape from the Harness (1) to expose the wires.

There will be several splices with orange wire, select the splice that has exactly 6 orange wires in it.

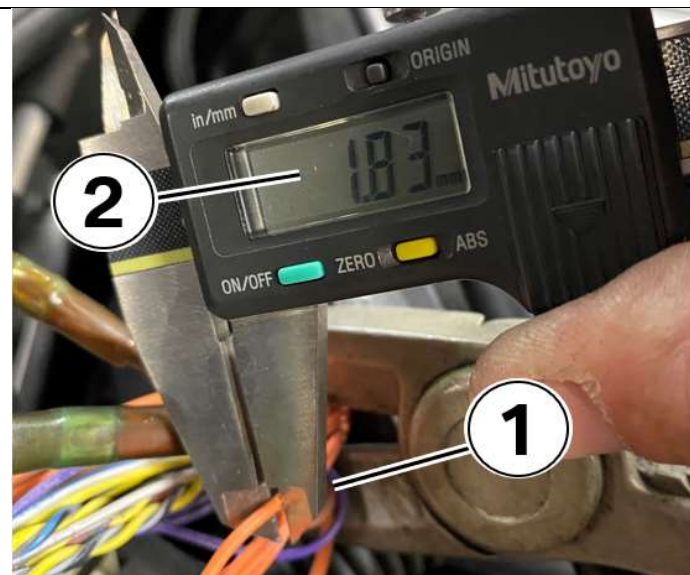
To identify the correct wire a digital caliper must be used to ensure accuracy. Use the digital caliper to measure the outside diameter (1) of each wire in this splice. Do not separate the splice.

In this example the correct wire is measured at 1.83 mm.

Select the wire that measures between 1.70 – 1.90 mm (1) and continue with Repair Instruction 00 72 067 “Retrofitting component protection and checking function of angle fitting”.
