SIB 11 01 22

## RECALL 22V-119: POSITIVE CRANKCASE VENTILATION (PCV) BLOW-BY HEATER

This Service Information Bulletin (Revision 3) replaces SI B11 01 22 **dated June 2022**.

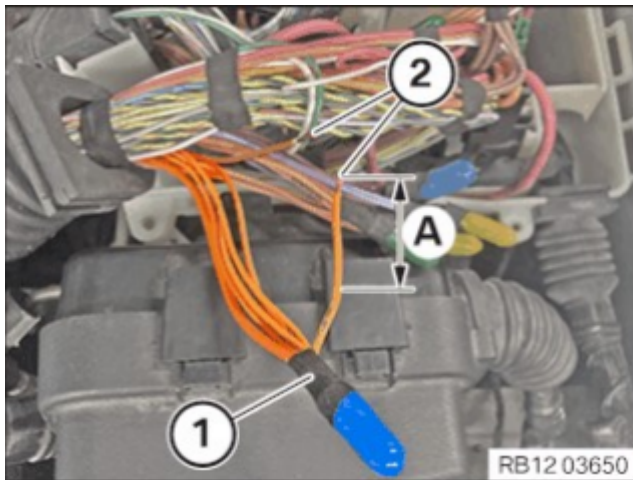
Repair Instruction 00 72 067 "Retrofitting component protection and checking function of angle fitting" indicates the splice cap is blue, this is not the actual color of the splice cap.

The picture has been edited to highlight the splice cap with blue coloring (1).

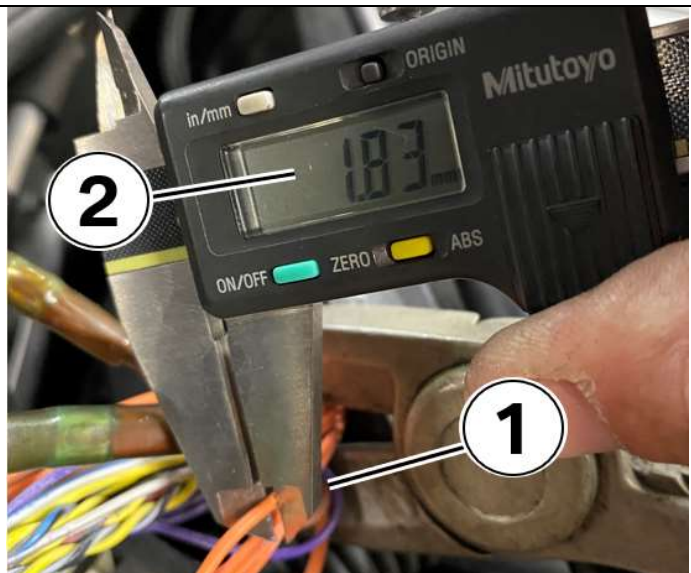
In this example the correct wire is measured at 1.83 mm.

To identify the correct wire a digital caliper must be used to ensure accuracy. Use the digital caliper to measure the outside diameter (1) of each wire in this splice. Do not separate the splice.

Select the wire that measures between 1.70 – 1.90 mm (1) and continue with Repair Instruction 00 72 067 “Retrofitting component protection and checking function of angle fitting”.

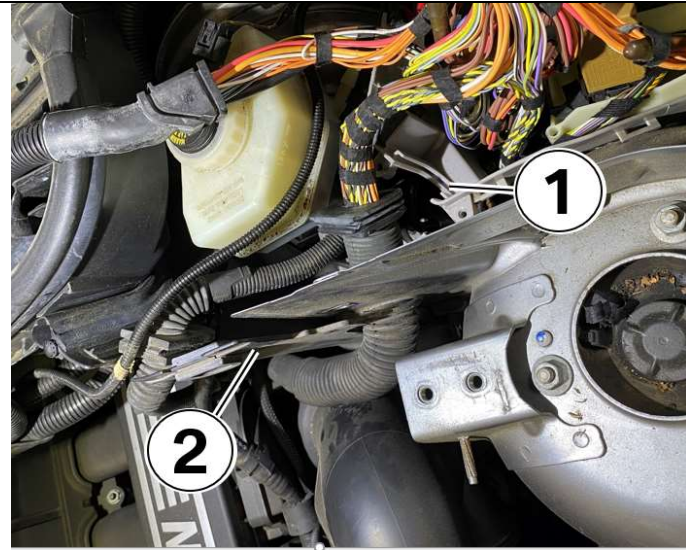
## E83 Vehicles:

For photo clarity the strut brace was removed. Do not remove the strut brace to perform this procedure.

Locate the harness (1) at the front corner of the e-box.

You will need to loosen the surrounding plastic trim (2) to access the soft rubber boot.

The splice will be located under the soft rubber boot, you will need to remove the harness from the e-box and pull back the rubber boot to expose them.
