SIB 11 01 22

2022-06-28

RECALL 22V-119: POSITIVE CRANKCASE VENTILATION (PCV) BLOW-BY HEATER

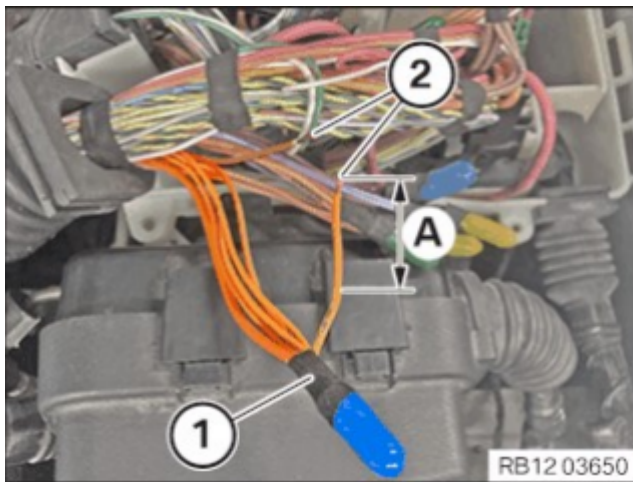
Electrical Harness Identification Hints:

Repair Instruction 00 72 067 “Retrofitting component protection and checking function of angle fitting” indicates the splice cap is blue, this is not the actual color of the splice cap.

The picture has been edited to highlight the splice cap with blue coloring (1).

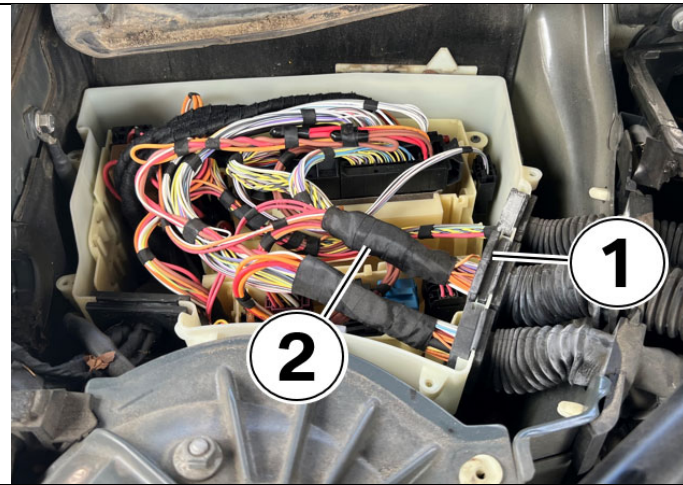
E60 & E61 Vehicles:

Locate the middle harness (1) in the e-box.

Unwrap the tape from the harness (2).

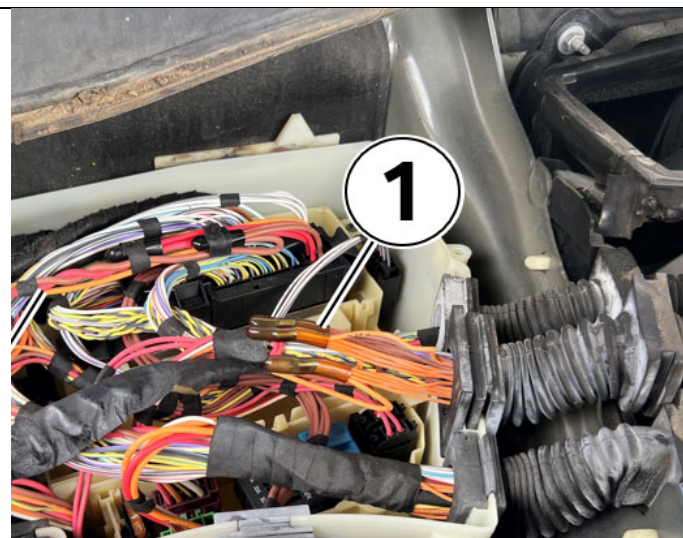
Under the tape there will be several splices with orange colored wire (1).

Select the splice that has exactly 6 orange wires in it.

Any splices with more or less wire will be the incorrect splice.

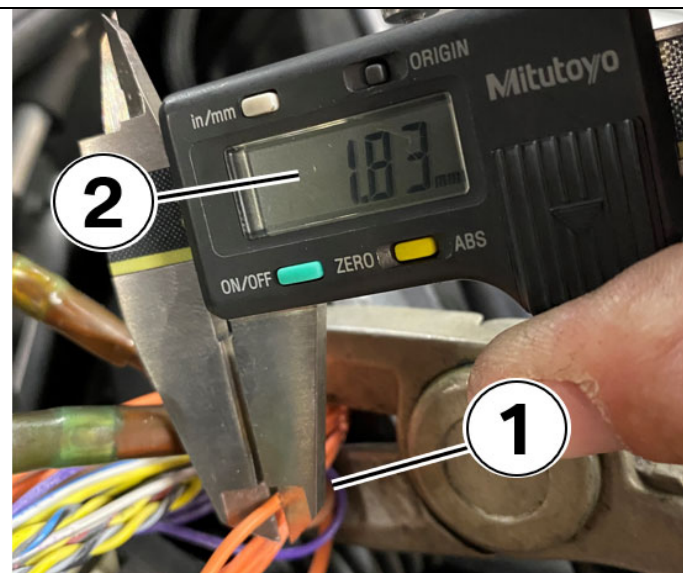
To identify the correct wire a digital caliper must be used to ensure accuracy. Use the digital caliper to measure the outside diameter (1) of each wire in this splice. Do not separate the splice.

In this example the correct wire is measured at 1.83 mm.

Wire outside diameter specifications:

1 wire = 2.15 - 2.40 mm – Incorrect wire

1 wire = 1.70 – 1.90 mm – Correct wire

4 wires = 1.35 – 1.55 mm – Incorrect wire

Select the wire that measures between 1.70 – 1.90 mm (1) and continue with Repair Instruction 00 72 067 “Retrofitting component protection and checking function of angle fitting”.

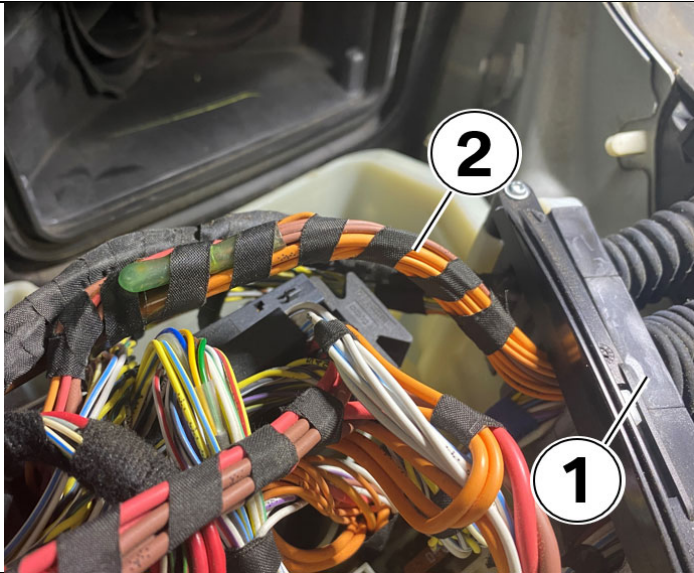
E70 Vehicles:

Locate the middle harness (1) in the e-box.

Unwrap the tape from the harness (2).

Under the tape there will be several splices with orange wire.

Select the splice that has exactly 8 orange wires in it.

Any splices with more or less wire will be the incorrect splice.

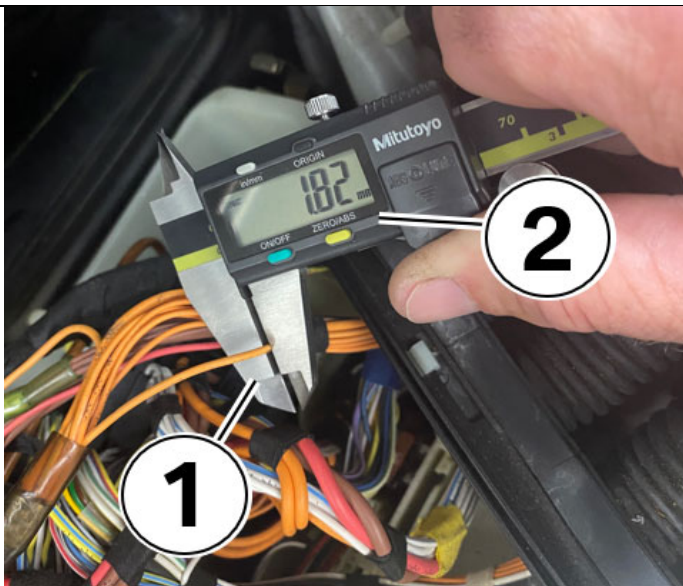
To identify the correct wire a digital caliper must be used to ensure accuracy. Use the digital caliper to measure the outside diameter (1) of each wire in this splice. Do not separate the splice.

In this example the correct wire is measured at 1.82 mm.

Wire outside diameter specifications:

1 wire = 2.80 – 3.10 mm – Incorrect wire

1 wire = 1.90 – 2.10 mm – Incorrect wire

1 wire = 1.70 – 1.90 mm – Correct wire

5 wires = 1.40 – 1.60 mm – Incorrect wire

Select the wire that measures between 1.70 – 1.90 mm (1) and continue with Repair Instruction 00 72 067 "Retrofitting component protection and checking function of angle fitting".

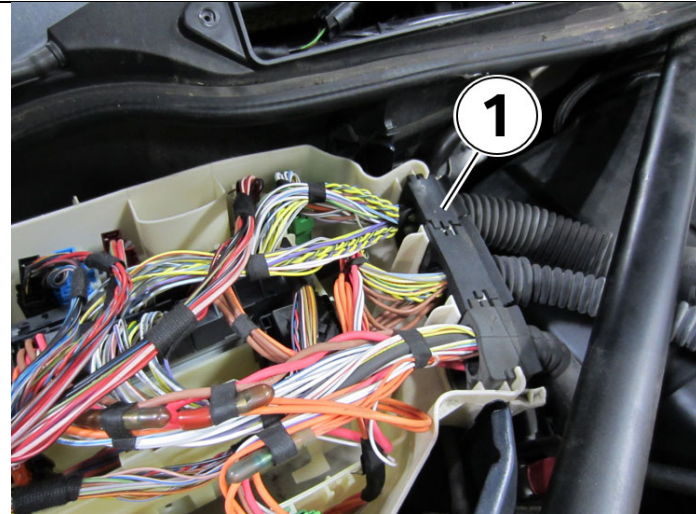
E82, E88, E90, E91, E92 and E93 Vehicles:

Locate the harness (1) at the rear corner of the e-box.

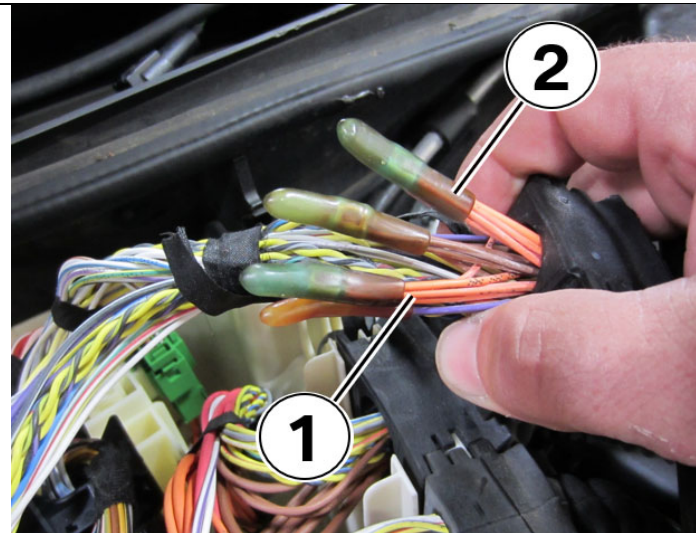
The splice will be located under the soft rubber boot, you will need to remove the harness from the e-box and pull back the rubber boot to expose them.

Unwrap the tape from the harness.

Under the tape will be several splices with orange wire, select the splice that has exactly 6 orange wires in it.

Any splices with more or less wire will be the incorrect splice.

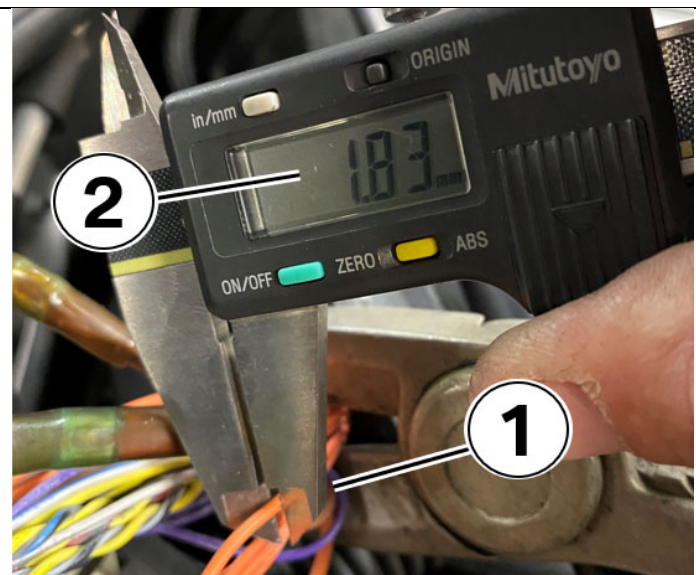
To identify the correct wire a digital caliper must be used to ensure accuracy. Use the digital caliper to measure the outside diameter (1) of each wire in this splice. Do not separate the splice.

In this example the correct wire is measured at 1.83 mm.

Wire outside diameter specifications:

1 wire = 2.15 – 2.40 mm – Incorrect wire

1 wire = 1.70 – 1.90 mm – Correct wire

4 wires = 1.35 – 1.55 mm – Incorrect wire

Select the wire that measures between 1.70 – 1.90 mm (1) and continue with Repair Instruction 00 72 067 “Retrofitting component protection and checking function of angle fitting”.

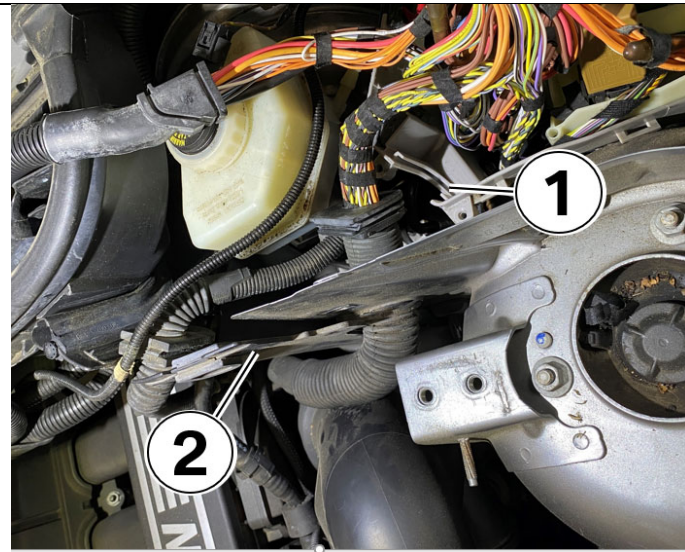
E83 Vehicles:

Locate the harness (1) at the front corner of the e-box.

You will need to loosen the surrounding plastic trim (2) to access the soft rubber boot.

The splice will be located under the soft rubber boot, you will need to remove the harness from the e-box and pull back the rubber boot to expose them.

For photo clarity the strut brace was removed. Do not remove the strut brace to perform this procedure.

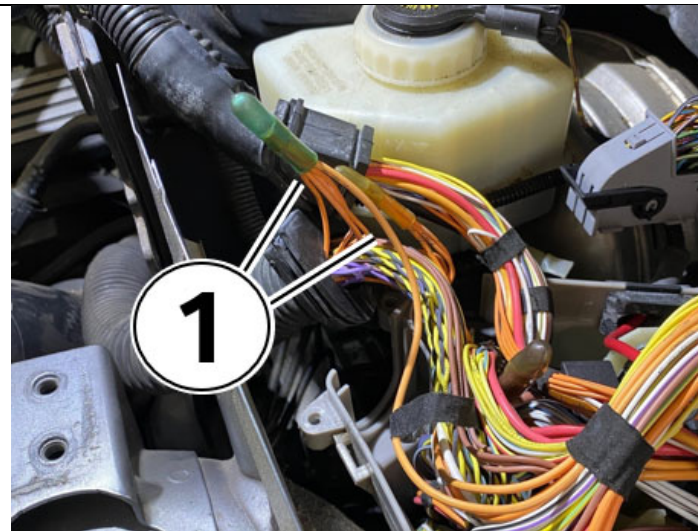
Unwrap the tape from the harness.

Under the tape there will be several splices with orange wire, select the splice that has exactly 6 orange wires in it.

Any splices with more or less wire will be the incorrect splice.

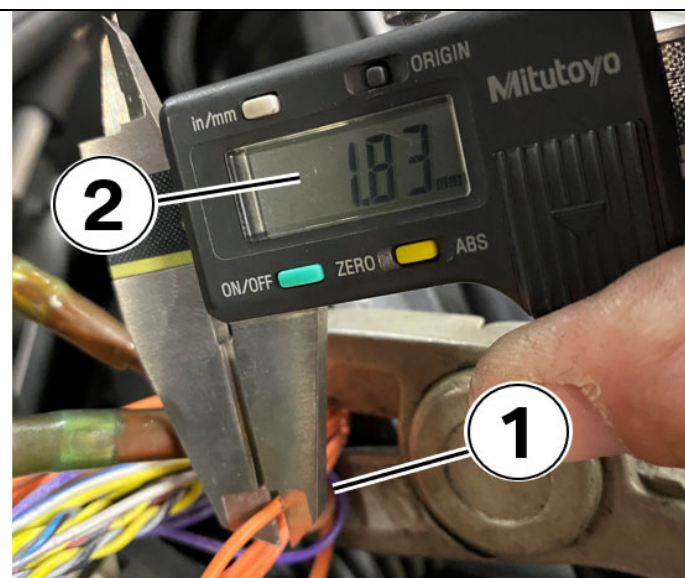
To identify the correct wire a digital caliper must be used to ensure accuracy. Use the digital caliper to measure the outside diameter (1) of each wire in this splice. Do not separate the splice. In this example the correct wire is measured at 1.83 mm.

Wire outside diameter specifications:

1 wire = 2.15 – 2.40 mm – Incorrect wire

1 wire = 1.70 – 1.90 mm – Correct wire

4 wires = 1.35 – 1.55 mm – Incorrect wire

Select the wire that measures between 1.70 – 1.90 mm (1) and continue with Repair Instruction 00 72 067 "Retrofitting component protection and checking function of angle fitting".

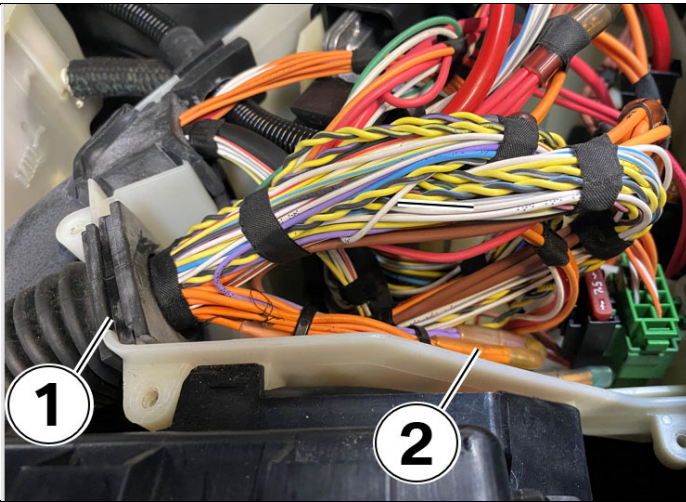
E85 & E86 Vehicles:

Locate the harness (1) at the front corner of the e-box.

In this particular application the splices are already exposed (2).

There will be several splices with orange wire, select the splice that has exactly 6 orange wires in it.

Any splices with more or less wire will be the incorrect splice.

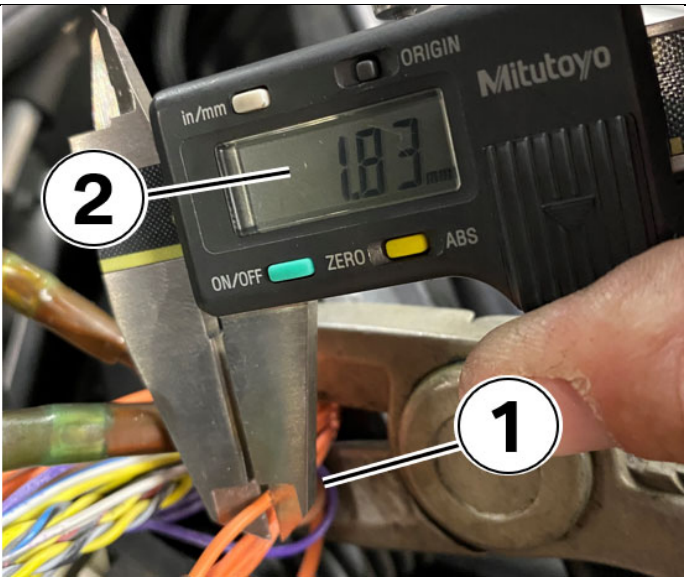
To identify the correct wire a digital caliper must be used to ensure accuracy. Use the digital caliper to measure the outside diameter (1) of each wire in this splice. Do not separate the splice.

In this example the correct wire is measured at 1.83 mm.

Wire outside diameter specifications:

- 1 wire = 2.15 – 2.40 mm – Incorrect wire
- 1 wire = 1.70 – 1.90 mm – Correct wire**
- 4 wires = 1.35 – 1.55 mm – Incorrect wire

Select the wire that measures between 1.70 – 1.90 mm (1) and continue with Repair Instruction 00 72 067 "Retrofitting component protection and checking function of angle fitting".
