TO: Mercedes-Benz Dealer Principals, General Managers, Sales Managers, Service Managers, Parts Managers	FROM: Gregory Gunther, Department Manager, Vehicle Compliance and Analysis, Engineering Services
RE: Recall Campaign Launch Notification Check Airbag Control Unit Installation MY21 S-Class (223 platform)	DATE: April 8, 2022

Campaign No. 2022030024, April 2022

SUBJECT: **Model S-Class (223 platform)**
Model Year 2021

Check Airbag Control Unit Installation

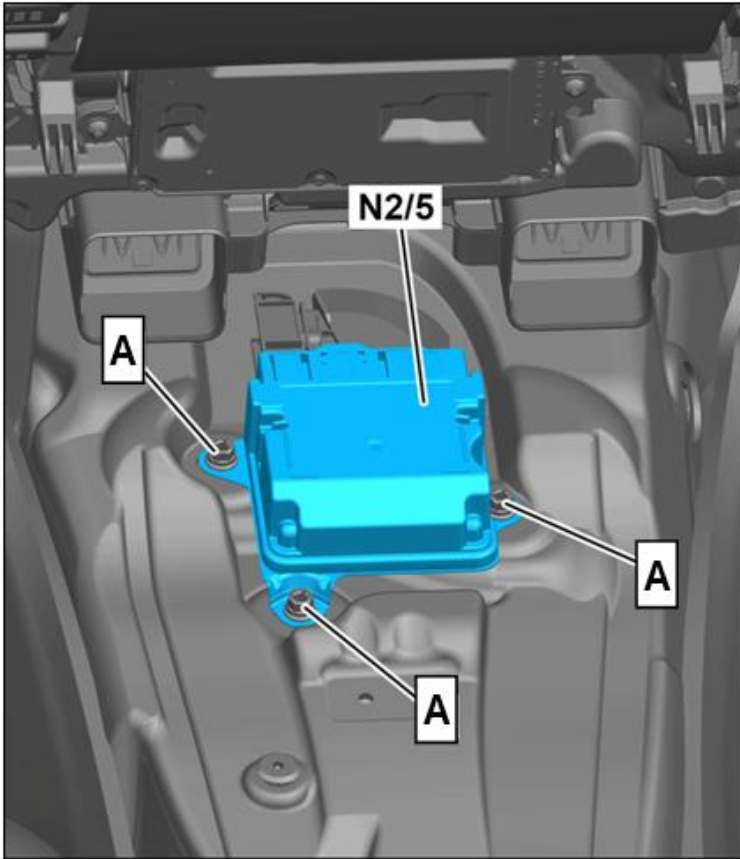
**Figure 1**

1. Expose restraint system control unit until the three bolting points (**A, figure 1**) can be accessed.

1. Remove 3 nuts (**A, figure 1**) and check thread at threaded studs including the nuts.
 - a. Thread at threaded studs and nuts **without** damage:
Carry out **work procedure A**.
 - b. Thread at threaded studs and nuts damaged:
Perform **work procedure B**.

1. **Tighten** nuts at bolting points with **specified torque**.

Nm Nut, restraint systems control unit to vehicle floor **10 Nm**
