## **SAFETY RECALL**

### **CONVENTIONAL AIR COMPRESSOR CHARGE PIPE TORQUE**

RECALL NO: M0360

REFERENCE NO: QA-220304-N1

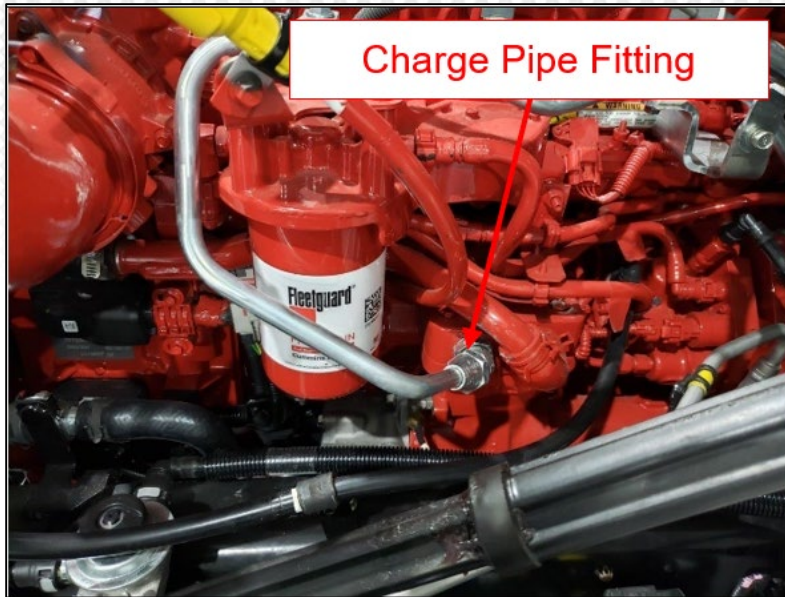
The charge pipe flare nut at the air compressor may not have been torqued to manufacturer specification. This procedure will document proper torque value application to the air compressor charge pipe flare nut, and leak check confirmation.

3. Locate the flare nut fitting on the left side of the engine that attaches the air compressor charge pipe to the air compressor.
