Safety Recall

Code: 20DN

Fuel Level Sender

February 08, 2023

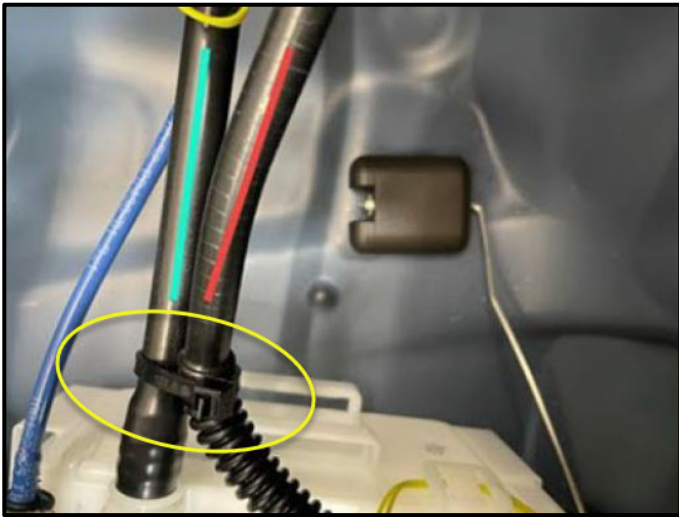
Remove tie wrap (if installed):

- A tie wrap <circle> may have been installed around the suction jet supply and vent lines during a previous repair.
- Check for the presence of this tie wrap. If this tie wrap is installed, it must be removed and discarded.

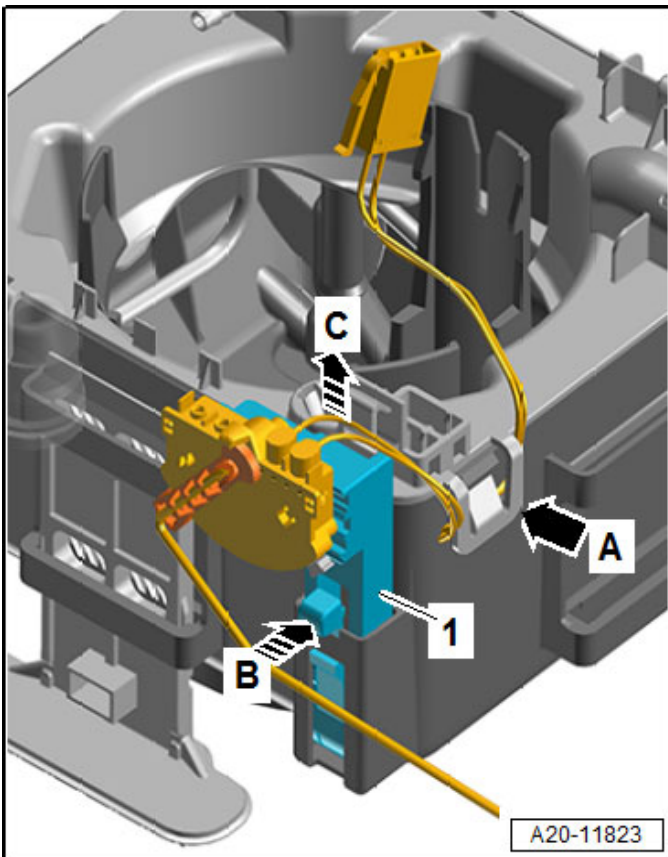
Remove fuel level sender:

- Reach through the installation opening in the fuel tank and free up the wire for the Fuel Level Sender at the baffle housing <arrow A>.
- Reach through the installation opening in the fuel tank, release the catch in direction of <arrow B> and at the same time, remove the fuel gauge <1> from the mount on the baffle housing in direction of <arrow C>.
- Carefully remove the fuel level sender from the fuel tank opening.

Contrary to the Repair Manual, the fuel level sender can be removed without removing the fuel delivery unit.

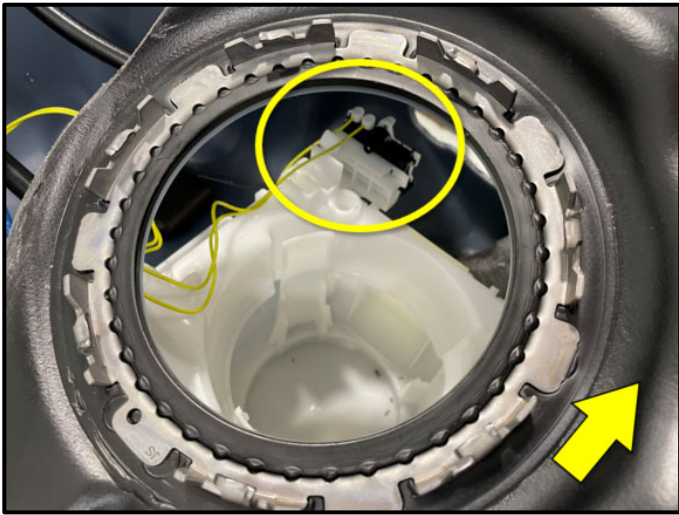
Fuel level sender denoted by the <circle>. Arrow denotes direction of vehicle travel. Fuel delivery unit shown removed for clarity.

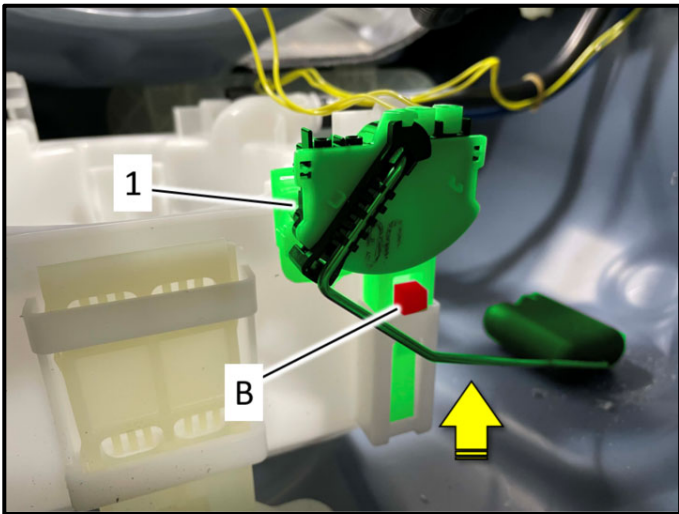
- Alternate view of removing fuel level sender.
- Press catch and remove fuel level sender <1> in direction of <arrow>.
