GROUP	MODEL
Safety Recall Campaign	2014-2016MY Cadenza (VG)
NUMBER	DATE
SC232 (Rev 4, 05/31/2023)	May 2022

SUBJECT: **WINDSHIELD INSPECTION & REATTACHMENT (SC232)**

This bulletin provides information to inspect and, if necessary, reattach the front windshield glass on 2014-2016MY Cadenza (VG) vehicles produced from February 1, 2013 through January 7, 2016. Certain sections of the front windshield glass may not have sufficient primer resulting in reduced adhesion of the windshield glass to the vehicle body. Although the exact cause of this condition is unknown, it is believed to be due to a deviation in the application of primer to the front windshield glass at the vehicle assembly plant. Insufficient adhesion can result in loosening of the front windshield glass, causing windshield separation. A separated windshield increases the risk of a crash and/or injury. Follow the procedure outlined in this publication to inspect the windshield for water leakage and, if necessary, remove and reattach the windshield. Before conducting the procedure, verify that the vehicle is included in the list of affected VINs.

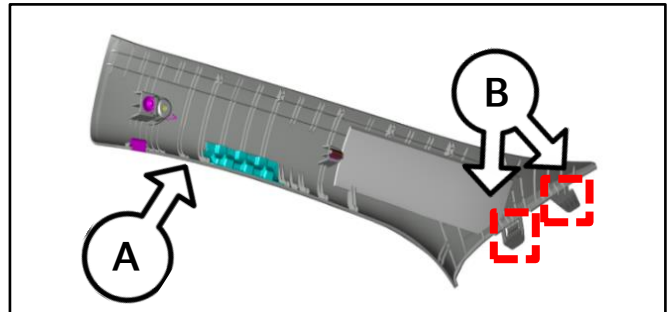
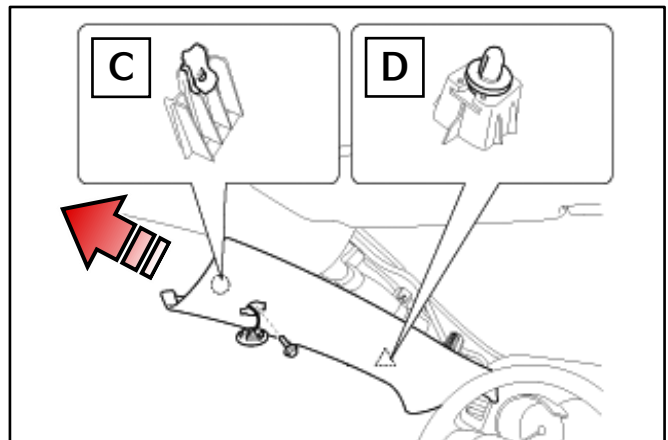
1. Before inspecting for leakage, remove the front pillar trim (A) on both sides of the vehicle by referring to the "Body (Interior and Exterior) → Interior → Interior Trim → Repair procedures" chapter in the applicable Shop Manual on KGIS.

- When removing the front pillar trim, be careful not to break the two (2) keys (B) at the bottom.
- After removing the screw and detaching clip (C) and fastener (D) lift the front pillar trim in the direction of the headlining to remove it.

Note: Ensure to install new A-Pillar trim fasteners.

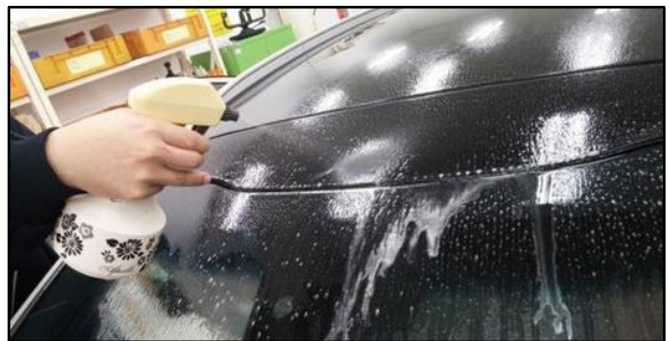
- 2a. Mix a solution of soap and water into a clean spray bottle as follows:
  - 500ml water
  - 20ml soap
- 2b. Spray a moderate amount of soapy water along the upper outside seal area of the windshield. Make sure the solution is evenly spread across the entire surface and edges.

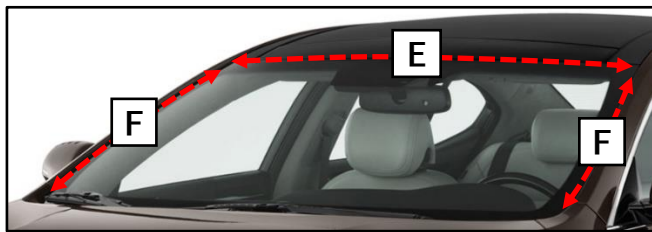
3. Inside the vehicle, inspect for water leakage along the top (E) and side pillar (F) areas of the windshield.

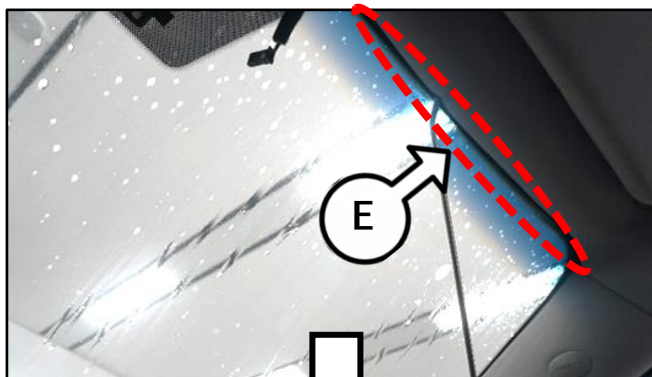
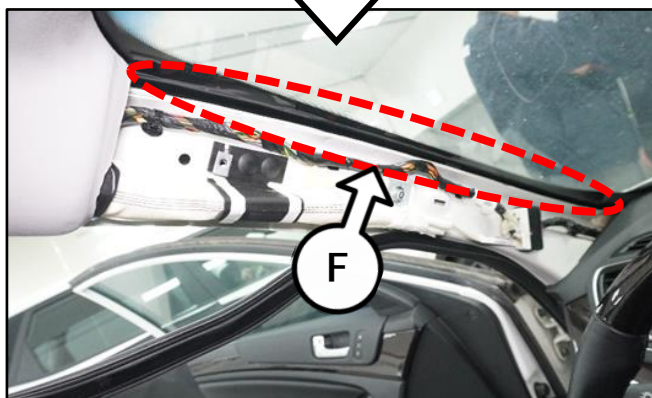
4. Using an air gun, blow air into these areas from inside the vehicle:

E: Between windshield glass and headliner.

F: Between windshield glass and front pillars.

When using the air gun, be careful NOT to lift or damage the inner tint lining on the windshield.

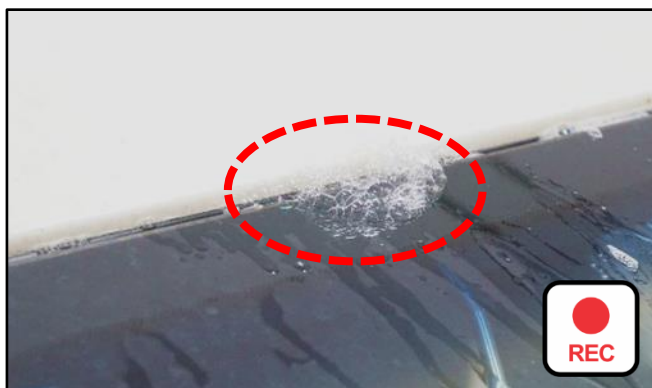
5. Immediately after blowing with the air gun, check for bubbles appearing on the outside of the windshield glass as shown.

- If air bubbles **are not** present, no further action is required. Reinstall all removed parts in the reverse order of removal. **Note:** New A-Pillar trim fasteners must be installed.

- If air bubbles **are** present, **open a Techline case online and attach a video of the leak PRIOR to removal**, and then proceed to the 'Repair Procedure' on page 4 to remove and reattach the front windshield glass.

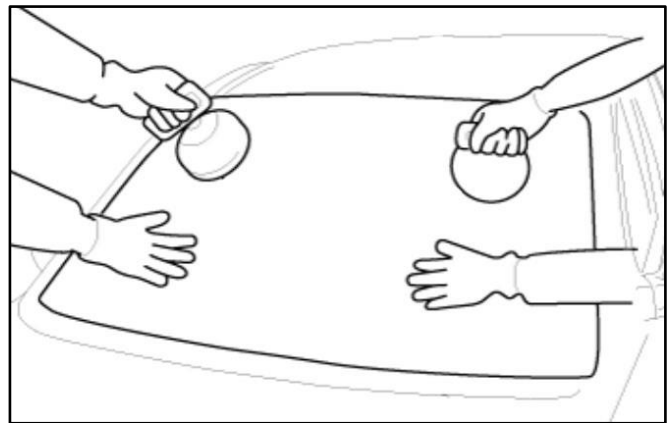
1. Replace the windshield glass by referring to the "Body (Interior and Exterior) → Interior → Windshield Glass → Repair procedures" chapter in the applicable Shop Manual on KGIS.

- Use a rotating wire removal tool during removal to reduce the possibility of damaging the glass.
- Be careful **NOT** to damage the windshield glass during removal. If the glass is damaged, it cannot be reused.

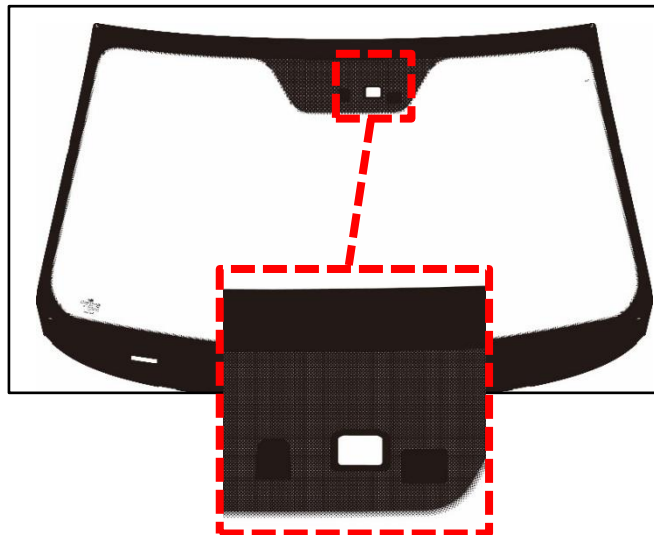
- Clean the surface of the rain sensor coupler mounting area shown on the 'new' windshield.

Be sure all dust/debris is removed from the windshield surface and the surface is warm (room temperature, 70°-75° degrees Fahrenheit) for the adhesive to adhere properly.

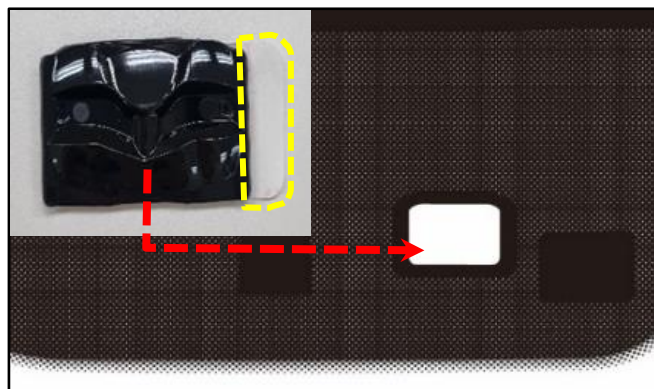
- Remove the protective double-sided adhesive tape film attached to rain sensor coupler.
- Install/adhere the rain sensor coupler to the windshield in the area shown by applying even pressure.

**Note:** Ensure there are no bubbles formed between the windshield and adhesive tape during application.
