GROUP	MODEL
Safety Recall Campaign	2014-2016MY Cadenza (VG)
NUMBER	DATE
SC232 (Rev 2, 11/10/2022)	May 2022

SAFETY RECALL CAMPAIGN

SUBJECT: **WINDSHIELD INSPECTION & REATTACHMENT (SC232)**

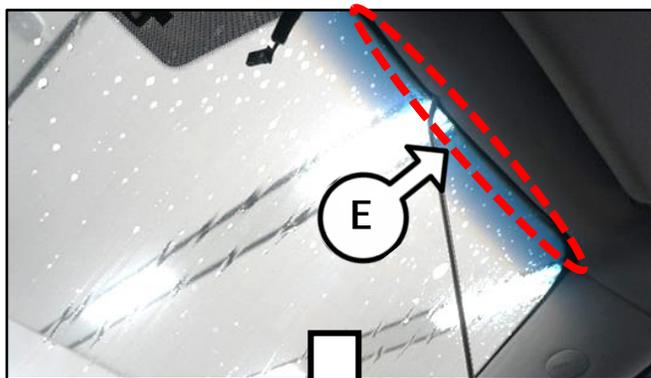
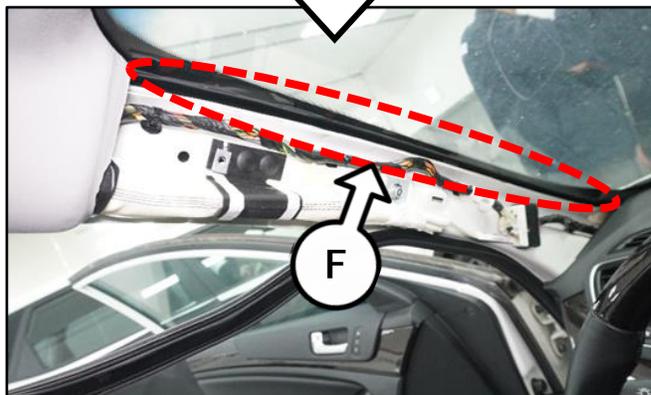
4. Using an air gun, blow air into these areas from inside the vehicle:

E: Between windshield glass and headliner.

F: Between windshield glass and front pillars.

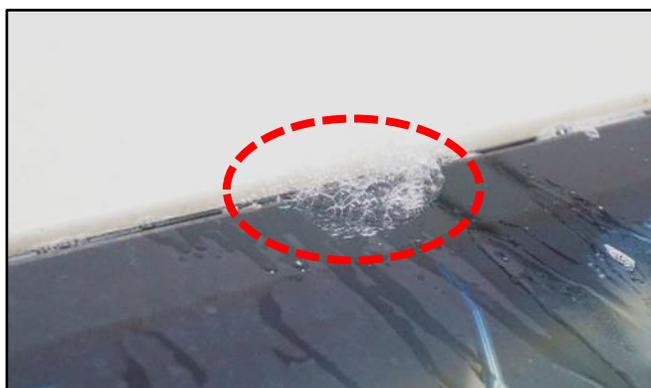
5. Immediately after blowing with the air gun, check for bubbles appearing on the outside of the windshield glass as shown.

- If air bubbles **are not** present, no further action is required. Reinstall all removed parts in the reverse order of removal.
- If air bubbles **are** present, proceed to the 'Repair Procedure' on page 4 to remove and reattach the front windshield glass.
