GROUP	MODEL
Safety Recall Campaign	2014-2016MY Cadenza (VG)
NUMBER	DATE
SC232 (Rev 5, 01/26/2024)	May 2022

SAFETY RECALL CAMPAIGN

SUBJECT: **WINDSHIELD INSPECTION & REATTACHMENT (SC232)**

This bulletin provides information to inspect and, if necessary, reattach the front windshield glass on 2014-2016MY Cadenza (VG) vehicles produced from February 1, 2013 through January 7, 2016. Certain sections of the front windshield glass may not have sufficient primer resulting in reduced adhesion of the windshield glass to the vehicle body. Although the exact cause of this condition is unknown, it is believed to be due to a deviation in the application of primer to the front windshield glass at the vehicle assembly plant. Insufficient adhesion can result in loosening of the front windshield glass, causing windshield separation. A separated windshield increases the risk of a crash and/or injury. Follow the procedure outlined in this publication to inspect the windshield for water leakage and, if necessary, remove and reattach the windshield. Before conducting the procedure, verify that the vehicle is included in the list of affected VINs.

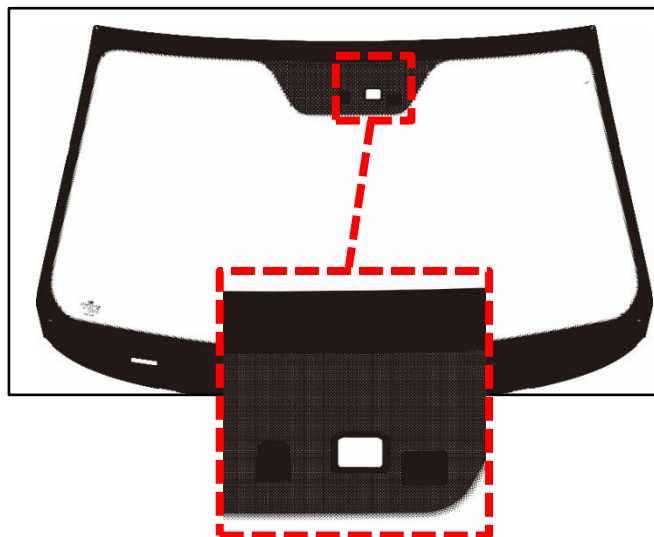
- Clean the surface of the rain sensor coupler mounting area shown on the 'new' windshield.

Be sure all dust/debris is removed from the windshield surface and the surface is warm (room temperature, 70°-75° degrees Fahrenheit) for the adhesive to adhere properly.
