GROUP	MODEL
Safety Recall Campaign	2014-2016MY Cadenza (VG)
NUMBER	DATE
SC232 (Rev 3, 05/23/2023)	May 2022

SUBJECT: **WINDSHIELD INSPECTION & REATTACHMENT (SC232)**

This bulletin provides information to inspect and, if necessary, reattach the front windshield glass on 2014-2016MY Cadenza (VG) vehicles produced from February 1, 2013 through January 7, 2016. Certain sections of the front windshield glass may not have sufficient primer resulting in reduced adhesion of the windshield glass to the vehicle body. Although the exact cause of this condition is unknown, it is believed to be due to a deviation in the application of primer to the front windshield glass at the vehicle assembly plant. Insufficient adhesion can result in loosening of the front windshield glass, causing windshield separation. A separated windshield increases the risk of a crash and/or injury. Follow the procedure outlined in this publication to inspect the windshield for water leakage and, if necessary, remove and reattach the windshield. Before conducting the procedure, verify that the vehicle is included in the list of affected VINs.

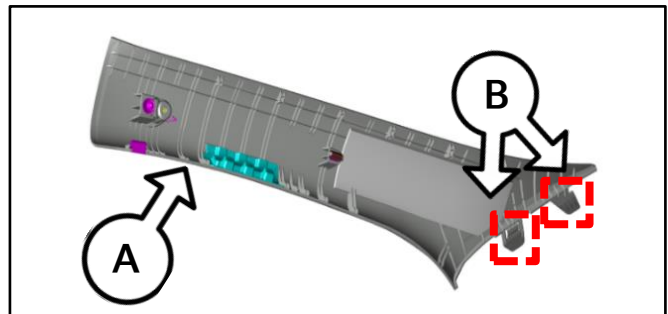
1. Before inspecting for leakage, remove the front pillar trim (A) on both sides of the vehicle by referring to the "Body (Interior and Exterior) → Interior → Interior Trim → Repair procedures" chapter in the applicable Shop Manual on KGIS.

- When removing the front pillar trim, be careful not to break the two (2) keys (B) at the bottom.
- After removing the screw and detaching clip (C) and fastener (D) lift the front pillar trim in the direction of the headlining to remove it.

Note: Ensure to install new A-Pillar trim fasteners.

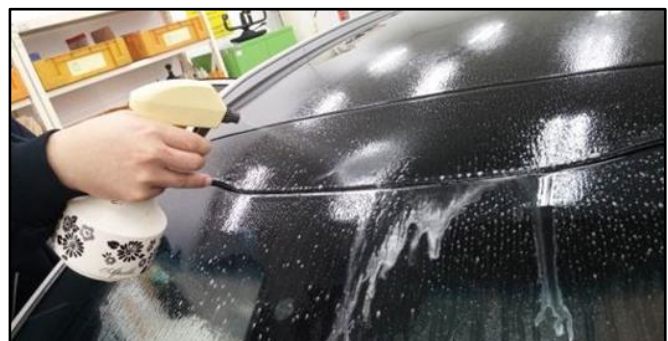
- 2a. Mix a solution of soap and water into a clean spray bottle as follows:
 - 500ml water
 - 20ml soap
- 2b. Spray a moderate amount of soapy water along the upper outside seal area of the windshield. Make sure the solution is evenly spread across the entire surface and edges.

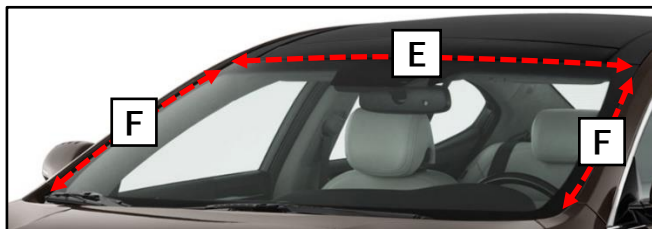
3. Inside the vehicle, inspect for water leakage along the top (E) and side pillar (F) areas of the windshield.

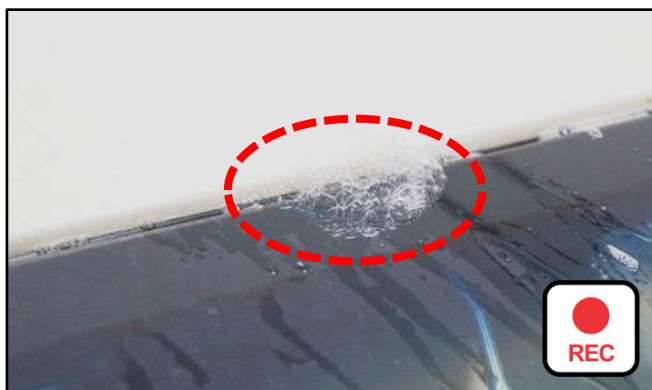
5. Immediately after blowing with the air gun, check for bubbles appearing on the outside of the windshield glass as shown.

- If air bubbles **are not** present, no further action is required. Reinstall all removed parts in the reverse order of removal. **Note:** New A-Pillar trim fasteners must be installed.

- If air bubbles **are** present, **open a Techline case online and attach a video of the leak PRIOR to removal**, and then proceed to the 'Repair Procedure' on page 4 to remove and reattach the front windshield glass.

Note: Be sure to clean off soap water residue from glass and paint surface.
