GROUP	MODEL
Safety Recall Campaign	2014-2016MY Cadenza (VG)
NUMBER	DATE
SC232 (Rev 1, 07/11/2022)	May 2022

SUBJECT: **WINDSHIELD INSPECTION & REATTACHMENT (SC232)**

This bulletin provides information to inspect and, if necessary, reattach the front windshield glass on 2014-2016MY Cadenza (VG) vehicles produced from February 1, 2013 through January 7, 2016. Certain sections of the front windshield glass may not have sufficient primer resulting in reduced adhesion of the windshield glass to the vehicle body. Although the exact cause of this condition is unknown, it is believed to be due to a deviation in the application of primer to the front windshield glass at the vehicle assembly plant. Insufficient adhesion can result in loosening of the front windshield glass, causing windshield separation. A separated windshield increases the risk of a crash and/or injury. Follow the procedure outlined in this publication to inspect the windshield for water leakage and, if necessary, remove and reattach the windshield. Before conducting the procedure, verify that the vehicle is included in the list of affected VINs.

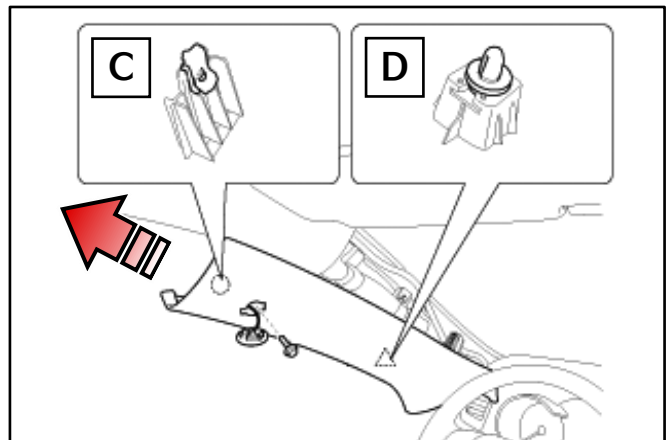
1. Before inspecting for leakage, remove the front pillar trim (A) on both sides of the vehicle by referring to the "Body (Interior and Exterior) → Interior → Interior Trim → Repair procedures" chapter in the applicable Shop Manual on KGIS.

- When removing the front pillar trim, be careful not to break the two (2) keys (B) at the bottom.
- After removing the screw and detaching clip (C) and fastener (D) lift the front pillar trim in the direction of the headlining to remove it.

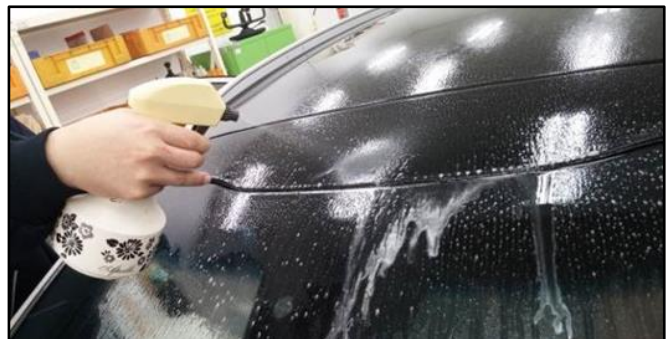
- 2b. Spray a moderate amount of soapy water along the upper outside seal area of the windshield. Make sure the solution is evenly spread across the entire surface and edges.

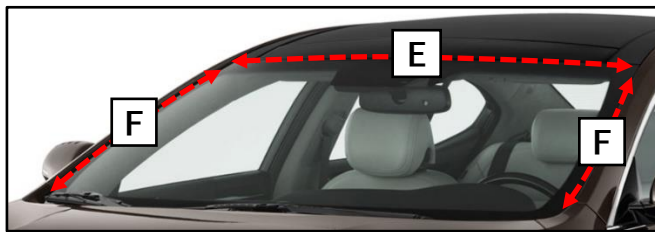
3. Inside the vehicle, inspect for water leakage along the top (E) and side pillar (F) areas of the windshield.

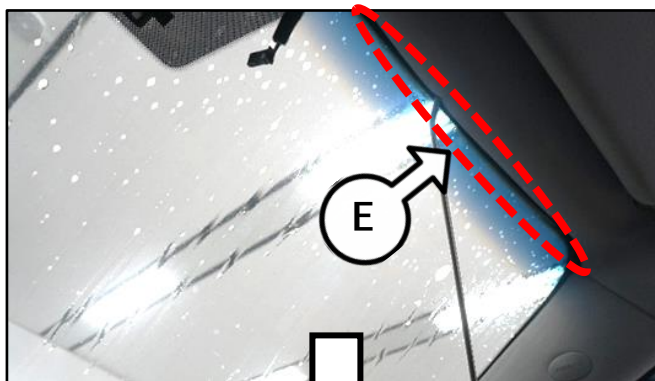
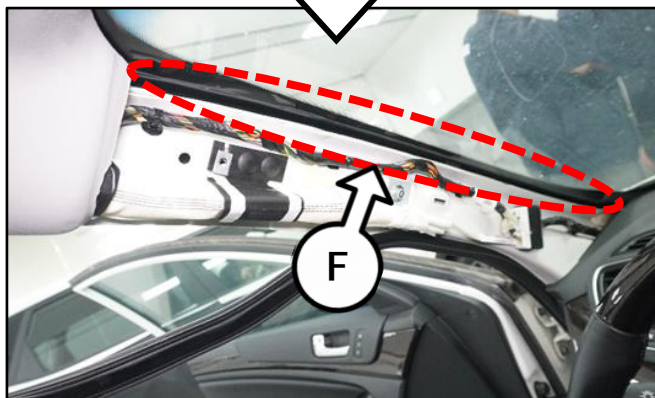
4. Using an air gun, blow air into these areas from inside the vehicle:

E: Between windshield glass and headliner.

F: Between windshield glass and front pillars.

When using the air gun, be careful NOT to lift or damage the inner tint lining on the windshield.

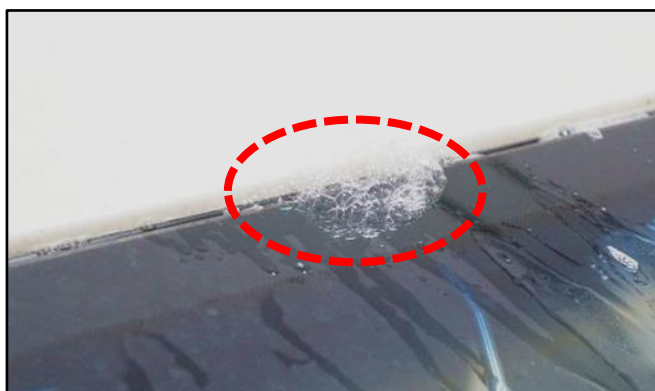
5. Immediately after blowing with the air gun, check for bubbles appearing on the outside of the windshield glass as shown.

- If air bubbles **are not** present, no further action is required. Reinstall all removed parts in the reverse order of removal.
- If air bubbles **are** present, proceed to the 'Repair Procedure' on page 4 to remove and reattach the front windshield glass.

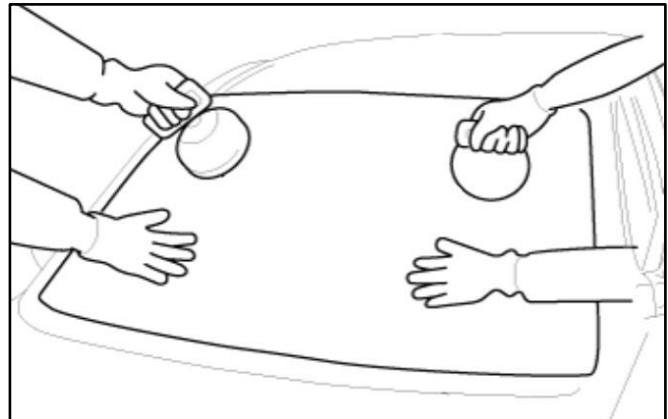
1. Remove and reattach the windshield glass by referring to the "Body (Interior and Exterior) → Interior → Windshield Glass → Repair procedures" chapter in the applicable Shop Manual on KGIS.

- Use a rotating wire removal tool during removal to reduce the possibility of damaging the glass.
- Be careful **NOT** to damage the windshield glass during removal. If the glass is damaged, it cannot be reused.
