Recall Campaign Bulletin

Campaign No. 2022040003, April 2022

SUBJECT: **Various Models**
Model Year 2007-2014

Update Control Unit Software Configuration

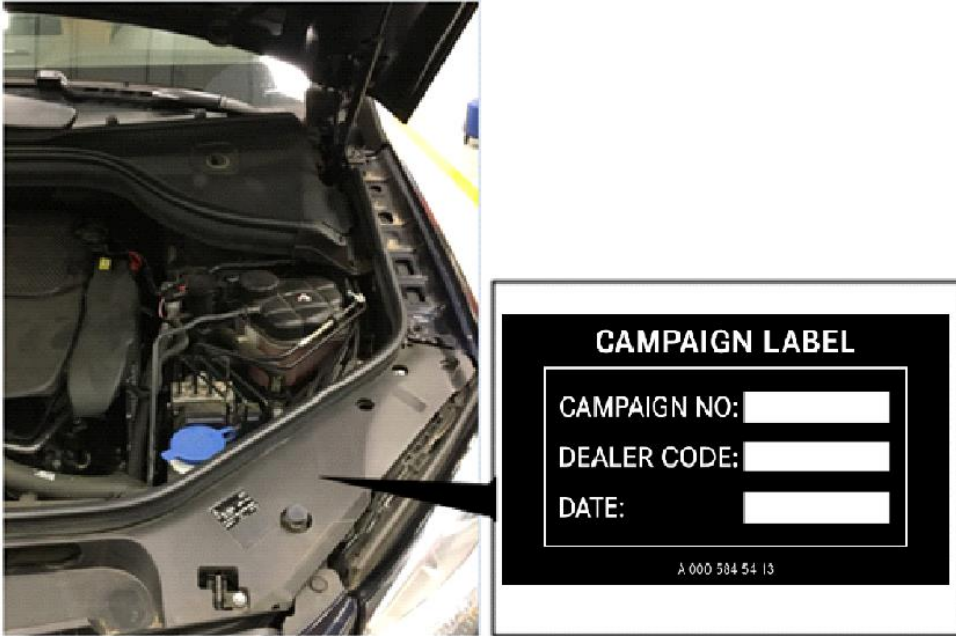
Figure 1

Apply Proof of Correction Label (A 000 584 54 13) to area identified in **Figure 1**. Fill in the blank areas of the label. The campaign number for the California Proof of Correction is unique and must be entered as such (**220403**), your dealer code, and the date of the repair, using a black permanent marker.

i Note: Clean bonding surface prior to affixing label.
