# Safety Recall

## Code: 42L8

**Subject** Rear Suspension Knuckles  
**Release Date** June 10, 2022

**Subject: Safety Recall 42L8 – Rear Suspension Knuckles**

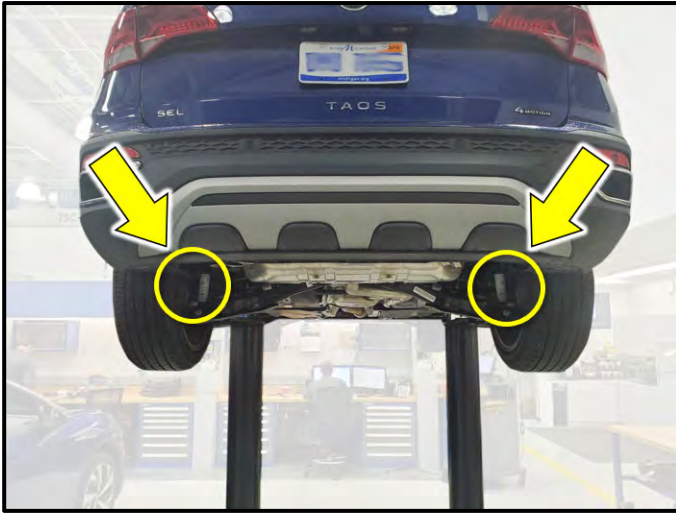
- Both rear wheel bearing housings must be inspected.
- Check the build date on each wheel bearing housing from the rear of the vehicle.

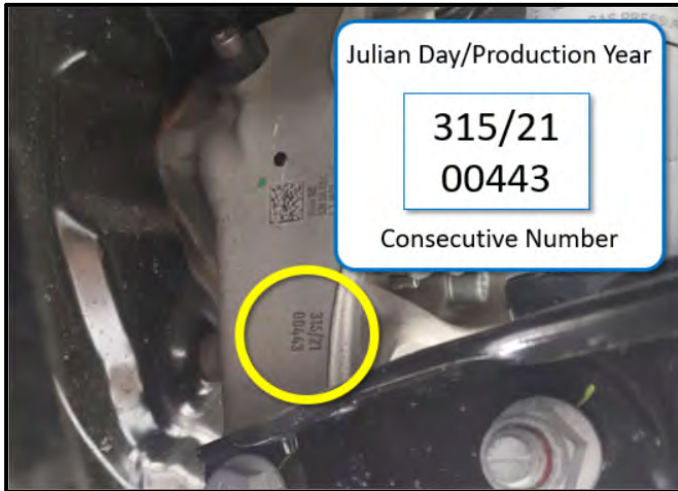
- The wheel bearing build date is read in the example shown.
- The build dates vary by model.

- If the build date of the wheel bearing housing matches the chart of affected build dates:
  - The wheel bearing housing must be replaced.
  - See Section C for wheel bearing housing replacement.
- If the build date does not match the chart:
  - The wheel bearing housing is OK.
  - Proceed to Section D if both wheel bearing housings are OK.

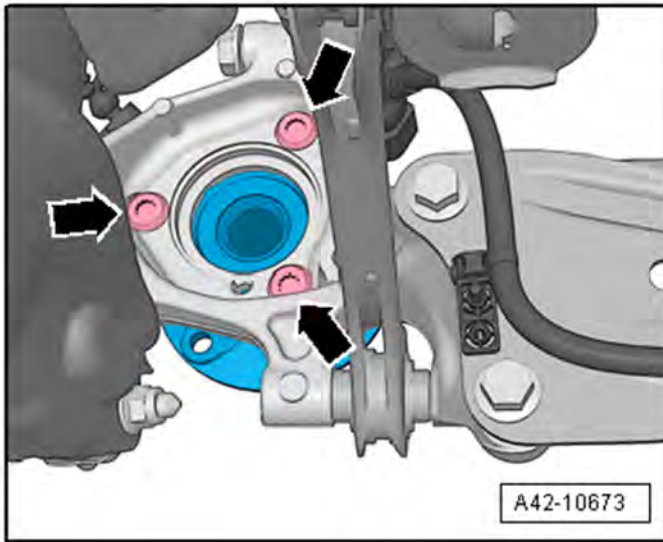
If the wheel bearing is seized to the wheel bearing housing, the wheel bearing should be replaced.

- Remove the bolts <arrows>.
- Remove the wheel bearing unit from the wheel bearing housing.
