Recall Campaign Bulletin

Campaign No. 2022030028, April 2022

SUBJECT: **Model S-Class (223 platform)**
Model Year 2022

Check and Replace Rear Axle Carrier

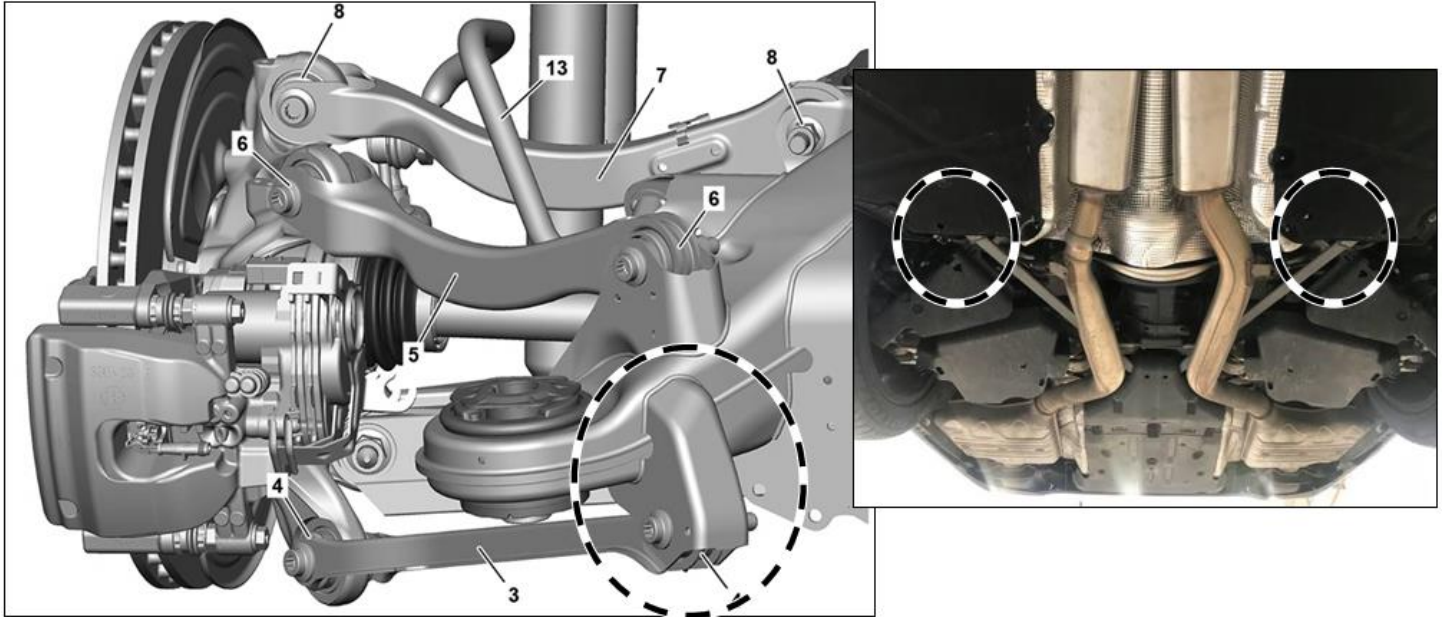
Figure 1

1. Lift vehicle.
2. Check weld seam (A, figure 2) of thrust arm connection to rear axle carrier **on both sides**.

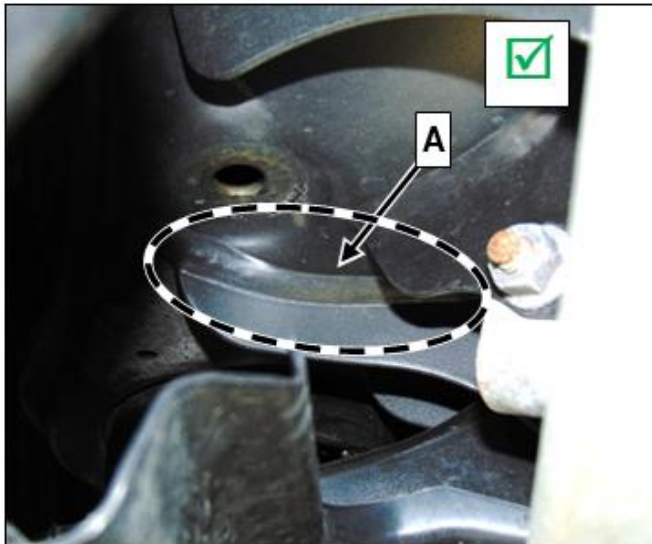
Figure 2

The connection must be end-to-end welded at the rear axle carrier!
-

- a. Weld seam (A) **not** OK: Perform **work procedure**.
- b. Weld seam (A) OK: **Perform step 3 and End measure**.

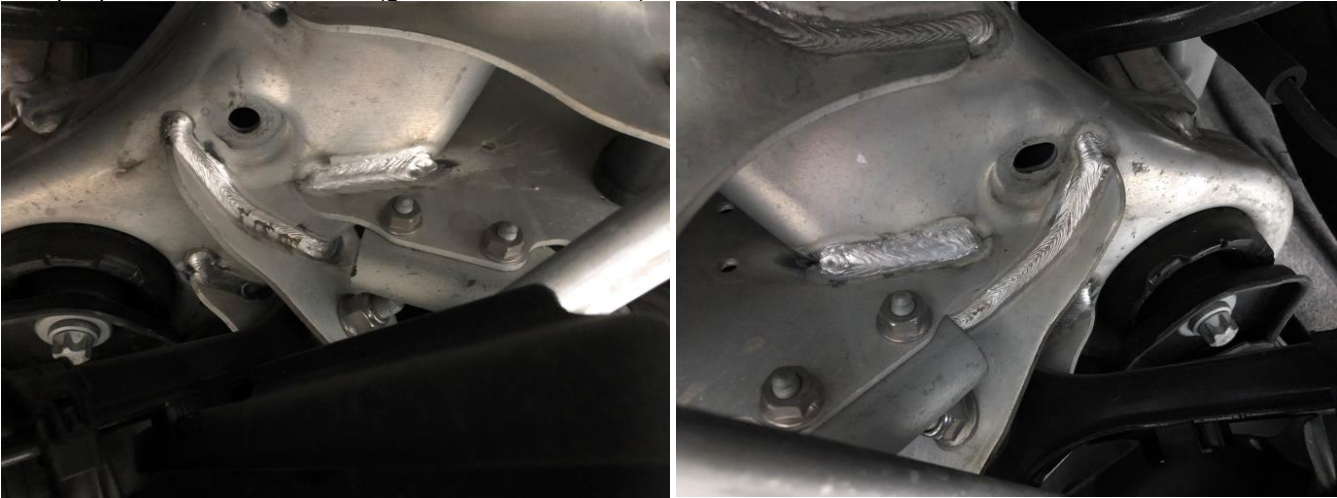
Sample pictures to be attached (good rear axle carrier)

(the color/material of the rear axle carrier could deviate from sample pictures)

3. Create **PTSS Informational only case** and document one high quality picture from the left and one from the right side.
