Keystone RV Company

SAFETY ADVISORY # 22-427

Norco Coupler Welds

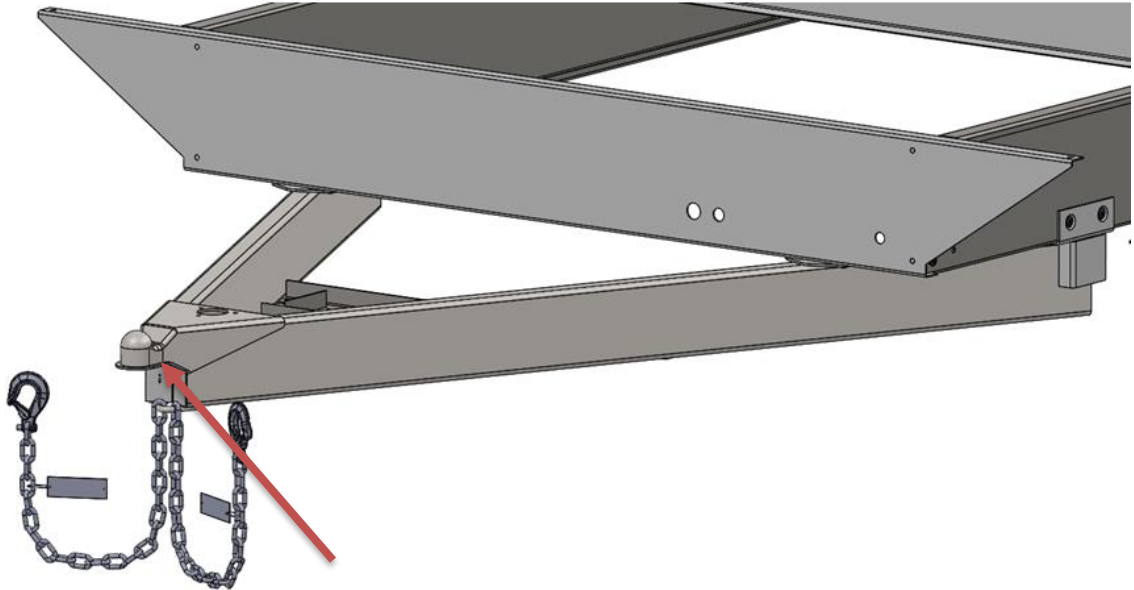
- 1) Inspection location: Bottom side of coupler located at the front end of the a-frame.

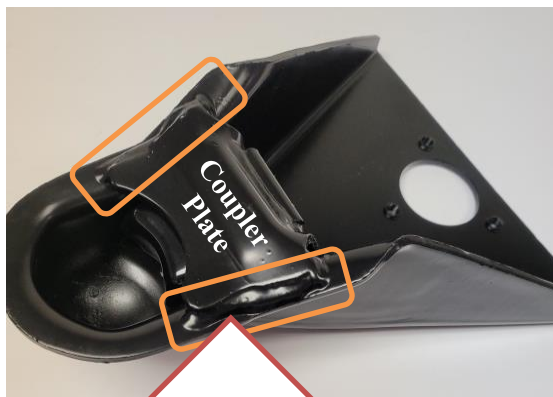
PASS (Painted View)

Weld
along
edges

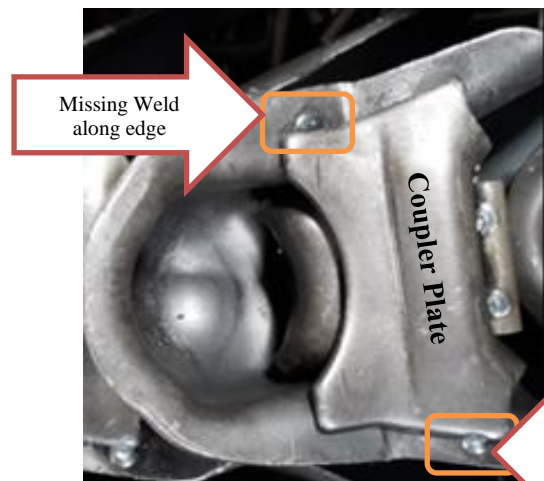
FAIL (Unpainted View)

- 2) Underneath the coupler, use a flashlight to inspect the welds at each side of the bottom coupler plate.
- a. To Pass Inspection: A weld bead should run along each side of the plate.
 - b. To Fail Inspection: A weld bead will not run along the side of the plate and there will only be tack welds

Missing Weld
along edge

Tack Weld
Only

- 1) In a circumstance that the coupler is only tack welded on the underneath plate, the coupler will need to be replaced by a qualified welder.
- 2) Safely support the front of the RV with jack stands and remove the tongue jack.
- 3) Carefully cut through the perimeter welds of the coupler allowing the defective coupler to be removed. *Use caution not to damage the draw tubes when cutting through the welds.*
- 4) Using a grinder, remove any excess weld from the draw tubes once the coupler has been removed.
