GROUP	MODEL
Safety Recall Campaign	2022MY Sorento (MQ4a) w/2.5L T-GDI
NUMBER	DATE
SC233	March 2022

**SUBJECT: TURBOCHARGER OIL FEED PIPE REPLACEMENT (SC233)**

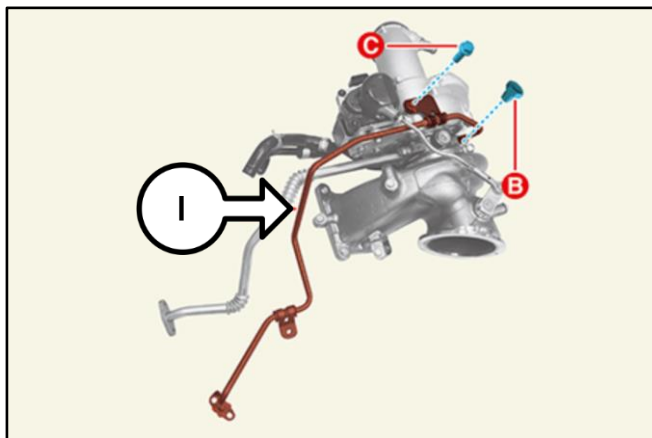
This bulletin provides information to replace the turbocharger oil feed pipe on some 2022MY Sorento (MQ4a) vehicles equipped with Theta III 2.5L T-GDI engines and produced from March 3, 2022 through March 8, 2022. During the production of the turbocharger oil feed pipe, a crack may have occurred at the eye joint of the oil feed pipe. If a crack occurred, oil may leak and contact certain hot surfaces in the engine compartment, increasing the risk of a fire. Follow the procedure outlined in this publication to replace the turbo oil feed pipe. Before conducting the procedure, verify that the vehicle is included in the list of affected VINs.

8. Remove the turbocharger oil feed pipe (I).

**Tightening torque specifications:**

Eyebolt - 20.3 - 23.1 lb-ft (27.5 - 31.4 N.m)

Mounting Nut - 7.2 - 8.7 lb.ft (9.8 - 11.8 N.m)

Bracket Bolt: - 7.2 - 8.7 lb.ft (9.8 - 11.8 N.m)

- 9a. Install the new turbocharger oil feed pipe (incl. new copper washer and gasket) and all other removed parts in the reverse order of removal.
- 9b. If the removed turbocharger oil feed tube was leaking due to a crack, ensure to confirm the oil level is topped off. Allows engine to run after installation and confirm no oil leak is present.
