TECHNICAL INSTRUCTIONS
FOR
SAFETY (NONCOMPLIANCE) RECALL 22TA03

Vehicle Stability Control System May Not Default to "On"

Certain 2020 – 2022 Model Year Highlander Hybrid
Certain 2021 – 2022 Model Year Mirai
Certain 2021 – 2022 Model Year Rav4 Prime
Certain 2022 Model Year Rav4 Hybrid
Certain 2021 – 2022 Sienna Hybrid
Certain 2021 – 2022 Venza Hybrid

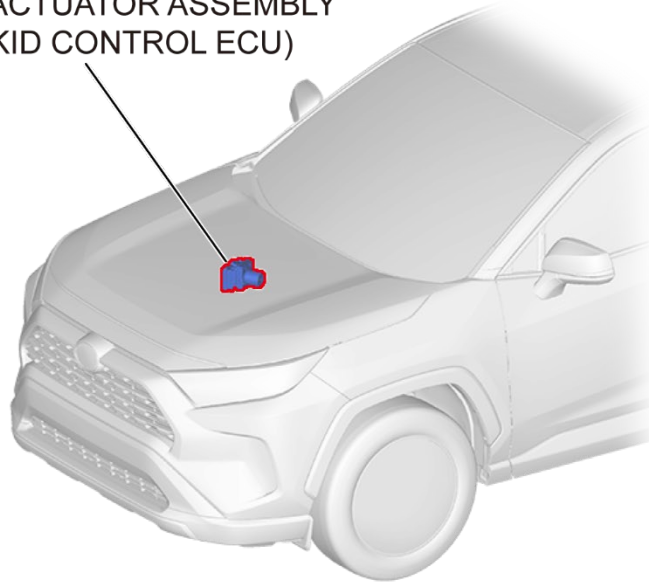
BRAKE ACTUATOR ASSEMBLY
(No. 2 SKID CONTROL ECU)

A software error can cause the Vehicle Stability Control system (VSC) not to default to “ON” the next time the car is started under certain circumstances. This can result in noncompliance with a federal safety requirement. Operating the vehicle with VSC deactivated could increase the risk of a crash in certain driving conditions.

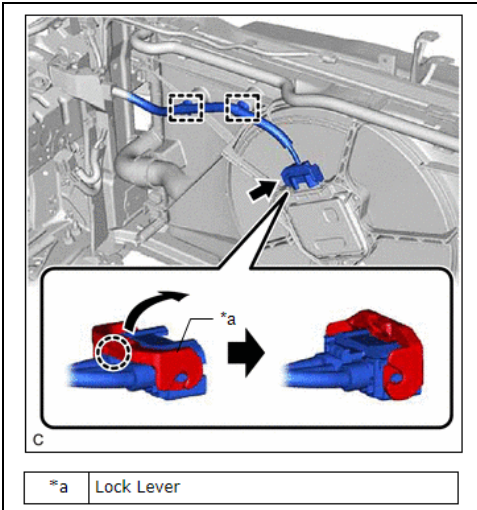
5. DISCONNECT COOLING FAN

If the cooling fans run during the Calibration update procedure, the battery voltage will be inconsistent and could cause damage to the control module(s).

- a. Disconnect the electrical connector from the cooling fan ECU on the radiator fan shroud.
