TECHNICAL INSTRUCTIONS
FOR
SAFETY (NONCOMPLIANCE) RECALL 22LA01

Vehicle Stability Control System May Not Default to "On"

Certain 2021 – 2022 Model Year LS 500h
Certain 2022 Model Year LX 600
Certain 2022 Model Year NX 350h
Certain 2022 Model Year NX 450h+

Update 7/21/22

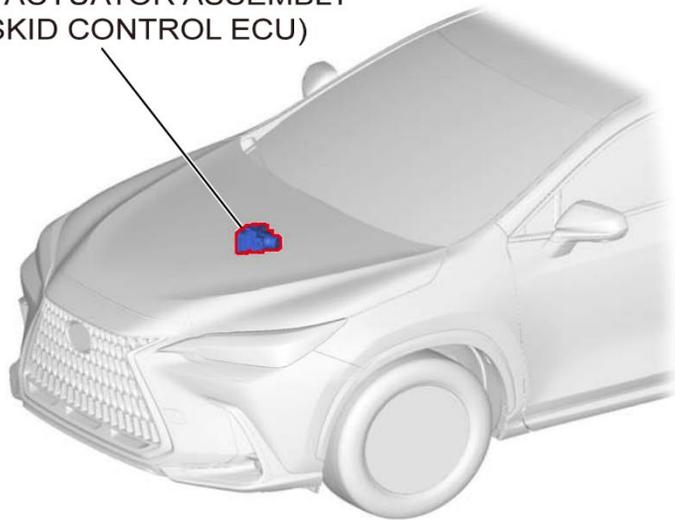
BRAKE ACTUATOR ASSEMBLY
(No. 2 SKID CONTROL ECU)

A software error can cause the Vehicle Stability Control system (VSC) not to default to “ON” the next time the car is started under certain circumstances. This can result in noncompliance with a federal safety requirement. Operating the vehicle with VSC deactivated could increase the risk of a crash in certain driving conditions.

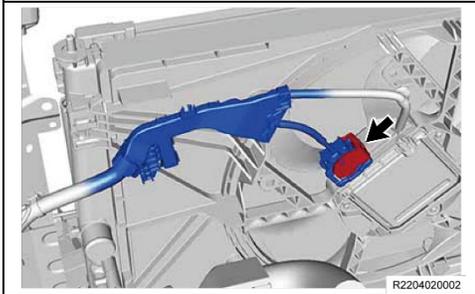
2. DISCONNECT COOLING FAN

If the cooling fans run during the Calibration update procedure, the battery voltage will be inconsistent and could cause damage to the control module(s).

- a. Disconnect the electrical connector from the cooling fan on the radiator fan shroud.
