ANA5 – Reworking Wiring Harness for Front Seats (Stop Delivery/Recall Campaign)

Model Line: **Taycan (Y1A)
Taycan Cross Turismo (Y1B)
Taycan Sport Turismo (Y1C)**

Model Year: **As of 2020 up to 2022**

Concerns: **Wiring harness for front seats on vehicle side**

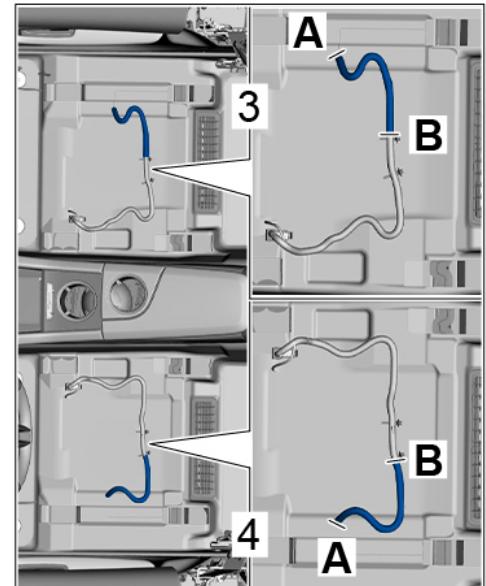
Reworking wire harness

- 2 Tightly wrap the wiring harness on the front right ⇒ *Reworking wire harness -3-* and left seat, ⇒ *Reworking wire harness -4-* including the protective tube for fabric, between the outlet opening on the carpeting ⇒ *Reworking wire harness -A-* and the first fastening clip on the seat frame ⇒ *Reworking wire harness -B-*. The textile fabric tape should overlap by approx. 1/3.
