TECHNICAL INSTRUCTIONS
FOR
SAFETY (NONCOMPLIANCE) RECALL 22TA04

Panoramic View Monitor System – Potential Failure to Display Rearview Image

Certain 2022 Model Year Tundra

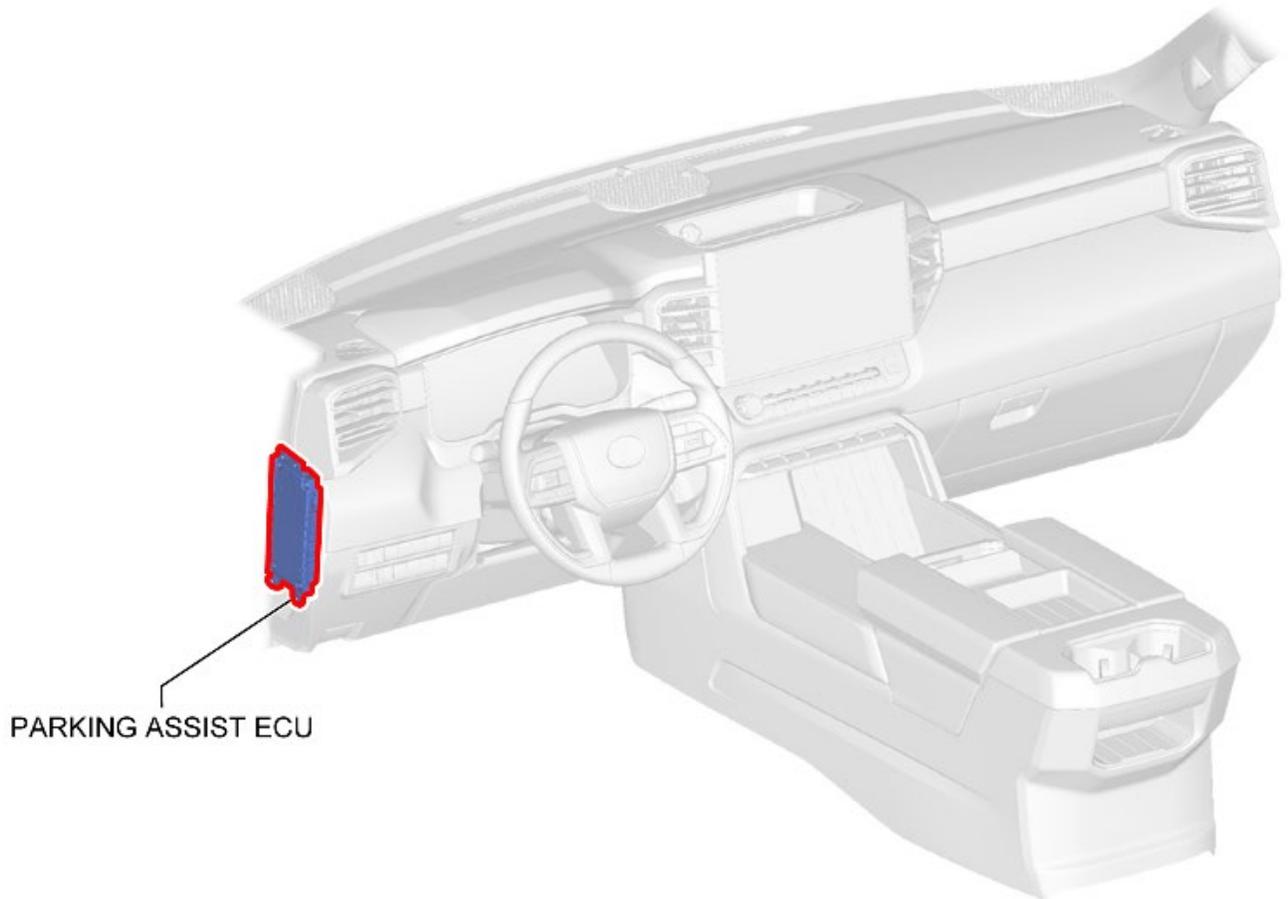
PARKING ASSIST ECU

In the affected vehicles, a software programming issue can cause individual cameras in the Panoramic View Monitoring (PVM) system, including the backup camera, to not display an image. If the backup camera image does not display when the vehicle is in reverse, the vehicle will not comply with safety regulations in certain markets and may increase the risk of a crash.

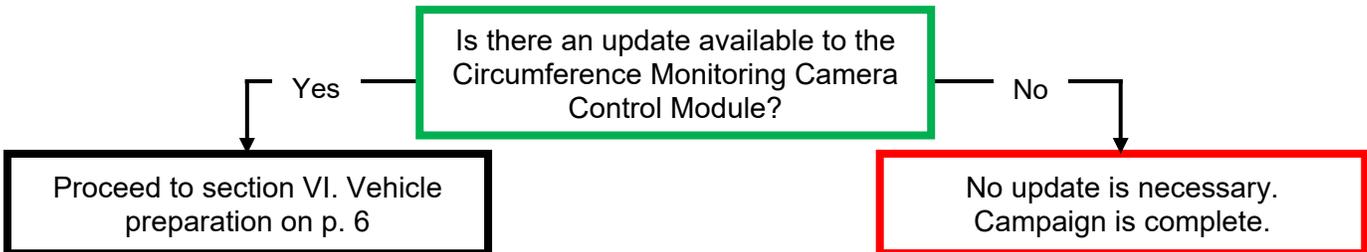
- Locate the **Update** column for the **Circumference Monitoring Camera Control Module** in the **Stored Data** tab for this vehicle.
- Determine the status of an available update for the Circumference Monitoring Camera Control Module; indicated by a YES or NO.
