# Recall Campaign Bulletin

Campaign No. 2022050011, May 2022

SUBJECT: **Model GLB-Class (247 platform)**  
**Model Year 2021**

## **Check Level Sensor Linkage Rear Axle**

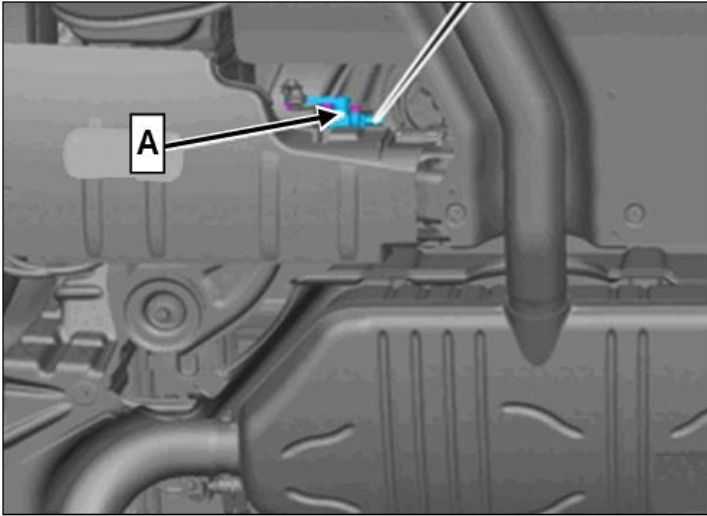
Figure 1

2. Check installation position of link rod of right rear axle level sensor (**A, figure 1**).
