# Recall Campaign Bulletin

Campaign No. 2022050015, May 2022

SUBJECT: **Model GL-Class, ML-Class, and R-Class (X164, W164 and 251 platform)  
Model Year 2006-2012**

## **Inspect Brake Booster – without Pedal Rework**

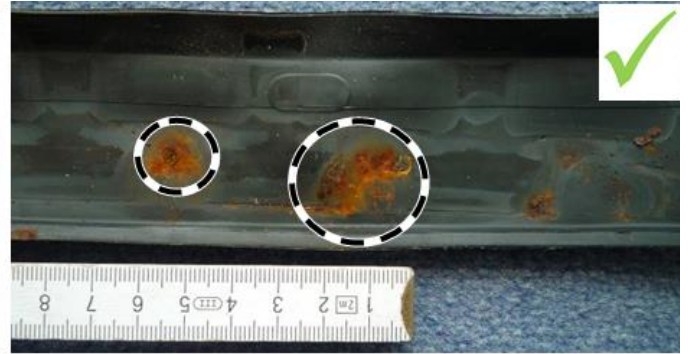
A maximum of **one point-shaped corrosion mark** with a diameter **greater than 15 mm** (Figures 6 and 7) is permitted.

- a. Corrosion measurements **Exceeds thresholds-Not OK: Carry out work procedure**
- b. Corrosion measurements **Does not exceed threshold-OK (Figures 5, 6 or 7): End measure.**

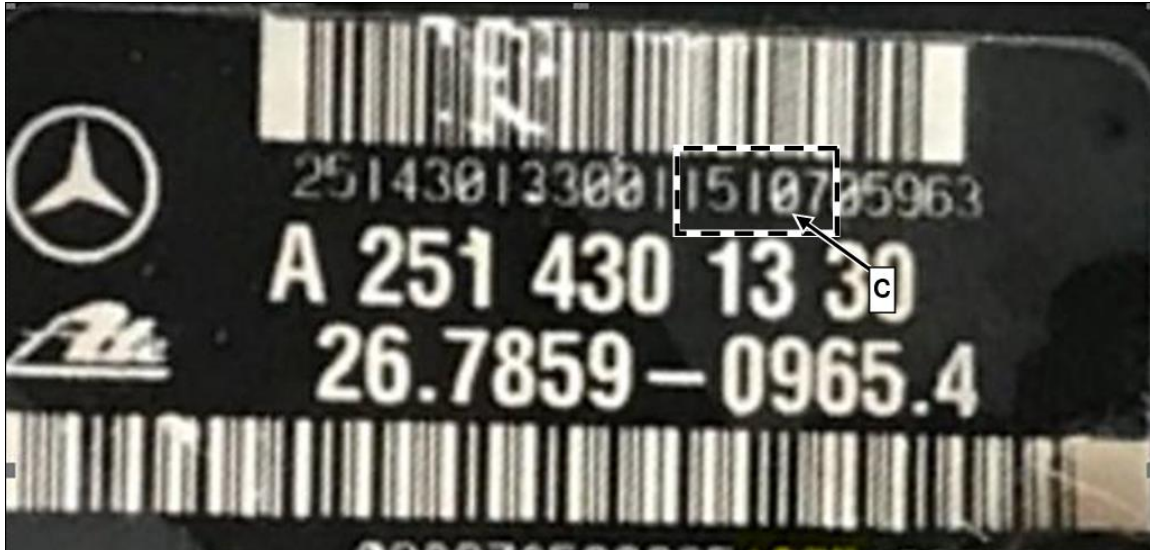
Figure 9

2. Check sequence of numbers on the barcode label (**C**, Figure 9).
  - a. If the numeric sequence between the 13<sup>th</sup> and 17<sup>th</sup> digits are **less than** "15126": Carry out **work procedure below**.
  - b. If the numeric sequence between the 13<sup>th</sup> and 17<sup>th</sup> digits are **greater than or equal to** "15126": **End measure**.
