Recall Campaign Launch Notification			May 28, 2022
Campaign No. :	NHTSA ID	Campaign Desc. :	<b>Inspect Brake Booster Without Pedal Rework</b>
2022050015	22V315	22P4290005	
<p>This is to notify you of the Recall Campaign Launch to inspect the brake booster on <b>278,173</b> Model Year (“MY”) 2006-2012 GL-Class, ML-Class, and R-Class (X164, W164 and 251 platform) vehicles. The recall campaign will be visible on the <a href="http://www.safercar.gov">www.safercar.gov</a> website and may generate questions from customers. Affected VINs will be flagged in VMI as “OPEN” on <b>May 28, 2022</b>.</p>			
<b>Background</b>			
<b>Issue</b>	<p>Mercedes-Benz AG (“MBAG”), the manufacturer of Mercedes-Benz vehicles, has determined that on certain Model Year (“MY”) 2006-2012 ML-Class, GL-Class (W164/X164 platform) and R-Class (251 platform) vehicles, the function of the brake booster might be affected due to advanced corrosion in the joint area of its housing. After extended time in the field and in conjunction with prolonged water exposure, this corrosion might lead to a vacuum leak at the brake booster. If this were to occur, the brake force support might be reduced, leading to an increase in the

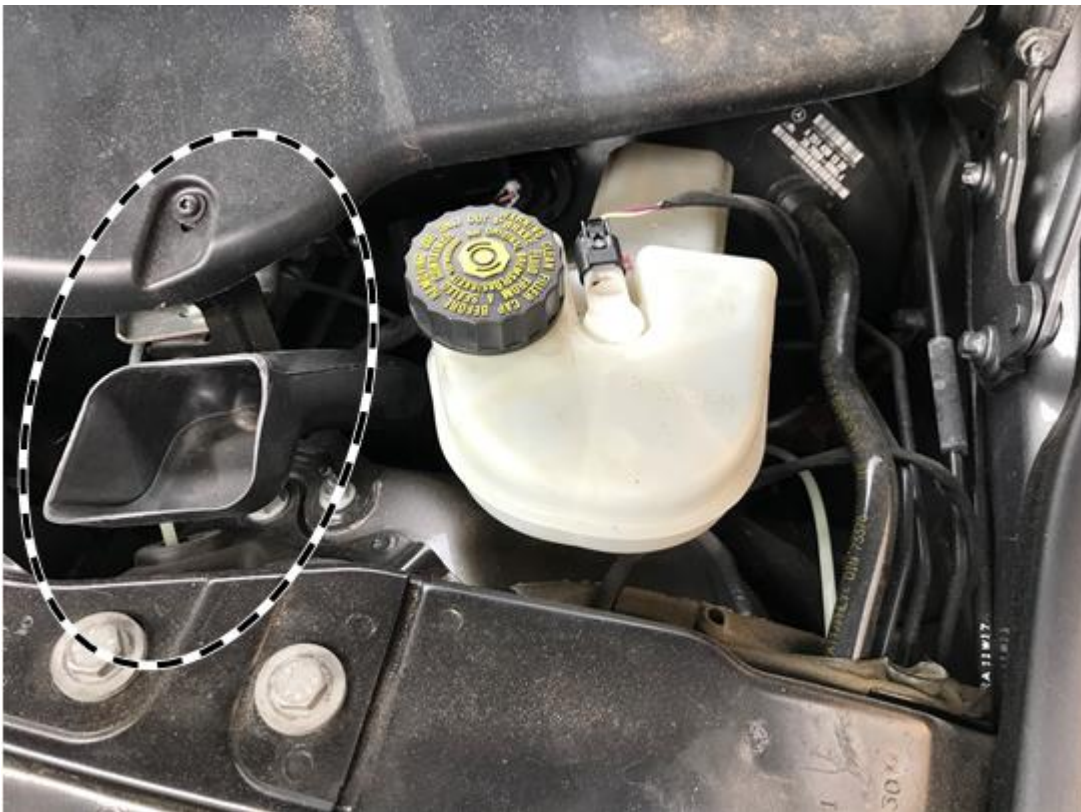
Figure 1

1. Open the hood and check the water drains (**marking, figure 1**) for correct installation and ability to drain.

**i** Clean and correctly install water drains if necessary.

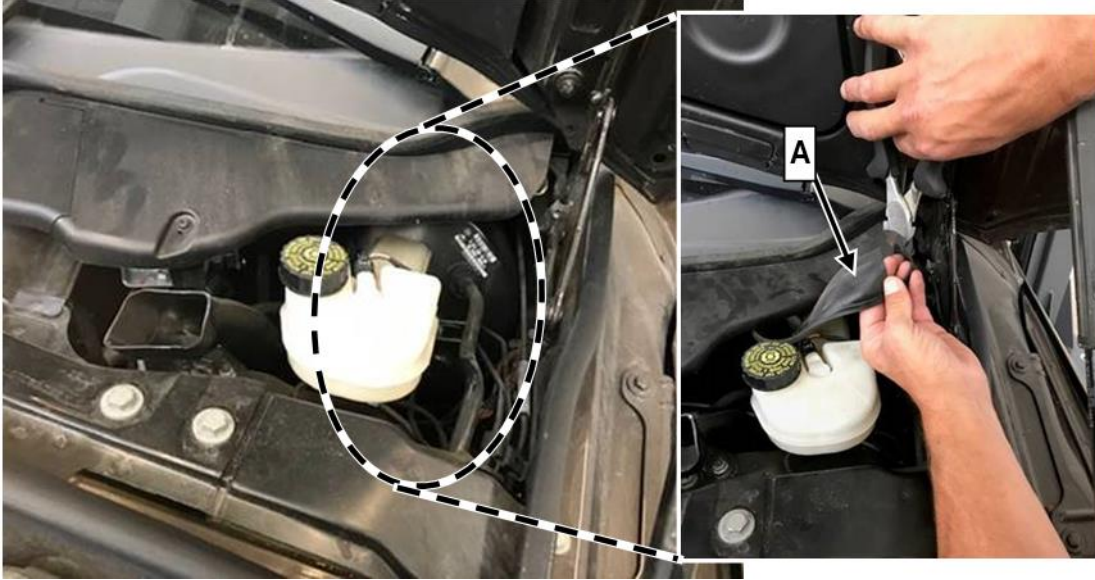
Figure 2

2. Remove the rubber sleeve wrapped around the brake booster (**A, figure 2**) with a suitable tool (hook and side cutting pliers). If the rubber sleeve is not present, please proceed to check/test procedure **A1**.

**i** The rubber sleeve should be separated above the barcode label on the brake booster as seen in (**A, figure 2** and **B, figure 4.1**).

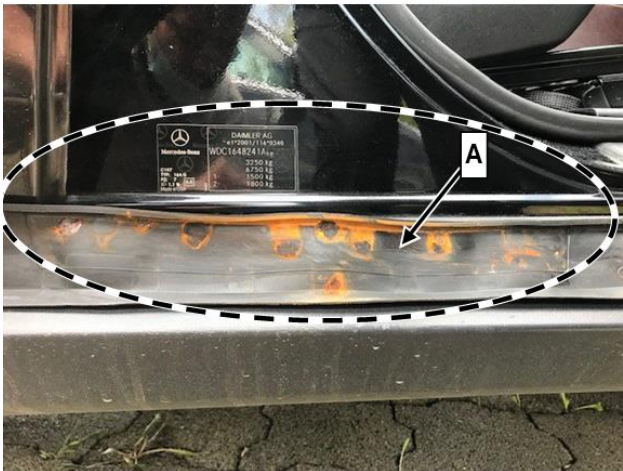
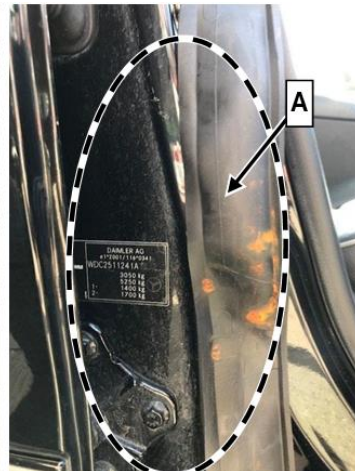
3. Take a photo of the rubber sleeve with the VIN label of the B-pillar (**A, figures 3 and 4**) and store to a local HDD/computer storage location with the vehicle service file and attach it to the warranty claim in EVA.

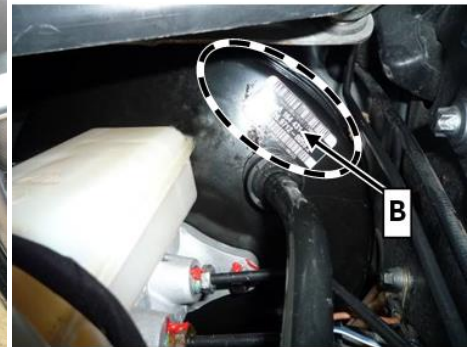
Figure 4.1

**i** If the rubber sleeve on the brake booster is **not** present, please take a photo of the barcode label (**B, figure 4.1**) on the brake booster and store to a local HDD/computer storage location with the vehicle service file and attach to the warranty claim in EVA. Then continue with **check/test procedure A1**.

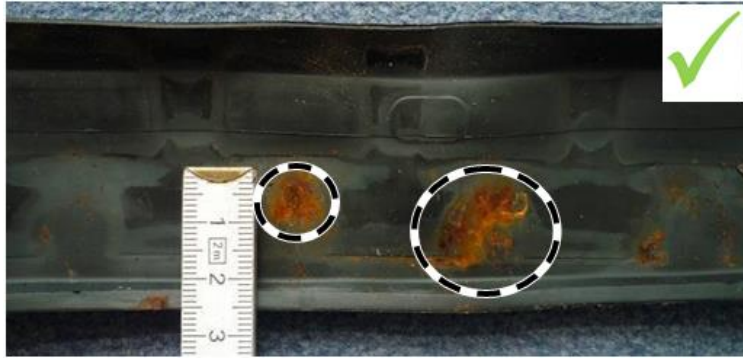
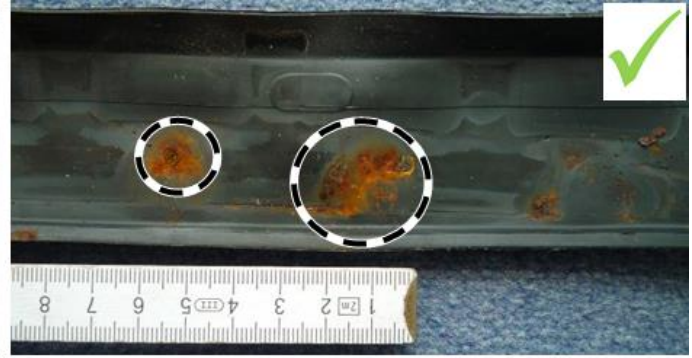
A maximum of **one point-shaped corrosion mark** with a diameter **greater than 15 mm** (**figures 6 and 7**) is permitted.

Figure 6 Ok

Figure 7 OK

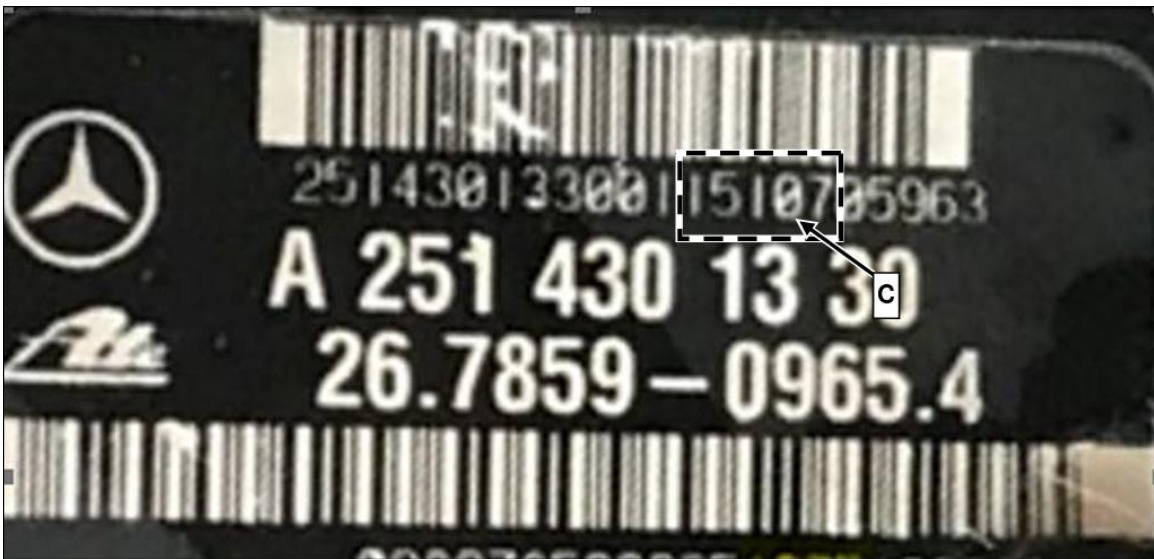
Figure 4.2

1. Check sequence of numbers on the barcode label (**C, figure 4.2**).
  - a. IF the sequence of numbers is **less than** "15126" starting from the 13th number: Perform **check/test procedure B - XENTRY/DAS**.
  - b. If the sequence of numbers is **greater than or equal to** "15126" starting from the 13th number: **End the measure**.
