Recall Campaign Bulletin

Campaign No. 2022050015, May 2022

SUBJECT: **Model GL-Class, ML-Class, and R-Class (X164, W164 and 251 platform)
Model Year 2006-2012**

Inspect Brake Booster – without Pedal Rework

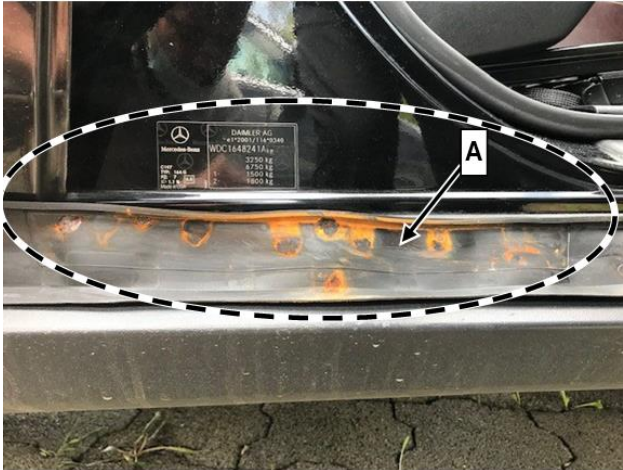
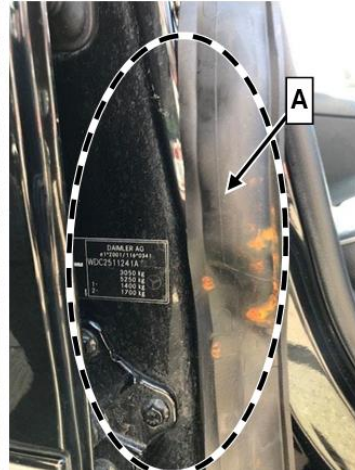
3. Take a photo of the rubber sleeve with the VIN label of the B-pillar (**A, figures 3 and 4**) and store to a local HDD/computer storage location with the vehicle service file and attach it to the warranty claim in EVA.

i These pictures serve as documentation of the current condition of the brake booster.
