TO: Mercedes-Benz Dealer Principals, General Managers, Sales Managers, Service Managers, Parts Managers	FROM: Gregory Gunther, Department Manager, Vehicle Compliance and Analysis, Engineering Services
RE: <b>Updated Recall Campaign Launch Notification – STOP DRIVE</b> <b>Inspect Brake Booster without Pedal Rework MY06-12 GL-Class, ML-Class, R-Class (X164, W164, 251 platform)</b>	UPDATE: July 22, 2022

Campaign No. 2022050015, May 2022

SUBJECT: **Model GL-Class, ML-Class, and R-Class (X164, W164 and 251 platform)  
Model Year 2006-2012**

## **Inspect Brake Booster – without Pedal Rework**

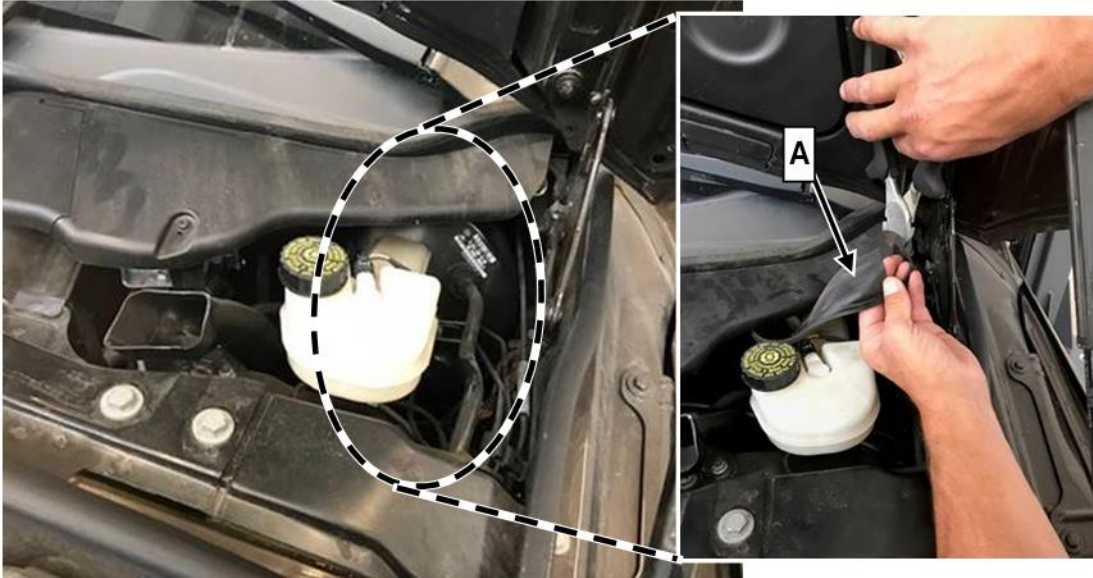
Figure 2

2. Remove the rubber sleeve wrapped around the brake booster (**A, figure 2**) with a suitable tool (hook and side cutting pliers). If the rubber sleeve is not present, please proceed to check/test procedure **A1**.
  - i** The rubber sleeve should be separated above the barcode label on the brake booster as seen in (**A, figure 2** and **B, figure 4.1**).

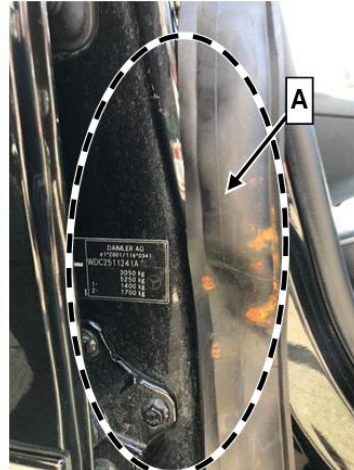
3. Take a photo of the rubber sleeve with the VIN label of the B-pillar (**A, figures 3 and 4**) and store to a local HDD/computer storage location with the vehicle service file and attach it to the warranty claim in EVA.
  - i** These pictures serve as documentation of the current condition of the brake booster.

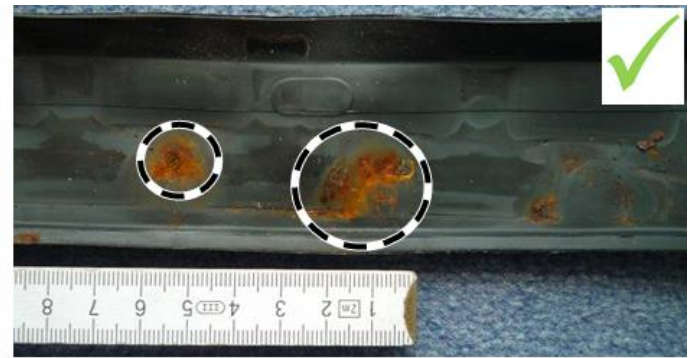
A maximum of **one point-shaped corrosion mark** with a diameter **greater than 15 mm** (**figures 6 and 7**) is permitted.

- Corrosion measurements **Exceeds thresholds-NOK**: Carry out **check/test procedure B - XENTRY/DAS**.
- Corrosion measurements **Does not exceed threshold-OK** (figure 5, 6 or 7): **End measure.** (Certificate of Passed Initial Diagnostic Brake Test not required).

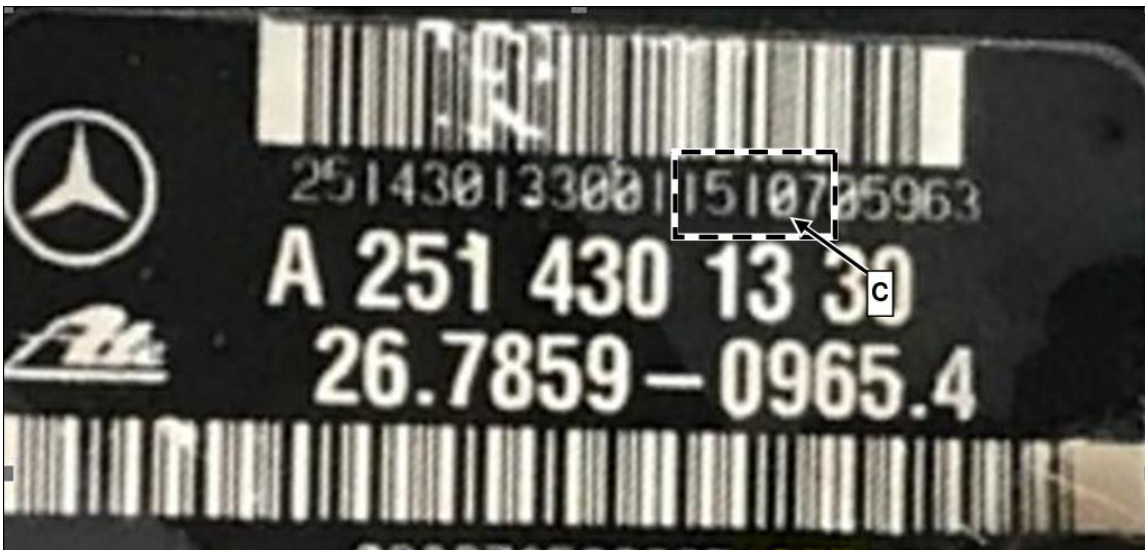
Figure 9

1. Check sequence of numbers on the barcode label (C, figure 9).
  - a. If the numeric sequence **between** numbers **13 and 17** is **less than** "15126": Carry out **scope of testing B - XENTRY/DAS**.
  - b. If the numeric sequence **between** numbers **13 and 17** is **greater than or equal to** "15126": **End measure**.
